# Synergistic Effects of Oxidation and Load on SiC/BN/SiC Ceramic Matrix Composite Degradation at Intermediate Temperatures

## Dissertation

Kaitlin Detwiler

May 2022

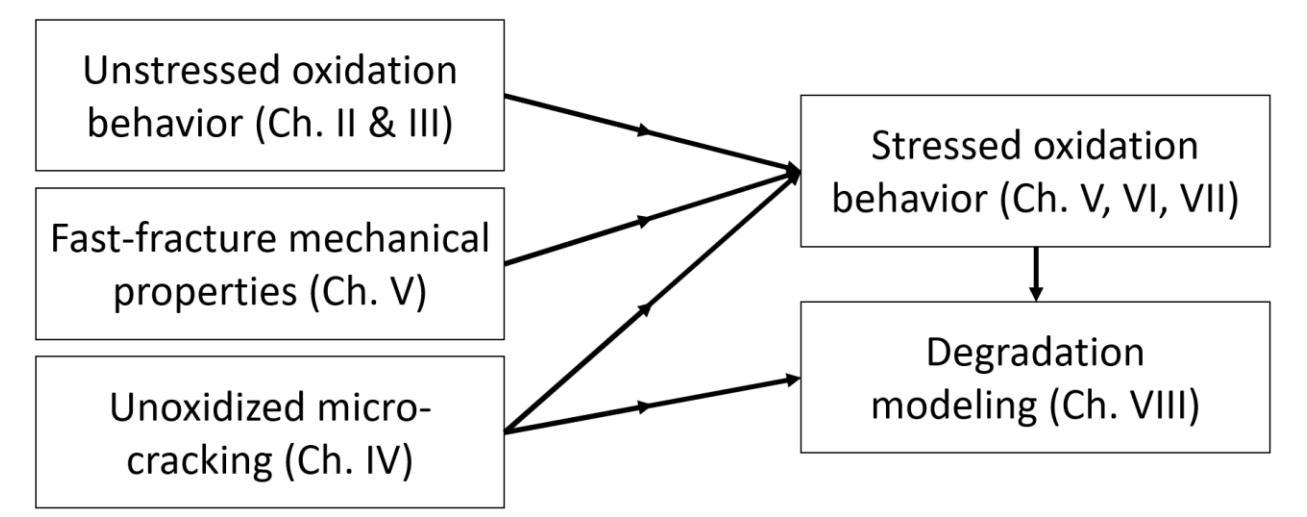
Figure 2: Schematic of data relationships in this dissertation. Data from each chapter is related to subsequent chapters to understand synergistic effects of oxidation and load on SiC/BN/SiC CMC degradation.

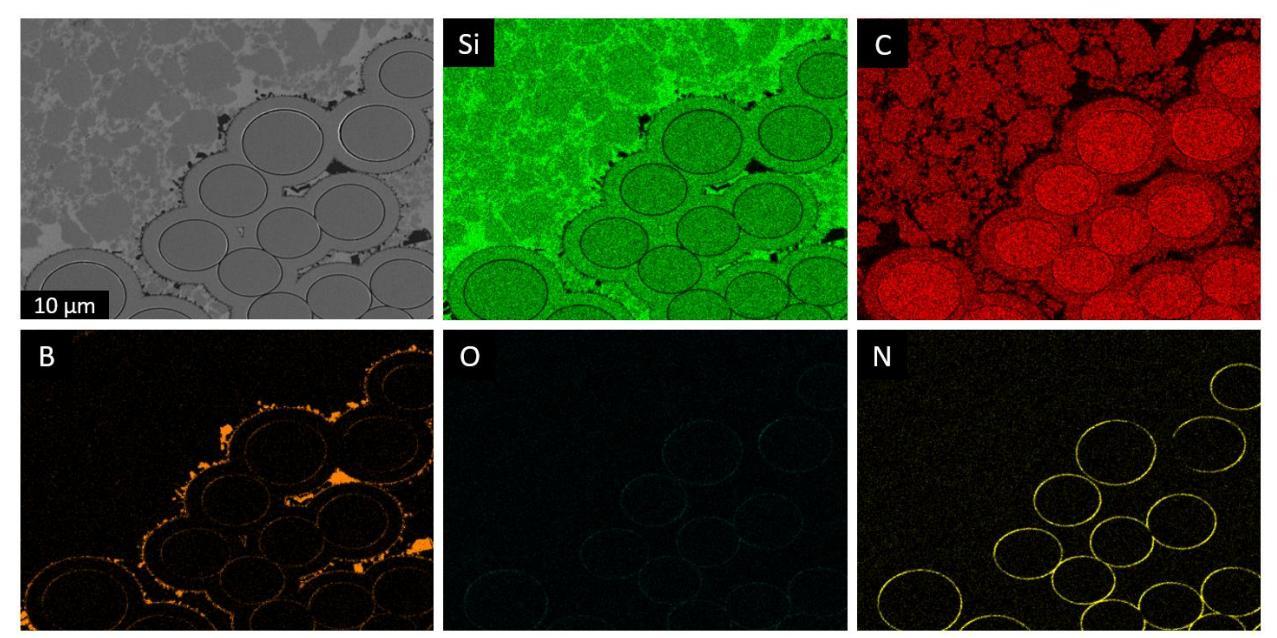
Figure 4: SEM/EDS maps of as-received SiC/BN/SiC CMC used in this study. EDS map colors are used throughout thesis document.

State of the art CMCs were provided by Rolls-Royce High Temperature Composites (RR-HTC). Scanning electron microscopy (SEM) and energy dispersive spectroscopy (EDS) were used to characterize as-received material, as seen in Figure 4. EDS maps are used throughout the dissertation to assess the post-exposure state of the material, and the same color scheme is kept throughout the work. It should be noted that in the as-received material, little oxygen signal is detected in the coatings at the surface, or in cross-sections of the coatings seen in a focus ion beam (FIB) milled cross-section in Figure 5. Nitrogen signal is used to assess the presence of the BN interphase post-exposure.

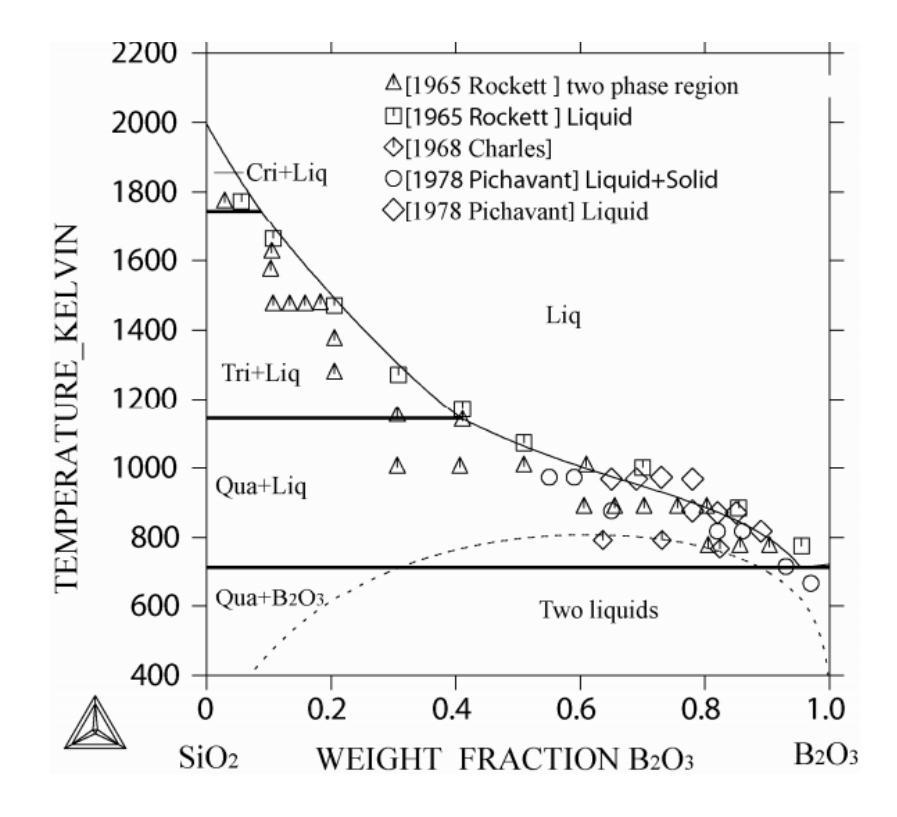
Figure 6:  $B_2O_3$ -SiO<sub>2</sub> phase diagram based on thermodynamic calculations and experimental data [10].

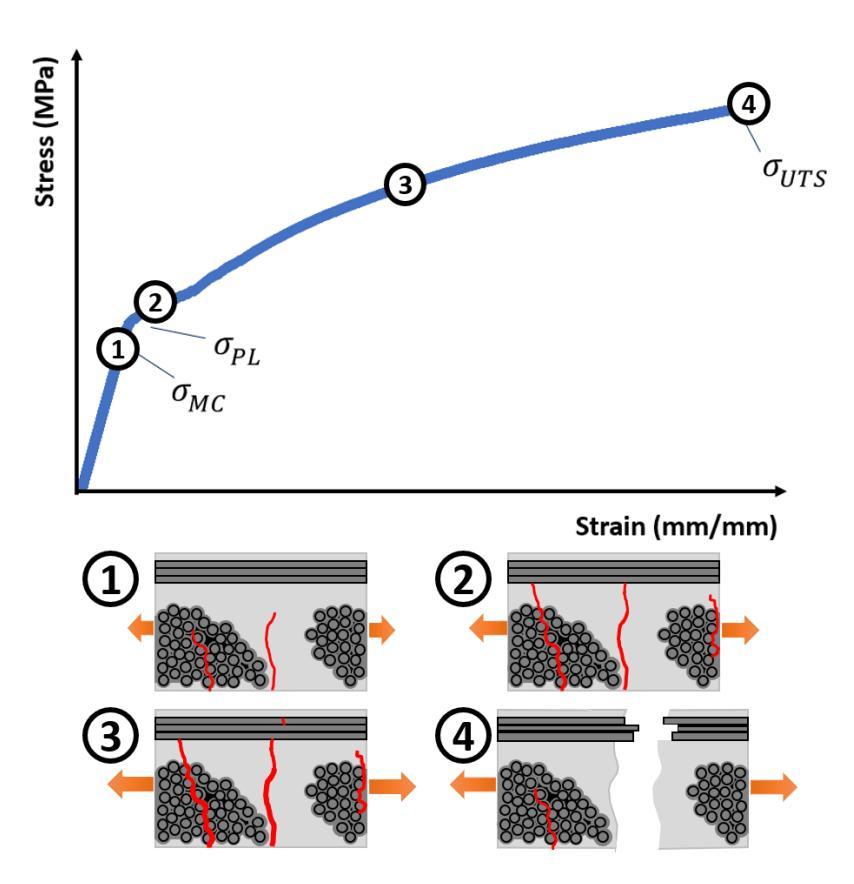
Figure 8: SiC/BN/SiC CMC stress-strain behavior, where 1) micro-cracks initiate between transverse fibers and in the matrix material at the matrix cracking stress ( $\sigma_{MC}$ ), 2) more cracks initiate and the existing cracks widen past the proportional limit ( $\sigma_{PL}$ ), 3) crack opening displacements widen further and stochastic fiber failure occurs and 4) the sample fails at the ultimate tensile stress ( $\sigma_{UTS}$ ).

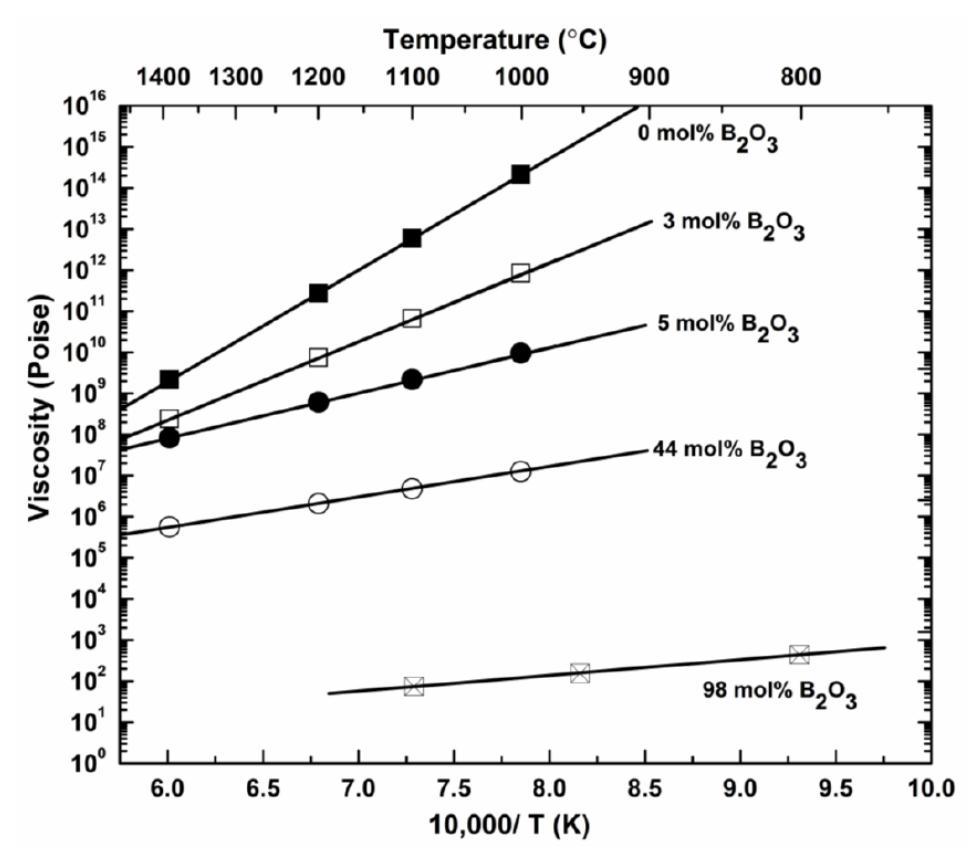
Figure 11: Borosilicate viscosity versus temperature. Viscosities are reported from Yan et al. (0, 3, 5, and 48 mol%  $B_2O_3$ ) [35] and Bruckner and Navarro (98 mol%  $B_2O_3$ ) [25]. Figure was reproduced from [18].

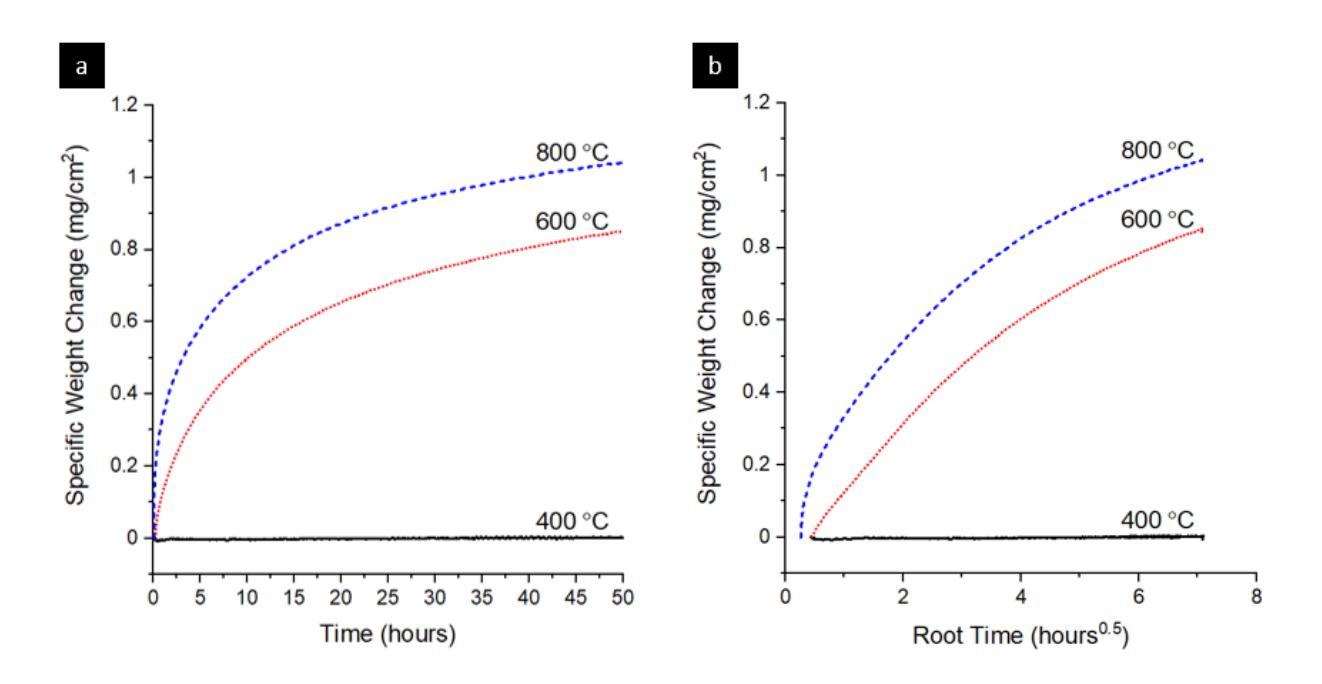
Figure 14: Specific weight change data for SiC/BN/SiC exposed to dry  $O_2$  for 50 hours at 400, 600, and 800°C vs. (a) time and (b) root time.

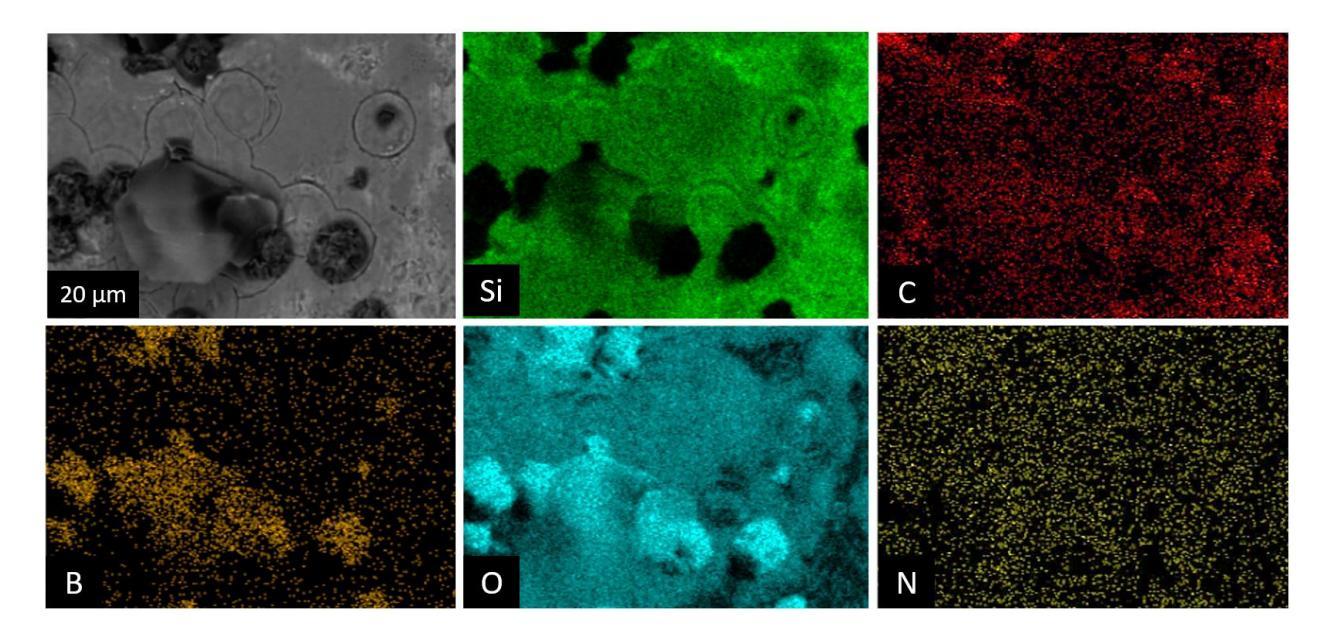
Figure 16: Fiber tow of SiC/BN/SiC sample exposed for 50 hours at 600°C in dry oxygen showing boria-rich and silica-rich regions of oxide growth.

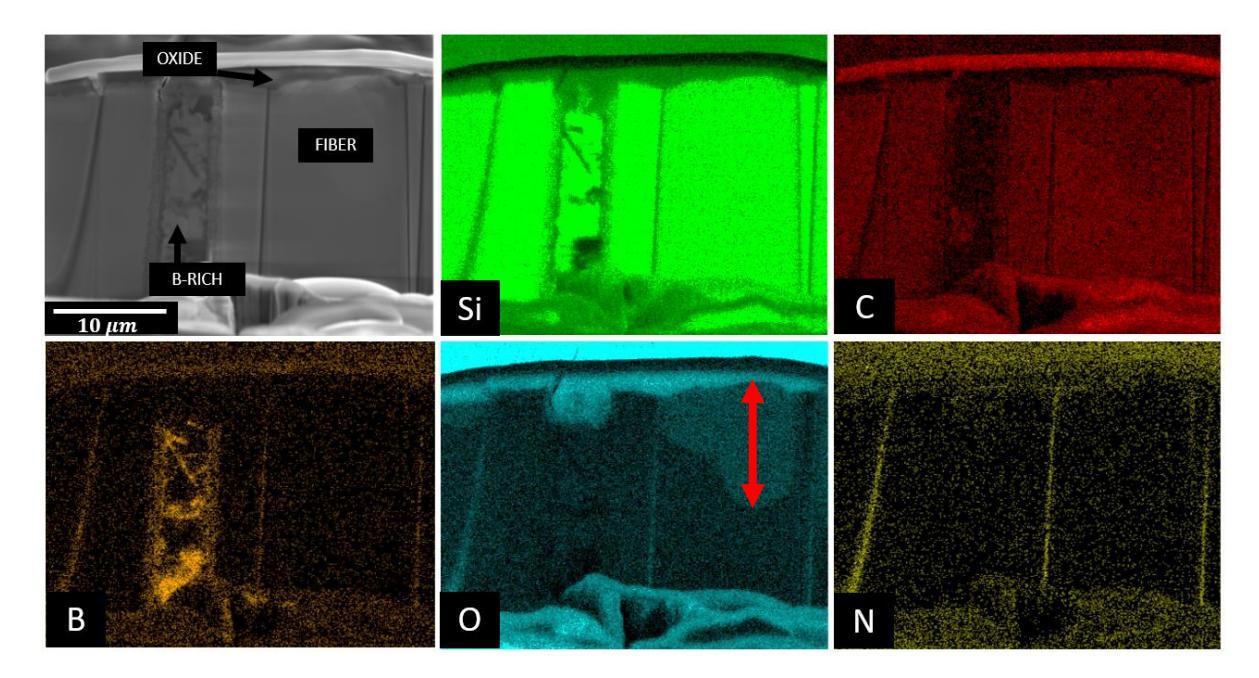
Figure 17: FIB cross-section of SiC/BN/SiC fibers exposed for 50 hours at 600°C in dry oxygen with surface oxide coverage. The red arrow in the oxygen map indicates oxygen solubility length in the fibers.

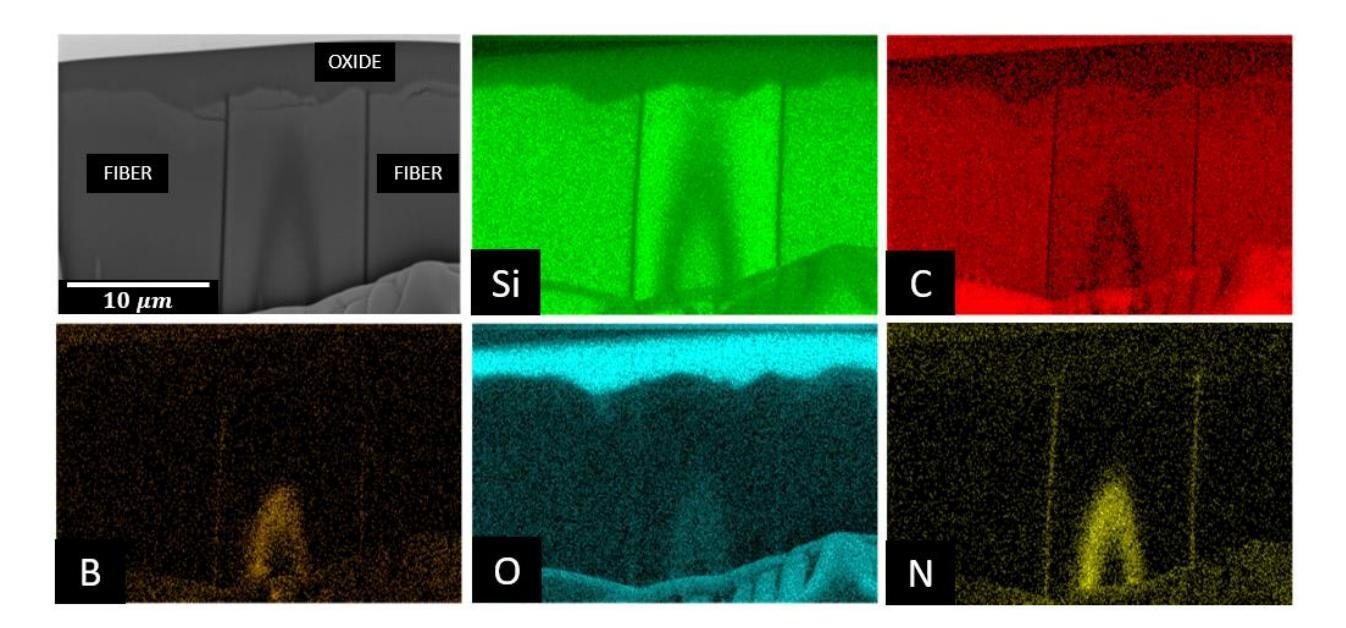
Figure 20: FIB cross-section of SiC/BN/SiC fibers exposed for 50 hours at 800°C in dry oxygen. Note the intact BN interphase and lack of oxygen solubility in the fibers.

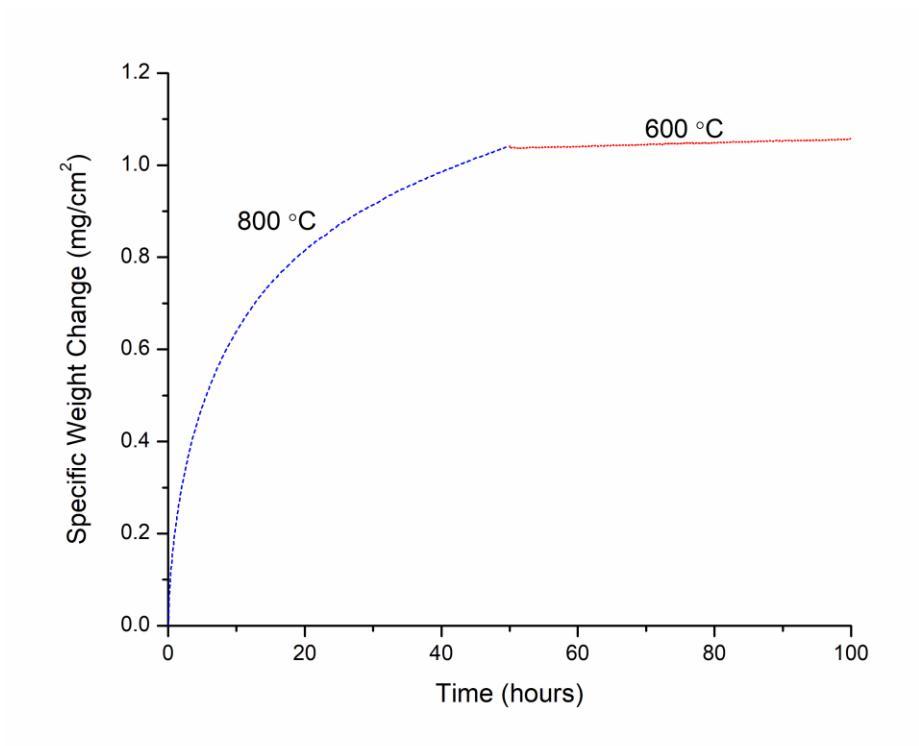
Figure 21: Specific weight change data for SiC/BN/SiC exposed to dry O2 for 50 hours at 800°C immediately followed by an exposure for 50 hours at 600°C.

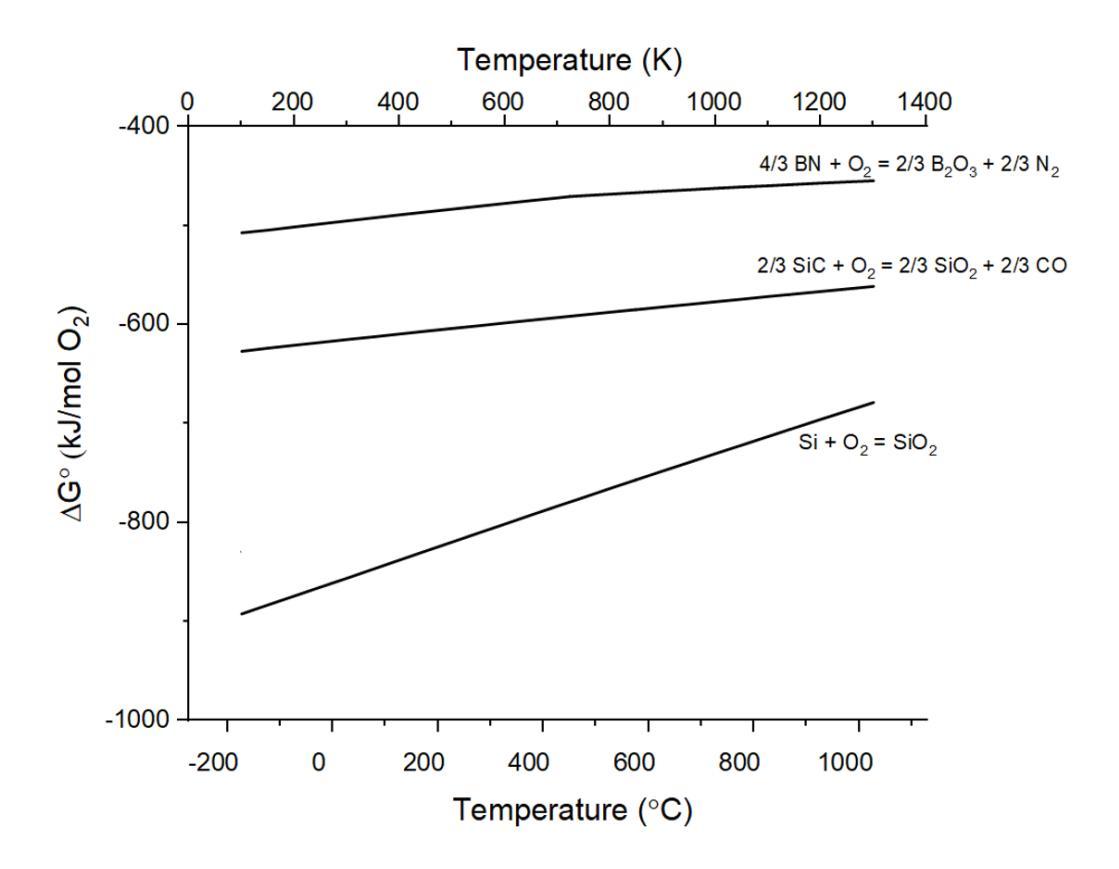
Figure 23: Ellingham Diagram for SiC/BN/SiC system calculated using the FactPS database in FactSage

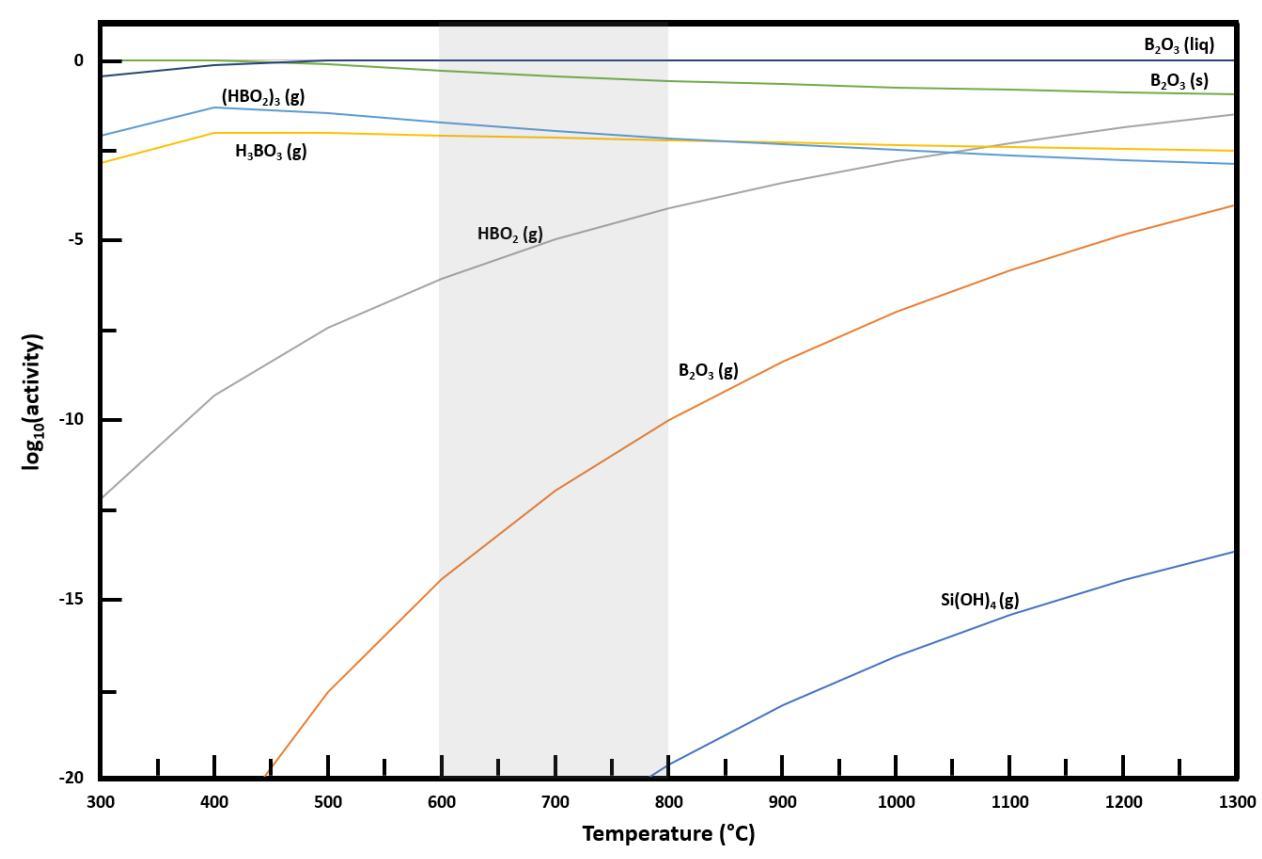
Figure 24: Activities of boron and silicon hydroxide species versus temperature for 0.5 mol  $H_2O$  and 0.5 mol  $O_2$  at 1 atm. The temperature region of interest is shaded in grey.

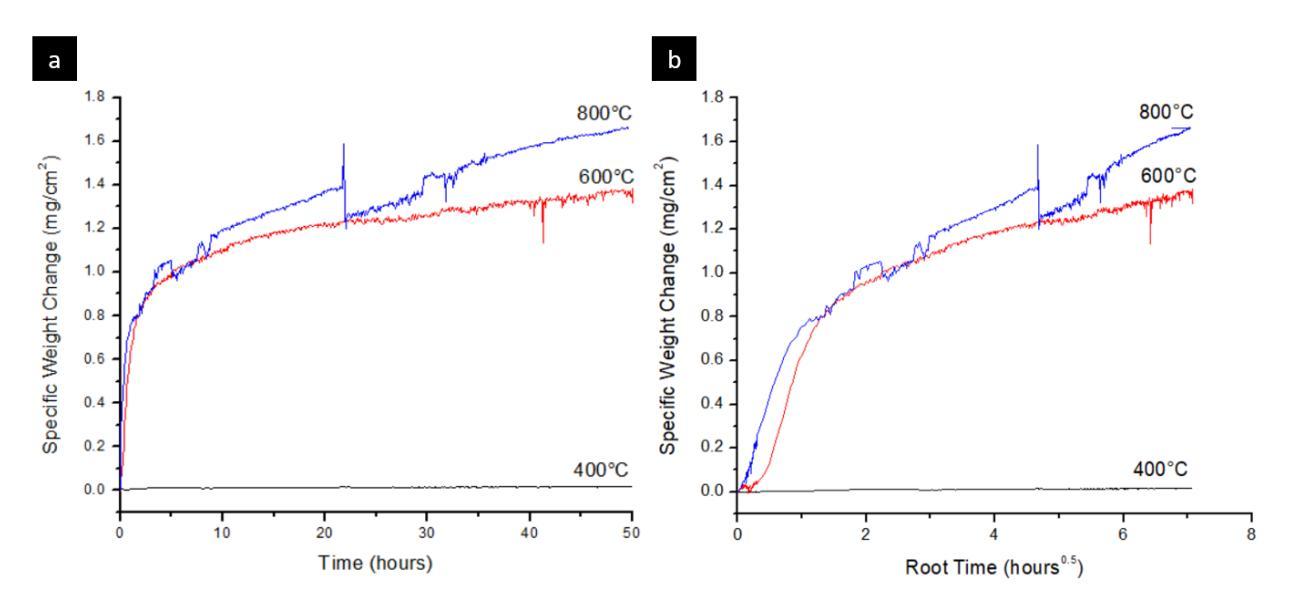
Figure 26: TGA specific weight change data for SiC/BN/SiC exposed to 50%  $O_2/50\%$  H<sub>2</sub>O for 50 hours at 400, 600, and 800°C versus a) time and b) root time.

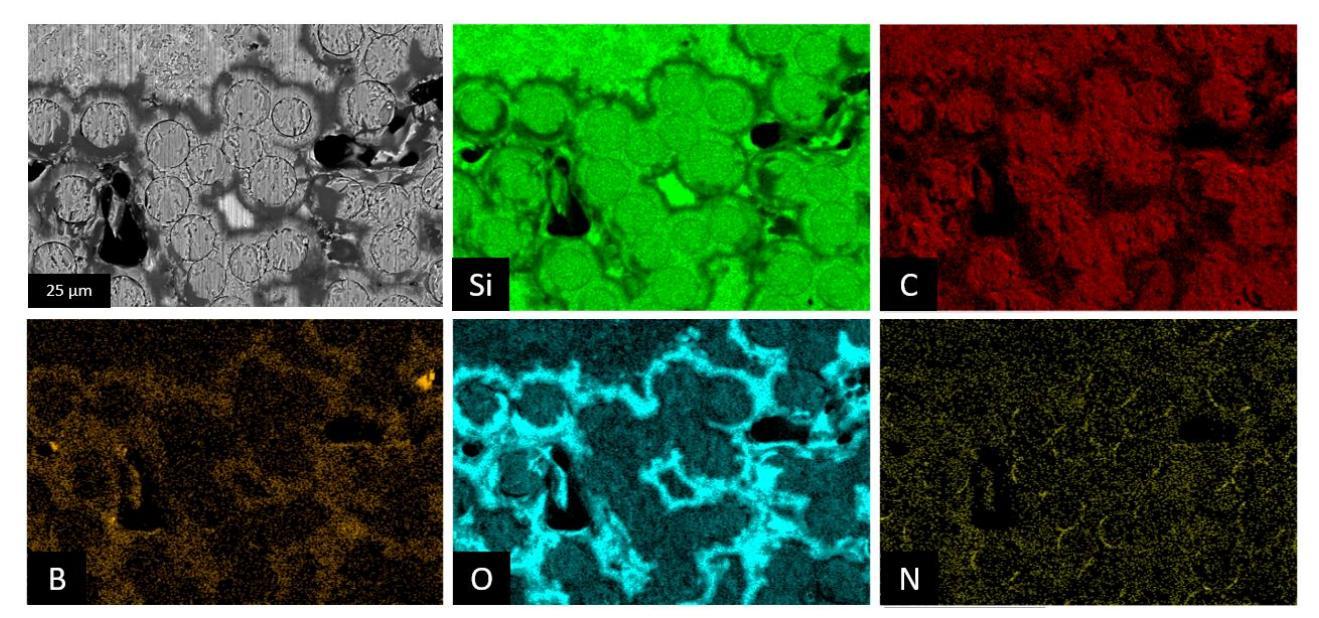
Figure 28: Fiber tow of SiC/BN/SiC sample exposed for 1 hour at 600°C in 50%  $H_2O/50\%$   $O_2$  gas mixture.

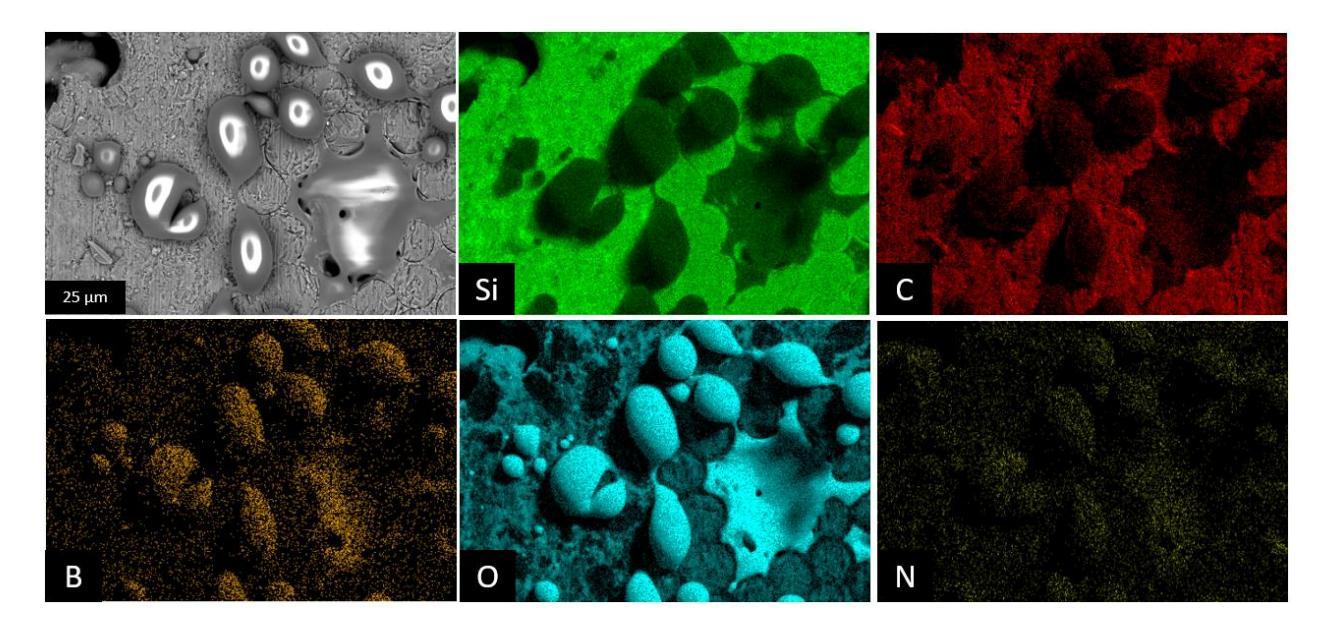
Figure 29: Fiber tow of SiC/BN/SiC sample exposed for 50 hours at 600°C in 50%  $H_2O/50\%$   $O_2$  gas mixture.

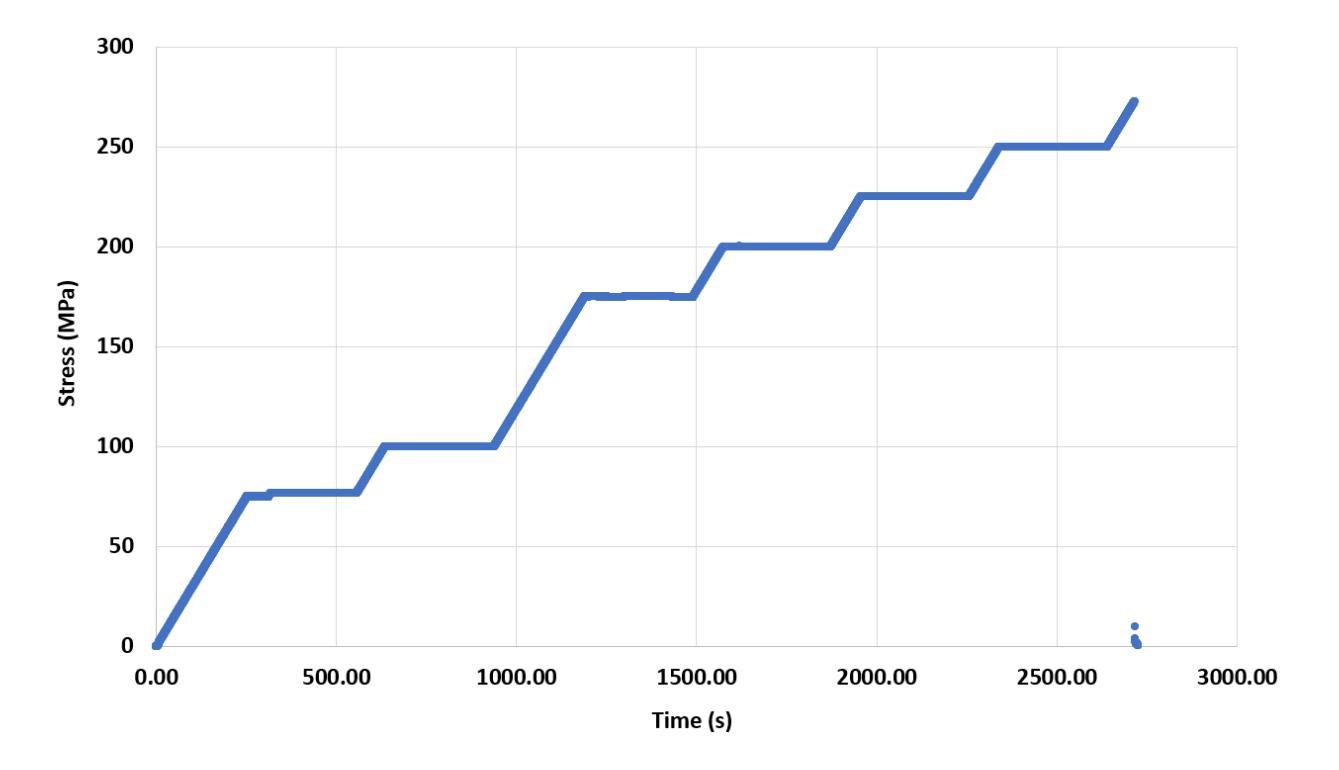
Figure 40: Stress (MPa) vs. Time (s) profile for strain gaged test specimen. Specimen was held at the desired load for approximately five minutes.

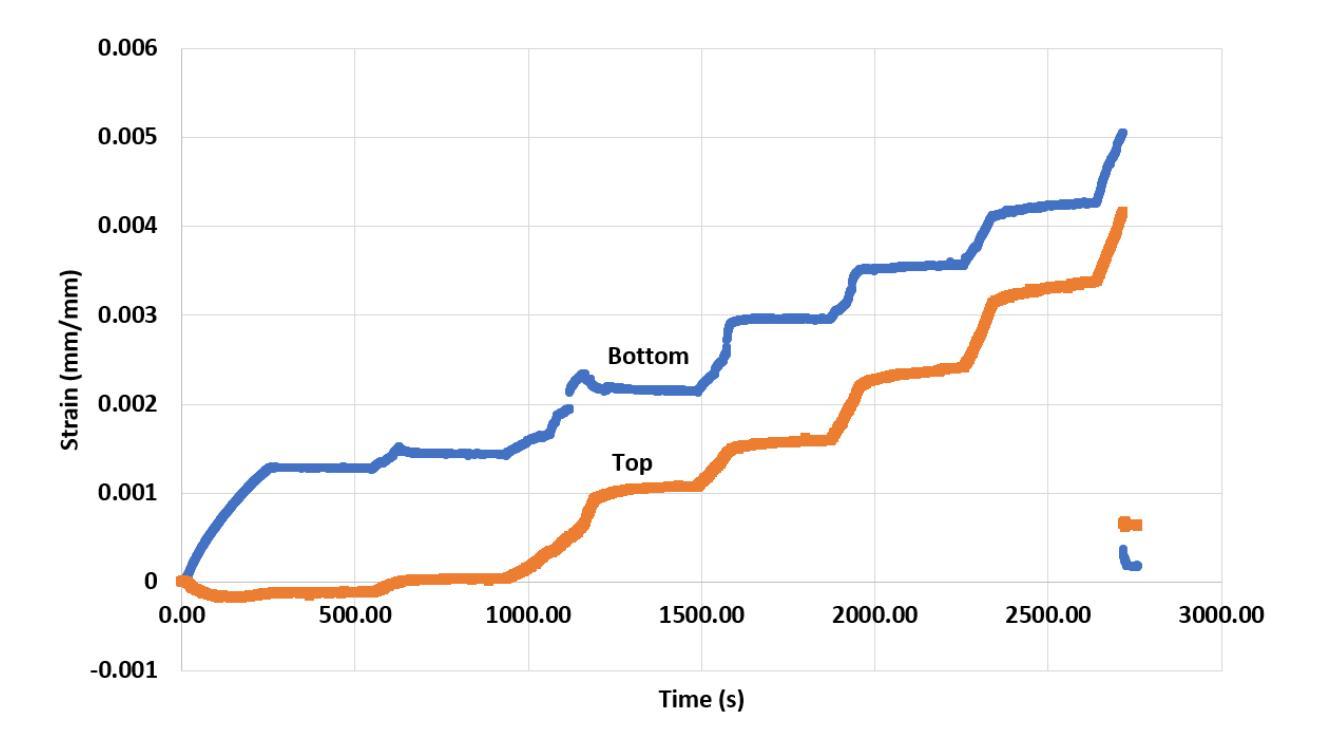
Figure 41: Strain (mm/mm) vs. Time (s) for bottom (blue) and top (orange) strain gages on CMC in tensile stage. Specimen was held at each load for approximately five minutes.

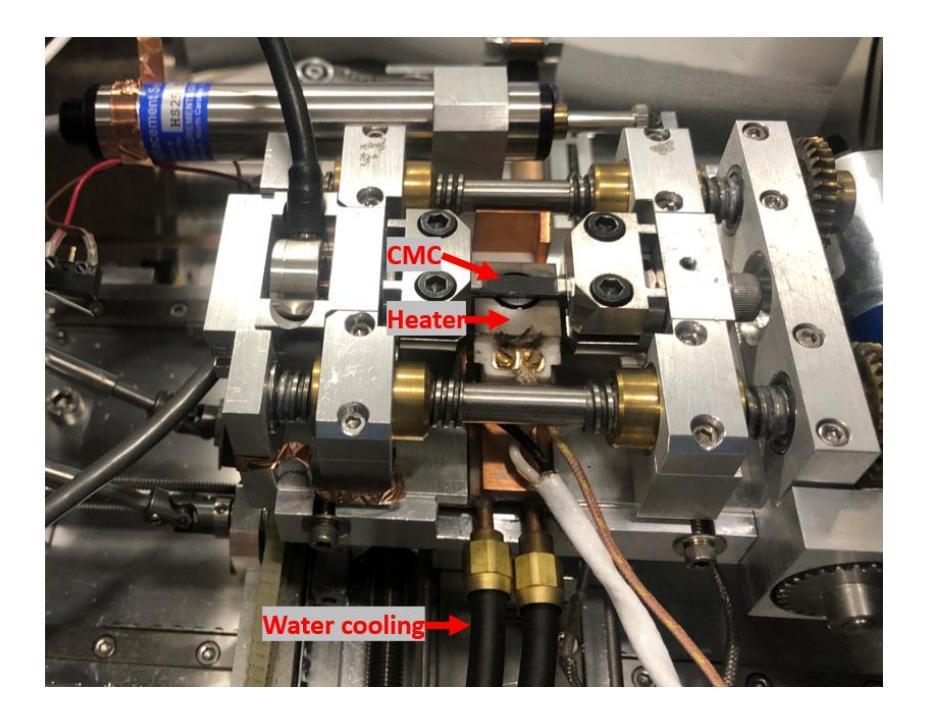
Figure 45: Tensile stage inside of SEM with CMC specimen and button heater.

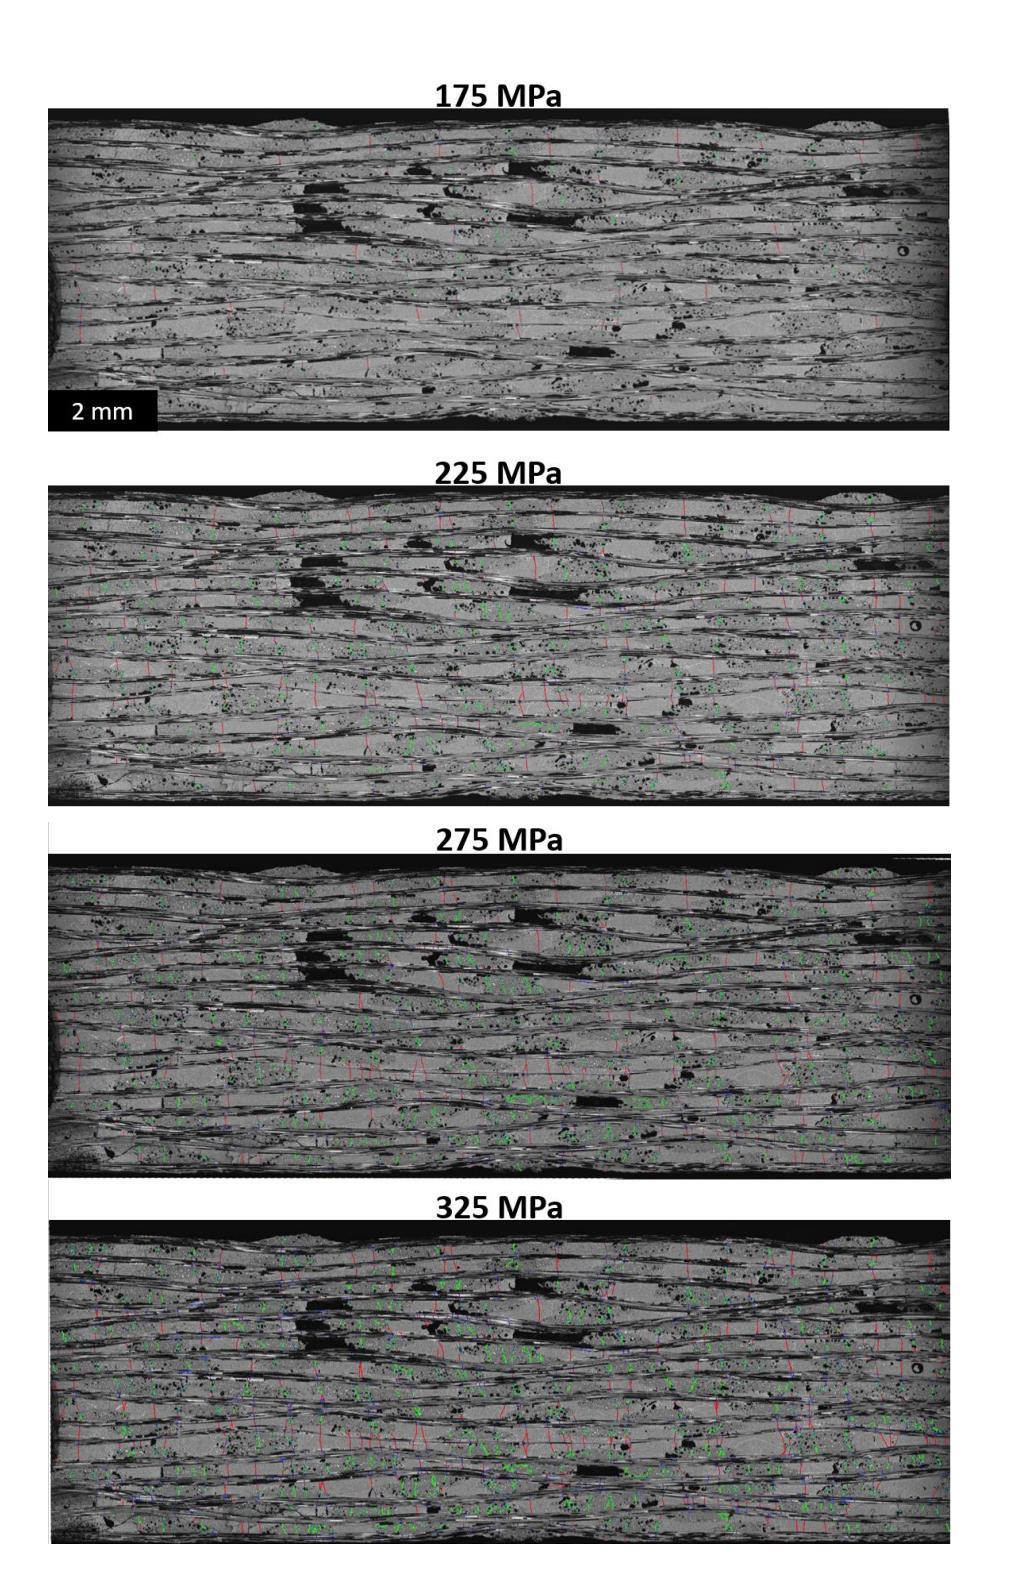
Figure 46: Light optical images of a SiC/BN/SiC CMC tested at room temperature with tensile stage at 175, 225, 275 and 325 MPa. Red lines represent cracks in the MI Si-SiC matrix, blue lines represent cracks in the CVI SiC, and green lines represent cracks in the BN fiber coating. Loading direction is horizontal.

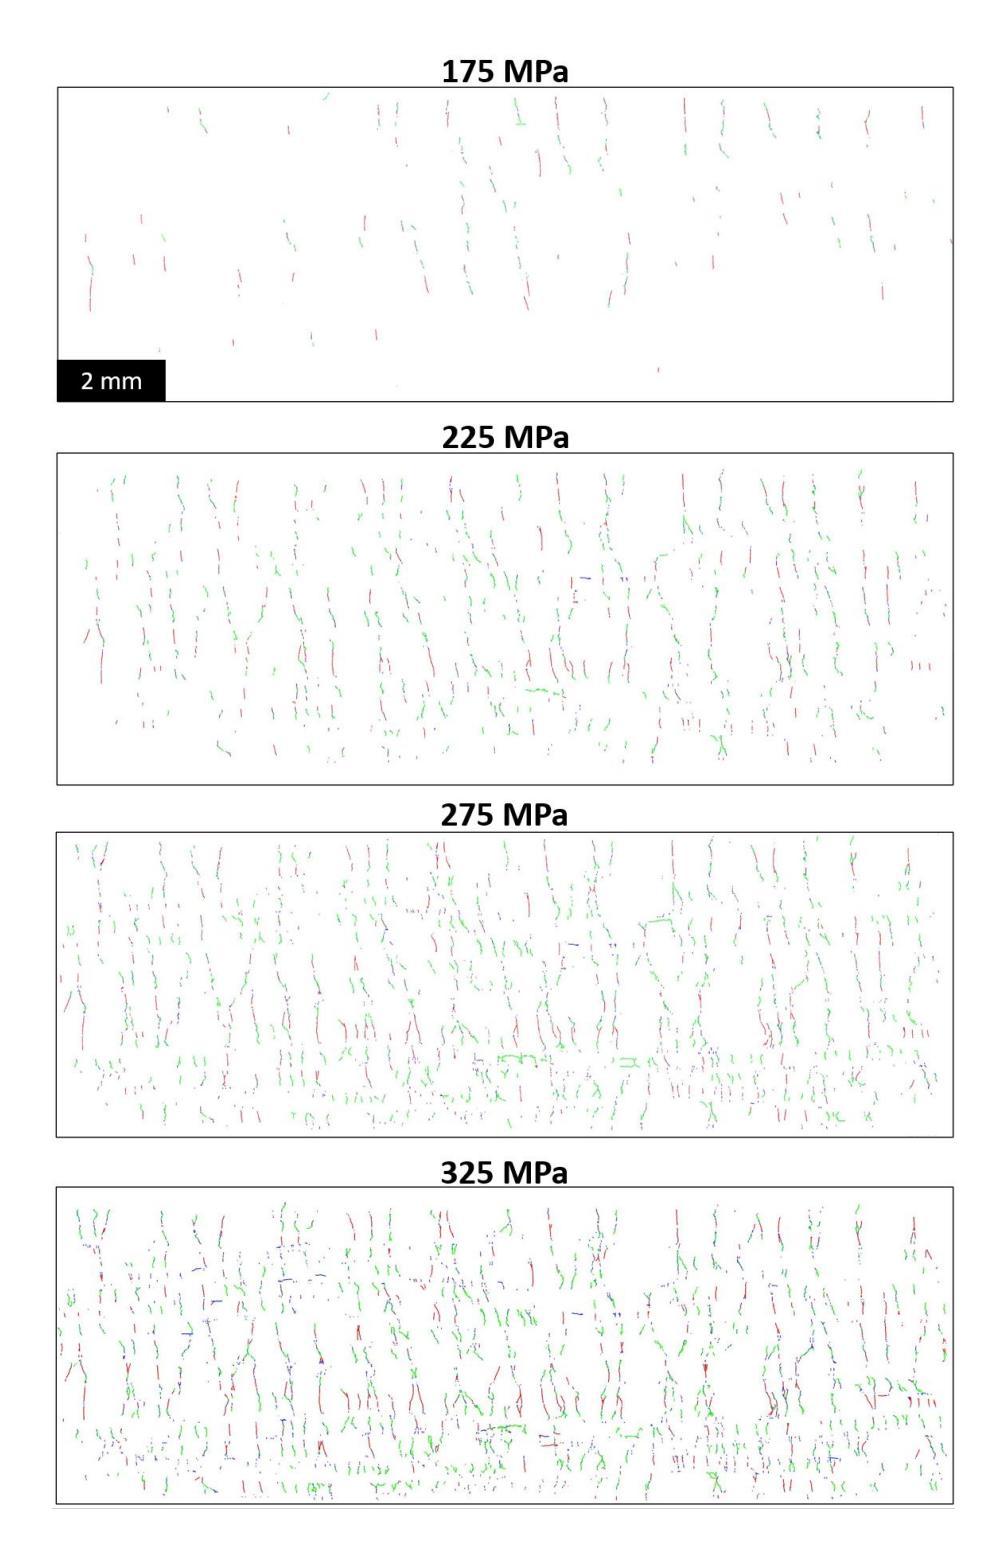
Figure 47: Masks of cracks marked on a SiC/BN/SiC CMC tested at room temperature with tensile stage at 175, 225, 275 and 325 MPa. Red lines represent cracks in the MI Si-SiC matrix, blue lines represent cracks in the CVI SiC, and green lines represent cracks in the BN fiber coating. Loading direction is horizontal.

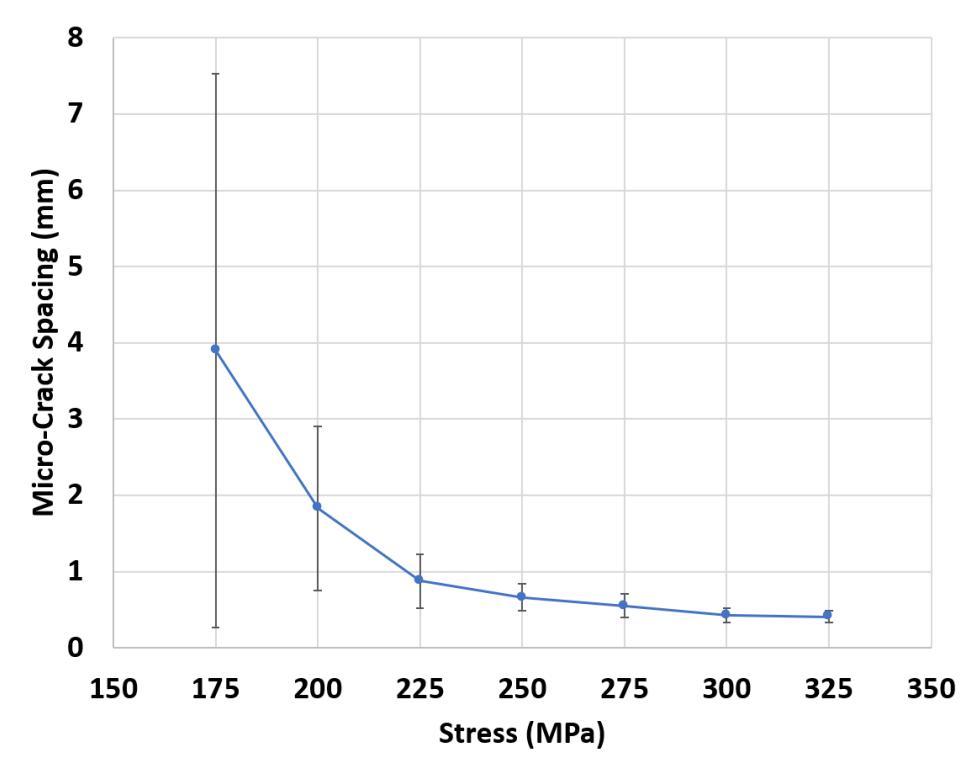
Figure 48: Micro-crack spacing vs. applied stress for a SiC/BN/SiC CMC tested at room temperature. Error bars are standard deviations.

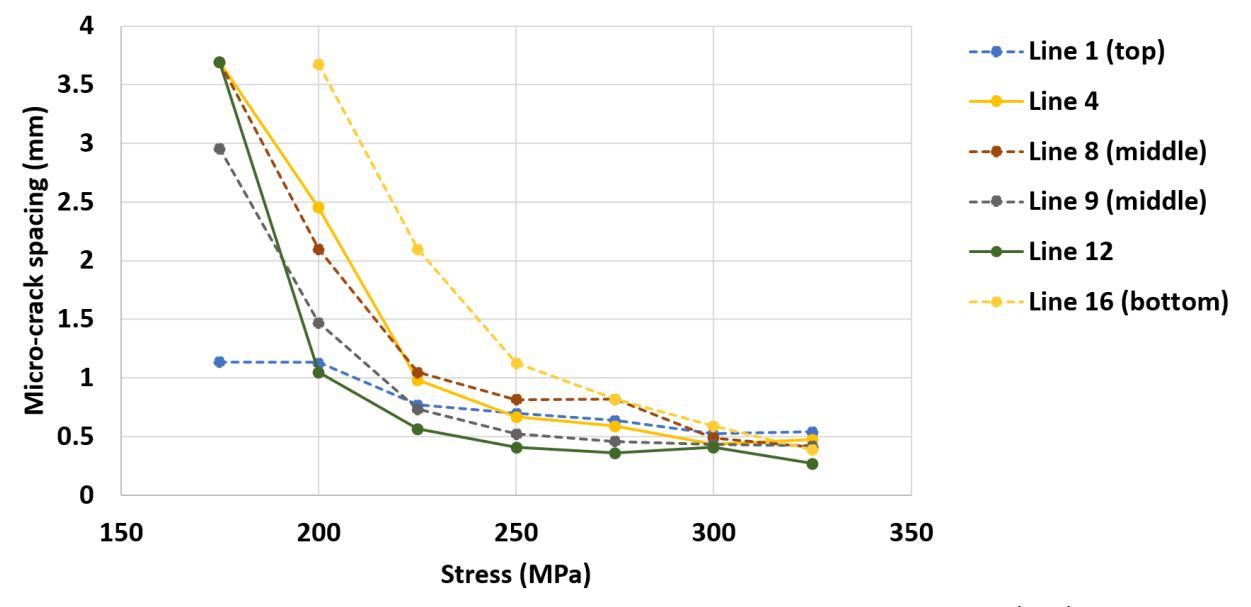
Figure 49: Micro-crack spacing for each line measured vs. applied stress for SiC/BN/SiC CMC tested at room temperature with tensile stage.
#### 4.3.2 Micro-crack composition at room temperature

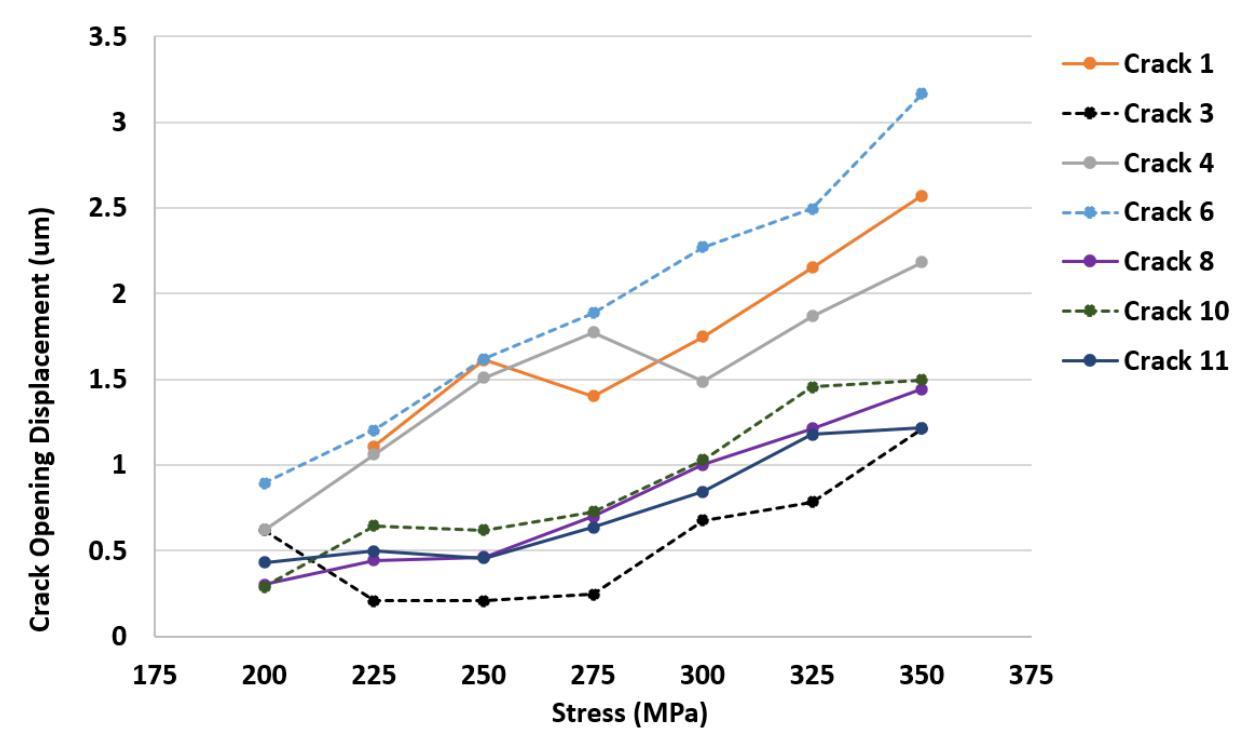
Figure 52: Crack opening displacements in matrix material vs. applied stress in SiC/BN/SiC CMC loaded at room temperature in SEM

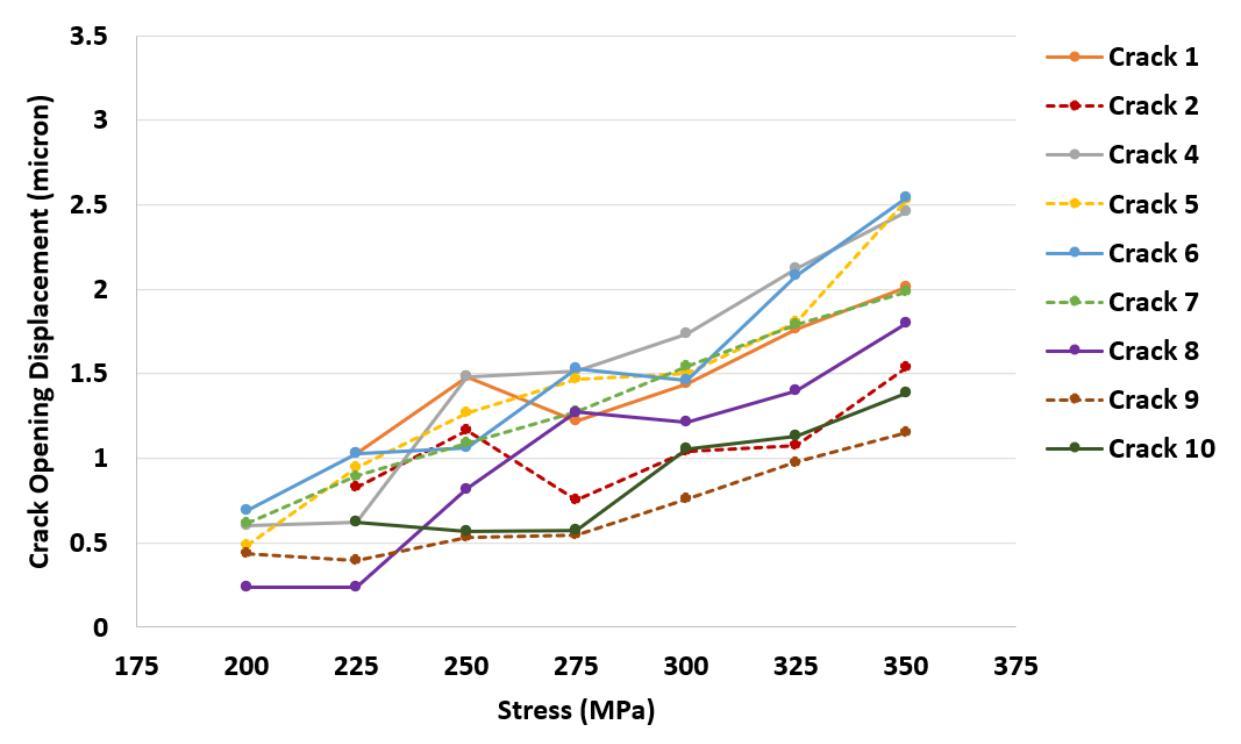
Figure 53: Crack opening displacements in transverse fiber tow vs. applied stress in SiC/BN/SiC CMC loaded at room temperature in SEM
