# Synergistic Effects of Oxidation and Load on SiC/BN/SiC Ceramic Matrix Composite Degradation at Intermediate Temperatures

## Dissertation

Kaitlin Detwiler

May 2022

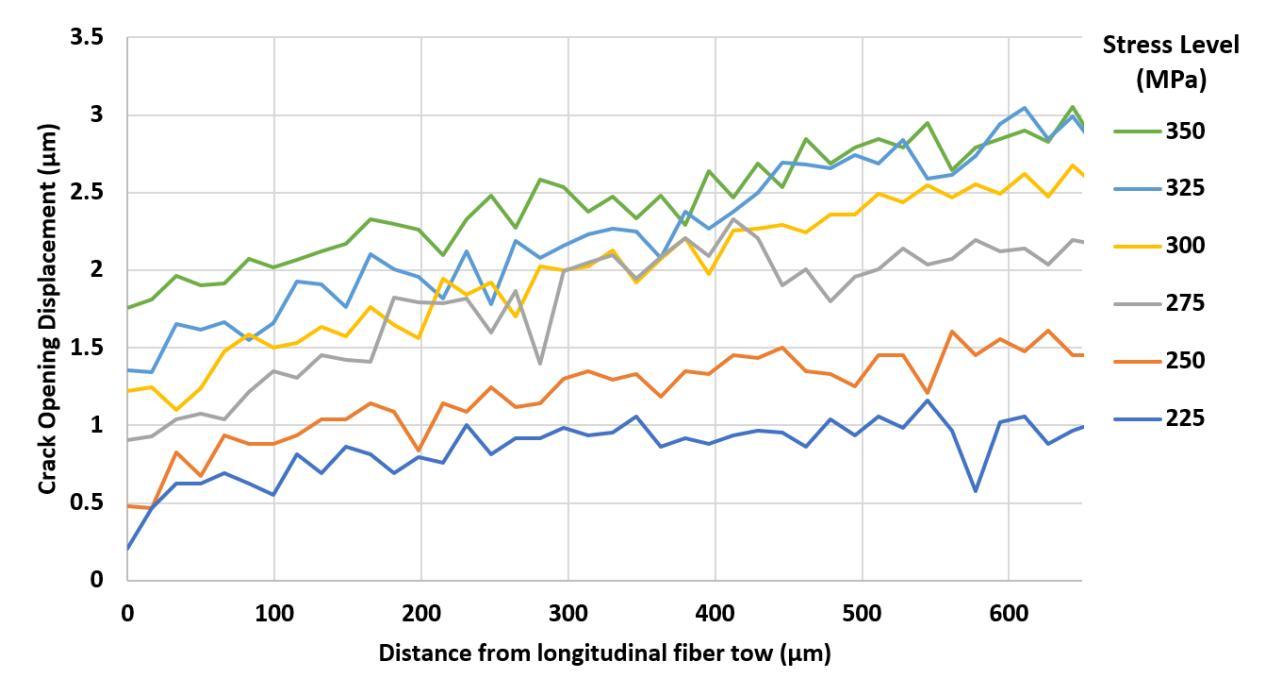
Figure 54: Crack opening displacement vs. the distance from the longitudinal fiber tow for crack 12 in a SiC/BN/SiC CMC. Crack 12 can be seen in Figure 55.

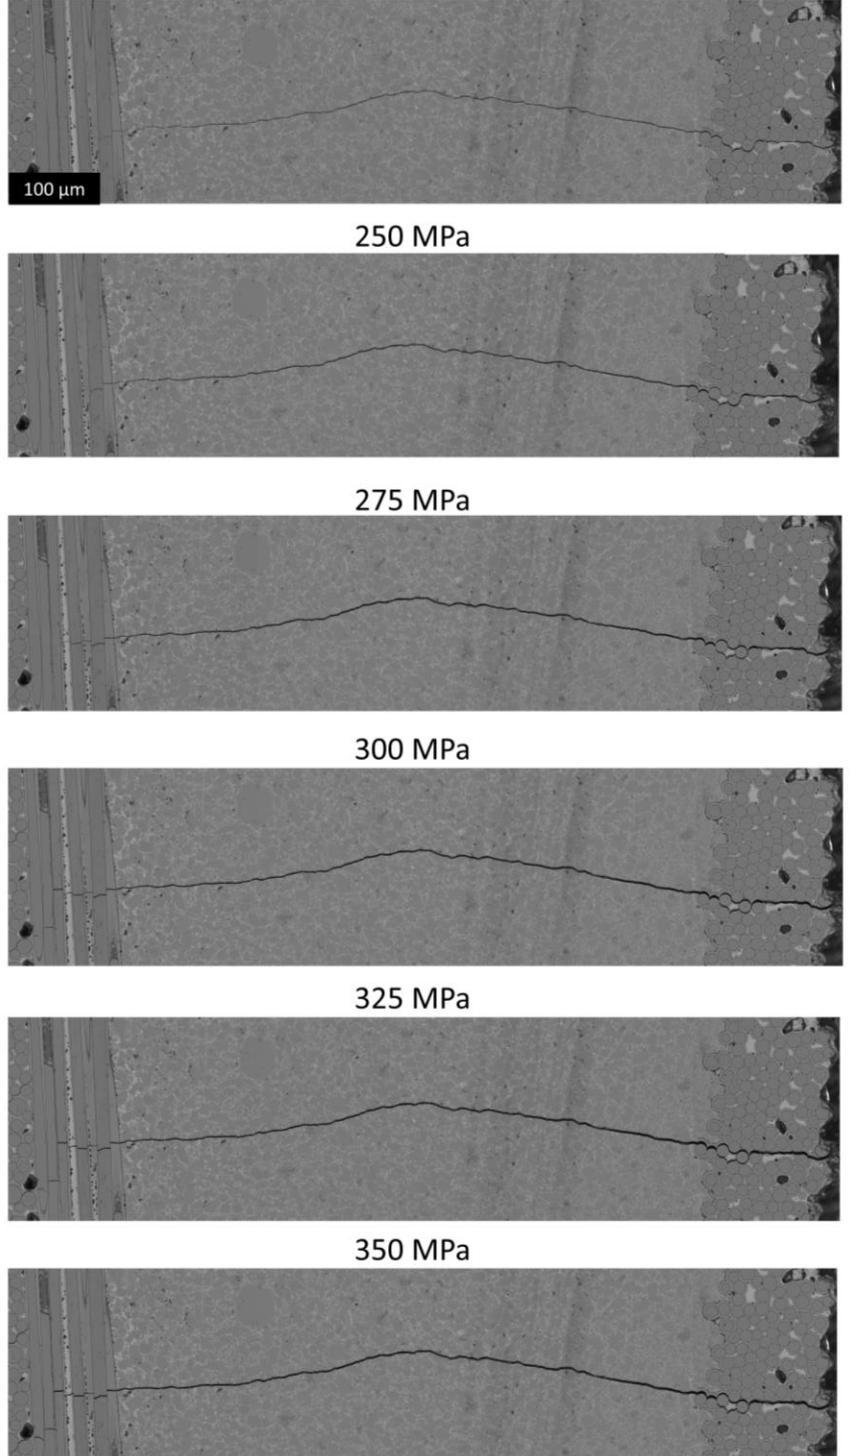
Figure 55: Stitched SEM micrographs of micro-crack 12 tested at room temperature. The COD increases with increased distance from the longitudinal, load-bearing fiber tow. Loading direction is vertical. Material is a SiC/BN/SiC CMC.

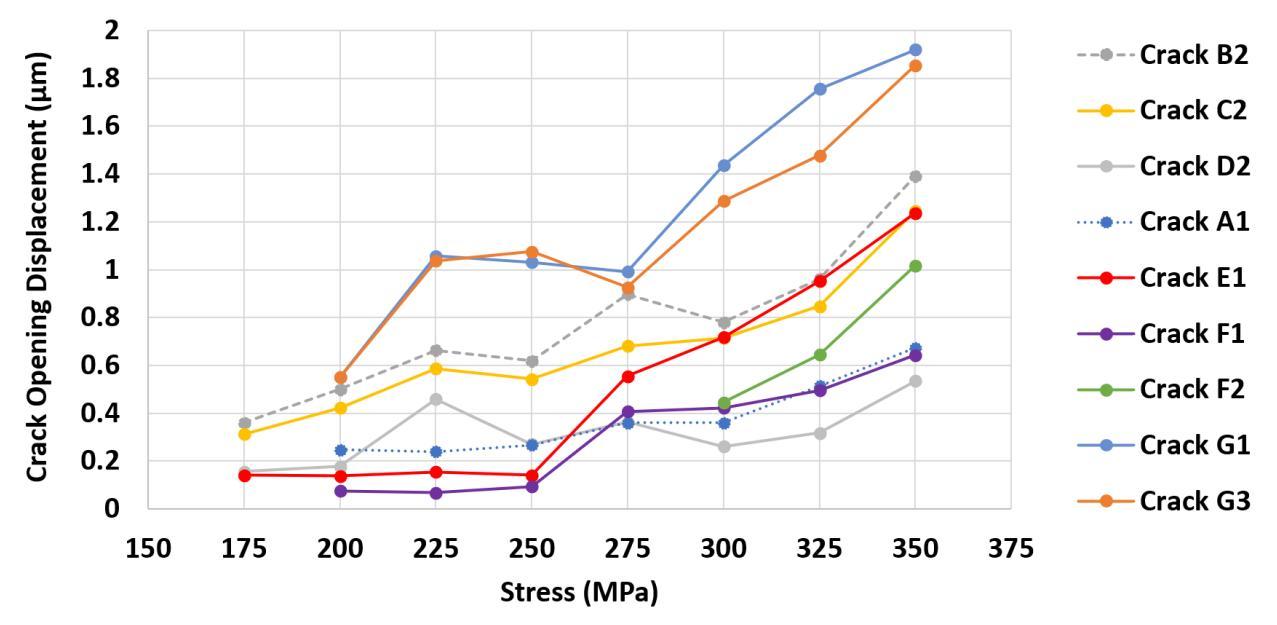
Figure 58: Crack opening displacements in matrix material vs. applied stress in SiC/BN/SiC CMC loaded at 600°C in SEM

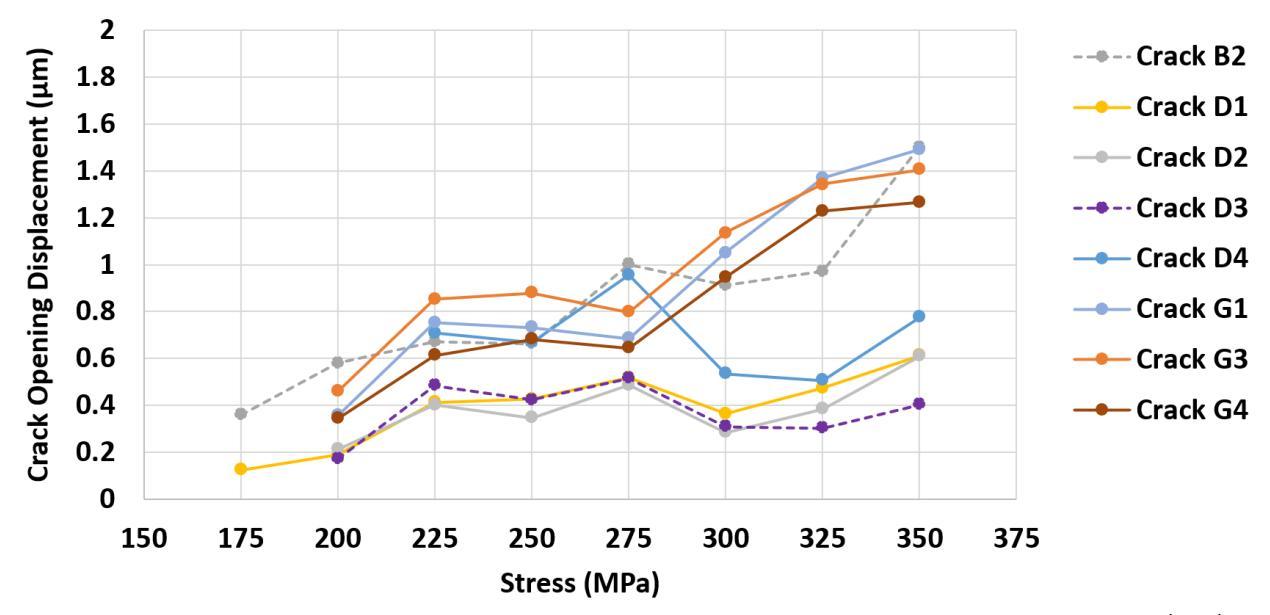
Figure 59: Crack opening displacements in transverse fiber tow vs. applied stress in SiC/BN/SiC CMC loaded at 600°C in SEM

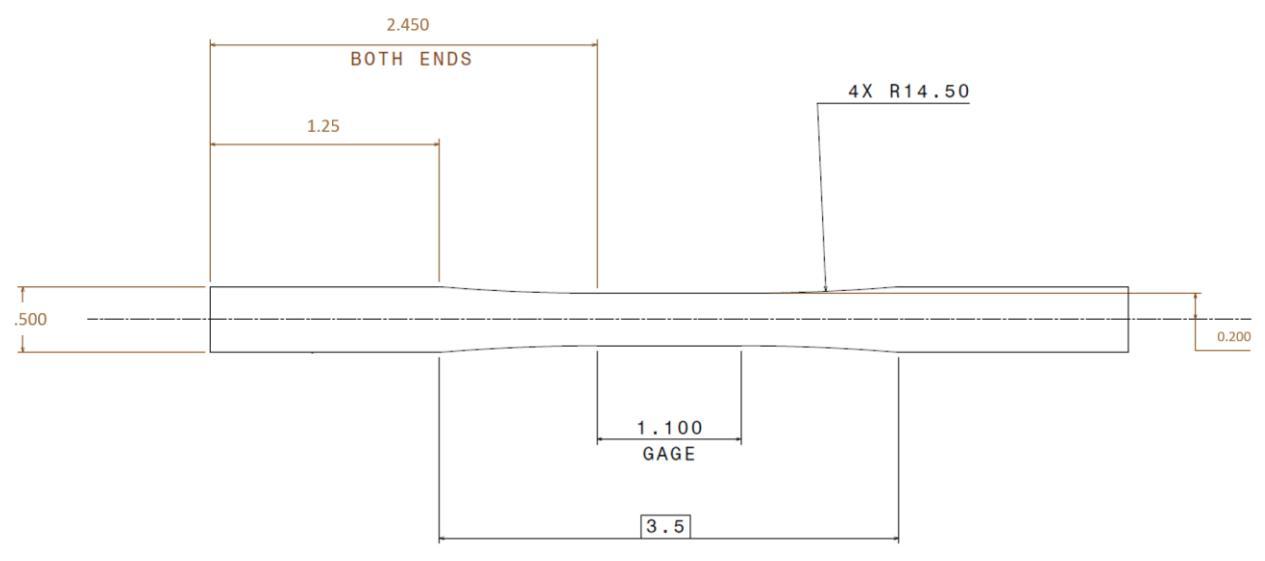
Figure 63: Dimensions for SiC/BN/SiC CMC dogbones for fast fracture mechanical testing. All measurements in inches.

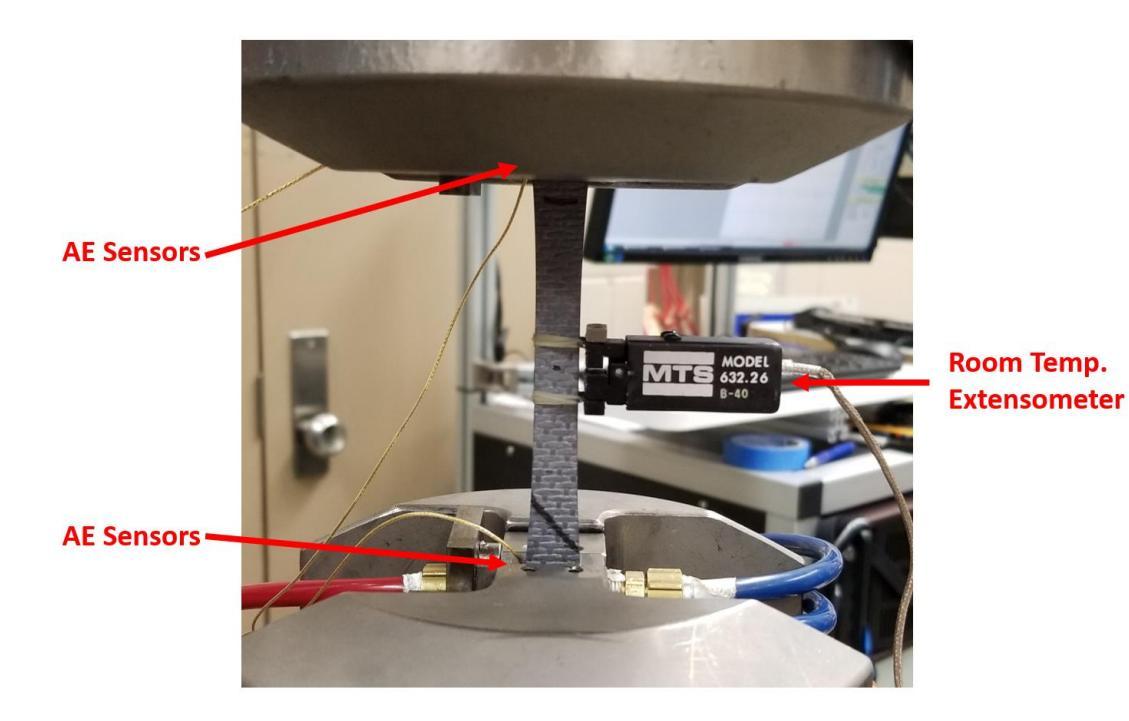
Figure 65: SiC/BN/SiC CMC dogbone in MTS servo-hydraulic load frame equipped with acoustic emission (AE) sensors and a room temperature extensometer.

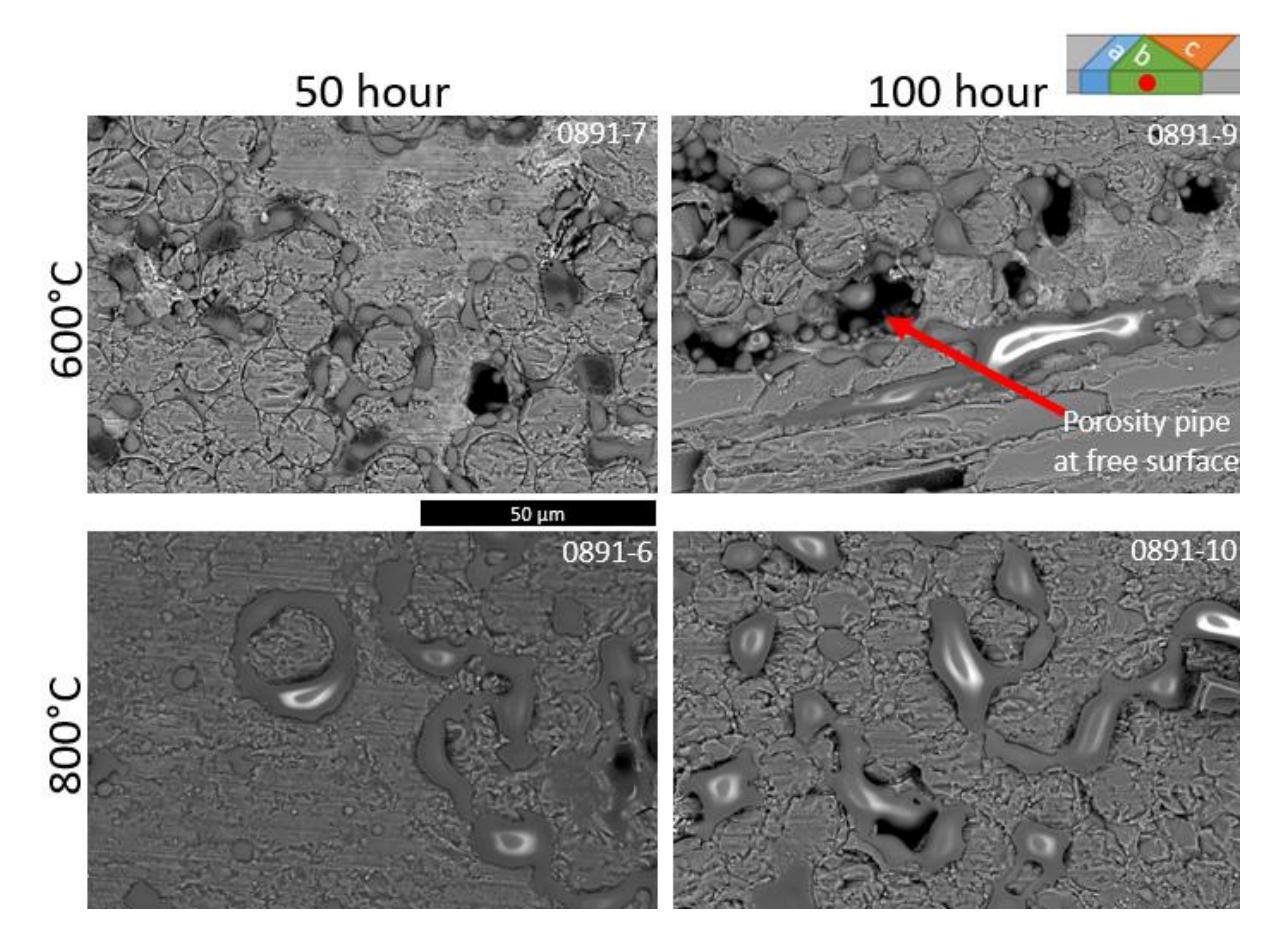
Figure 69: Backscatter SEM image of CMC surface oxide morphologies at 600 and 800°C after 50 and 100 hours at  $\sim \sigma_{MC}$  = 150 MPa in lab air

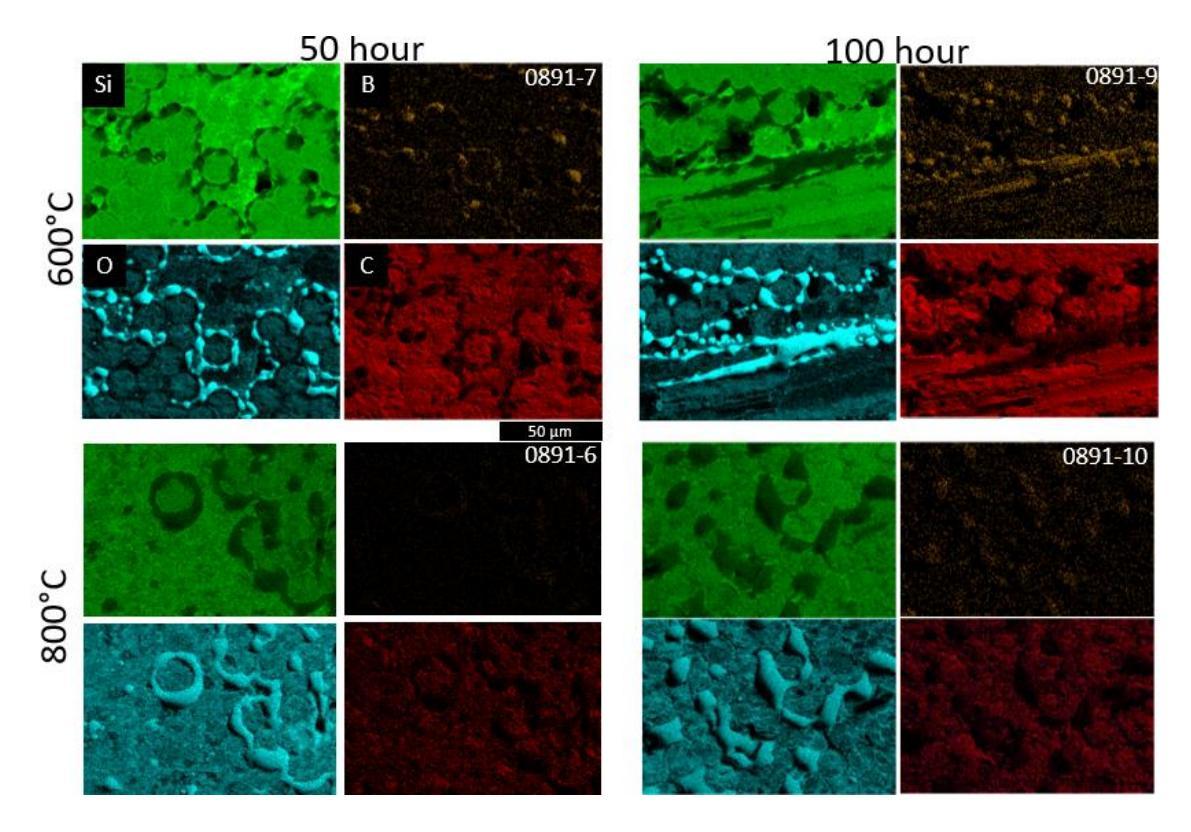
Figure 70: Si, B, O, and C EDS maps of SiC/BN/SiC CMC surface oxide at matrix cracking onset tested in lab air at 600 and 800°C for 50 and 100 hours at 150 MPa

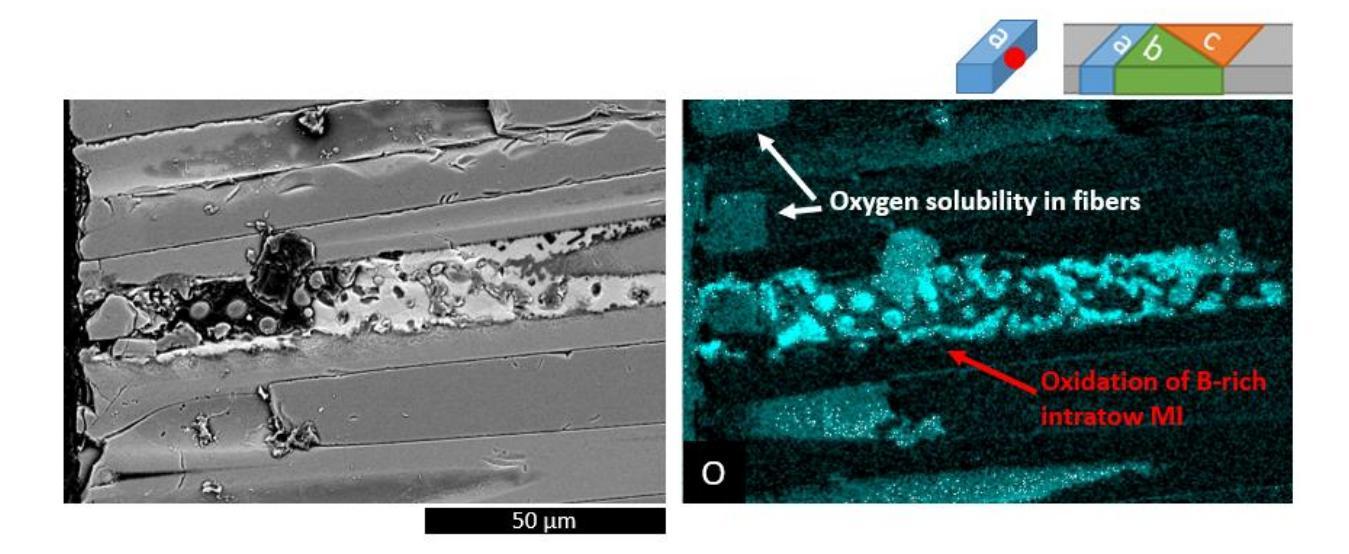
Figure 71: Oxygen solubility in Hi-Nicalon fibers (white arrows) and oxidation of B-rich intratow MI region (red arrow) in a SiC/BN/SiC CMC. Specimen was exposed to lab air for 100 hours at 600°C at 150 MPa.

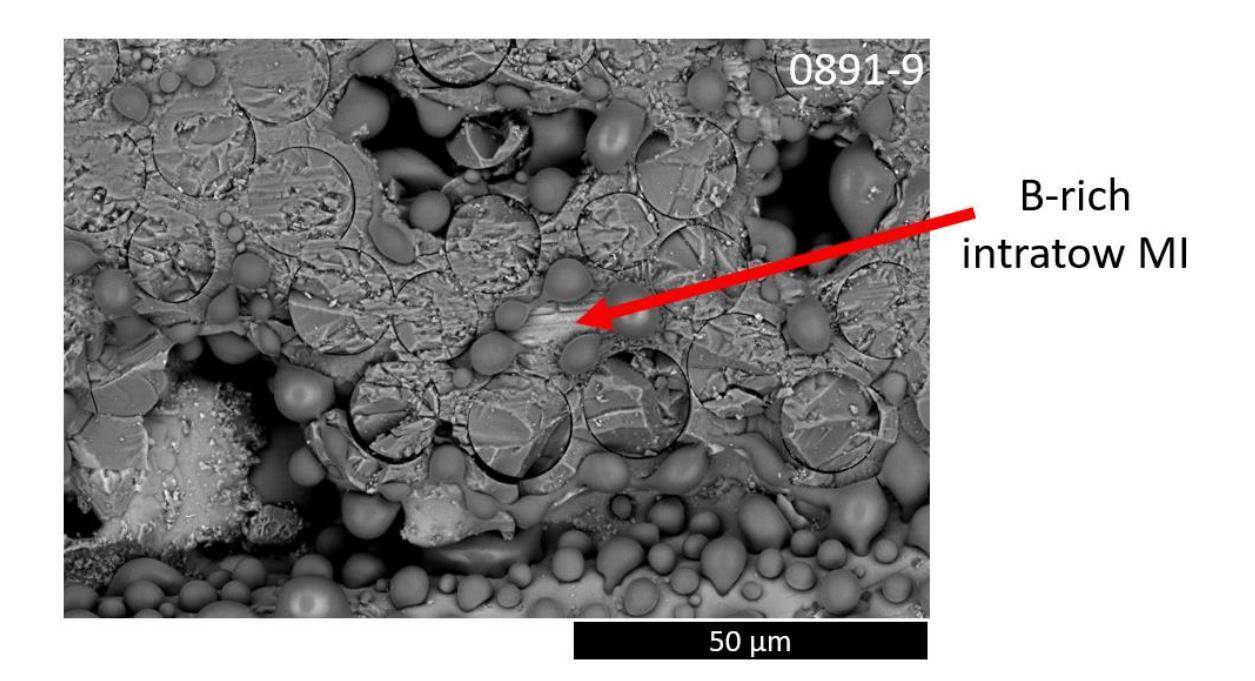
Figure 72: Example of SiC/BN/SiC CMC intratow region that is filled with melt-infiltrated silicon and is rich in B-containing species. Specimen was exposed to lab air for 100 hours at 600°C at 150 MPa.

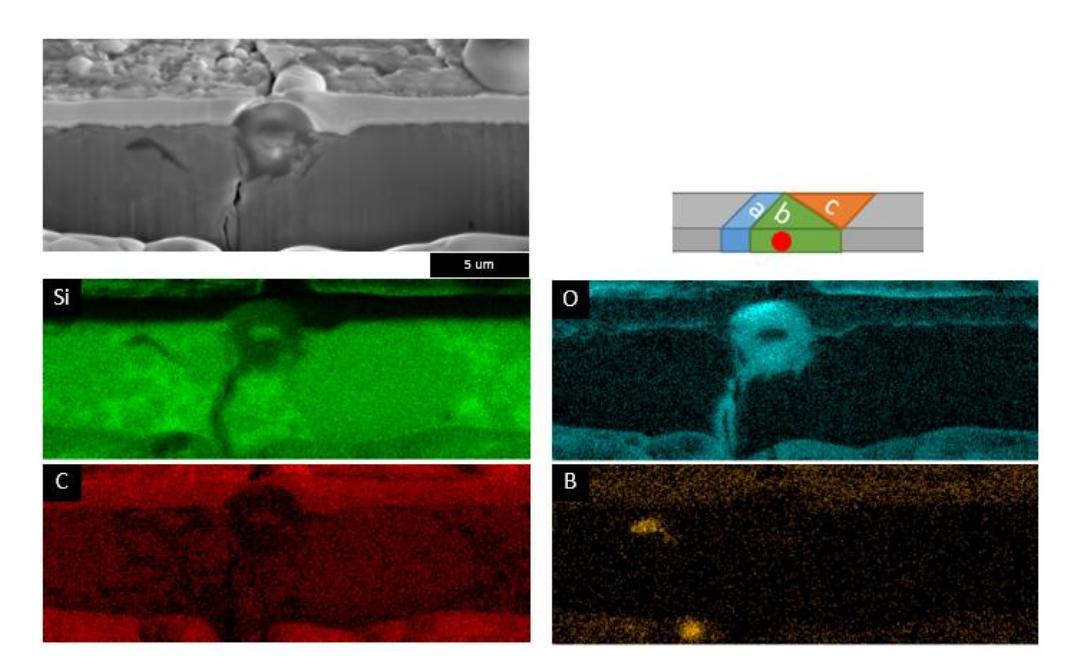
Figure 74: FIB cross-section of oxide filled crack from Figure 73. SiC/BN/SiC CMC was exposed to lab air at 800°C for 100 hours at 180 MPa.

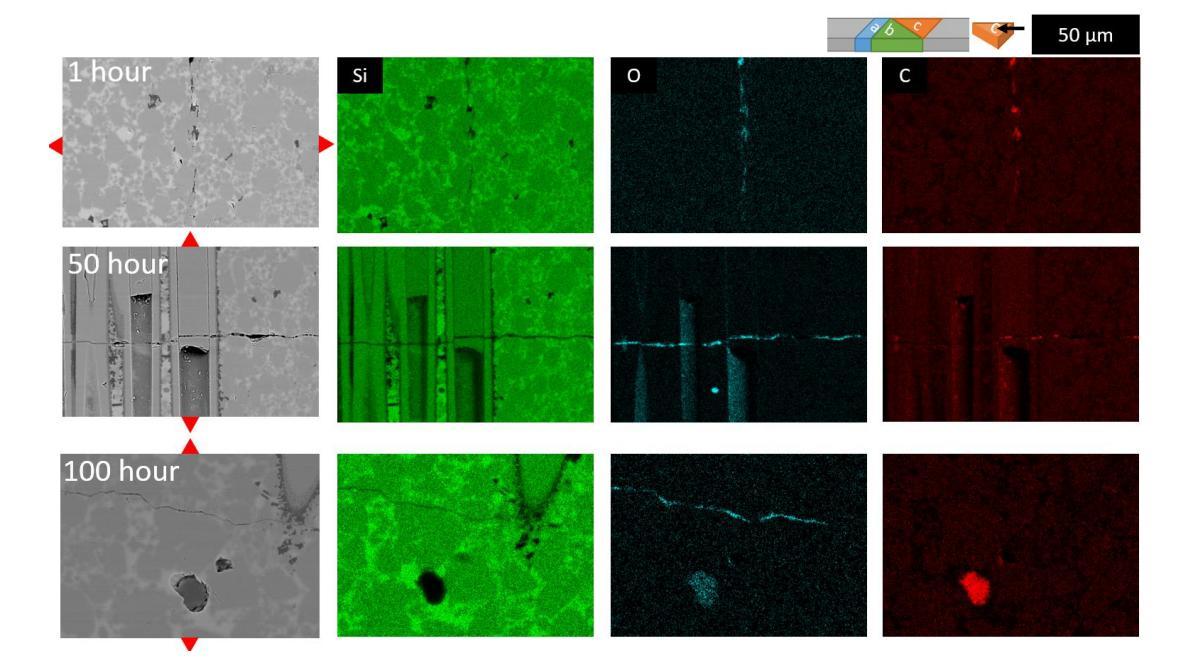
Figure 75: Oxide filling in interior cracks in the matrix of SiC/BN/SiC CMC. Specimens were exposed in lab air at 800°C at 180 MPa for 1, 50, and 100 hours. Red arrows on the backscatter image indicate loading direction.

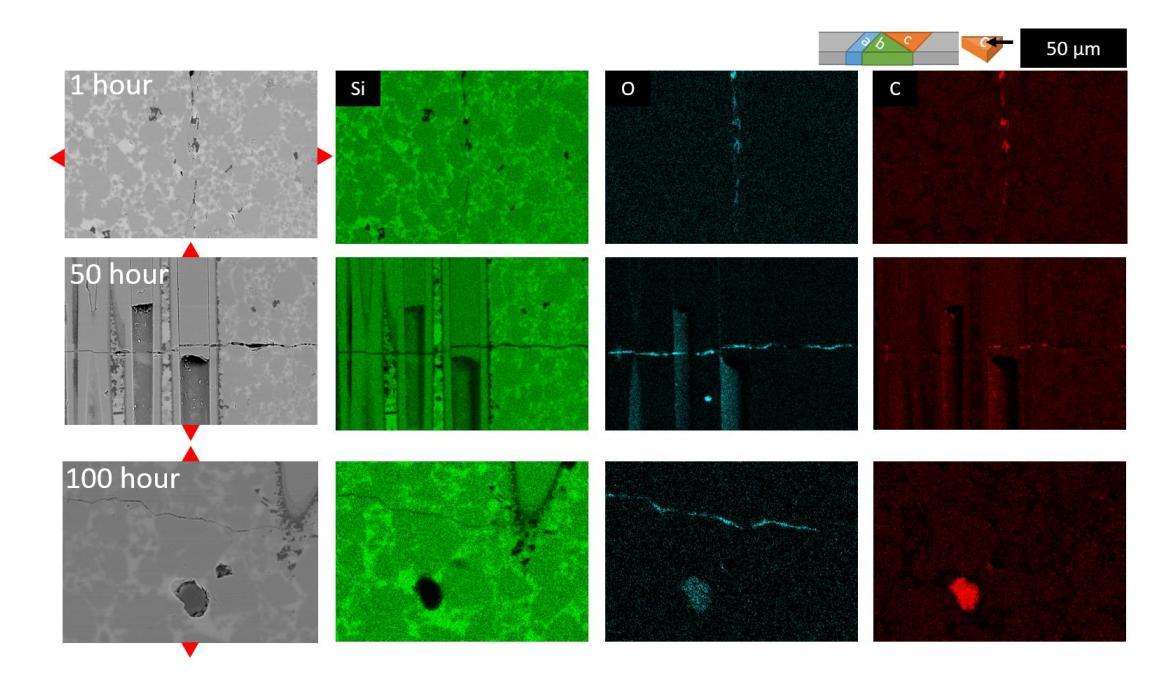
Figure 76: Oxide filling in interior cracks near fibers in SiC/BN/SiC CMC. Specimens were exposed in lab air at 800°C at 180 MPa for 1, 50, and 100 hours. Red arrows on the backscatter image indicate loading direction.

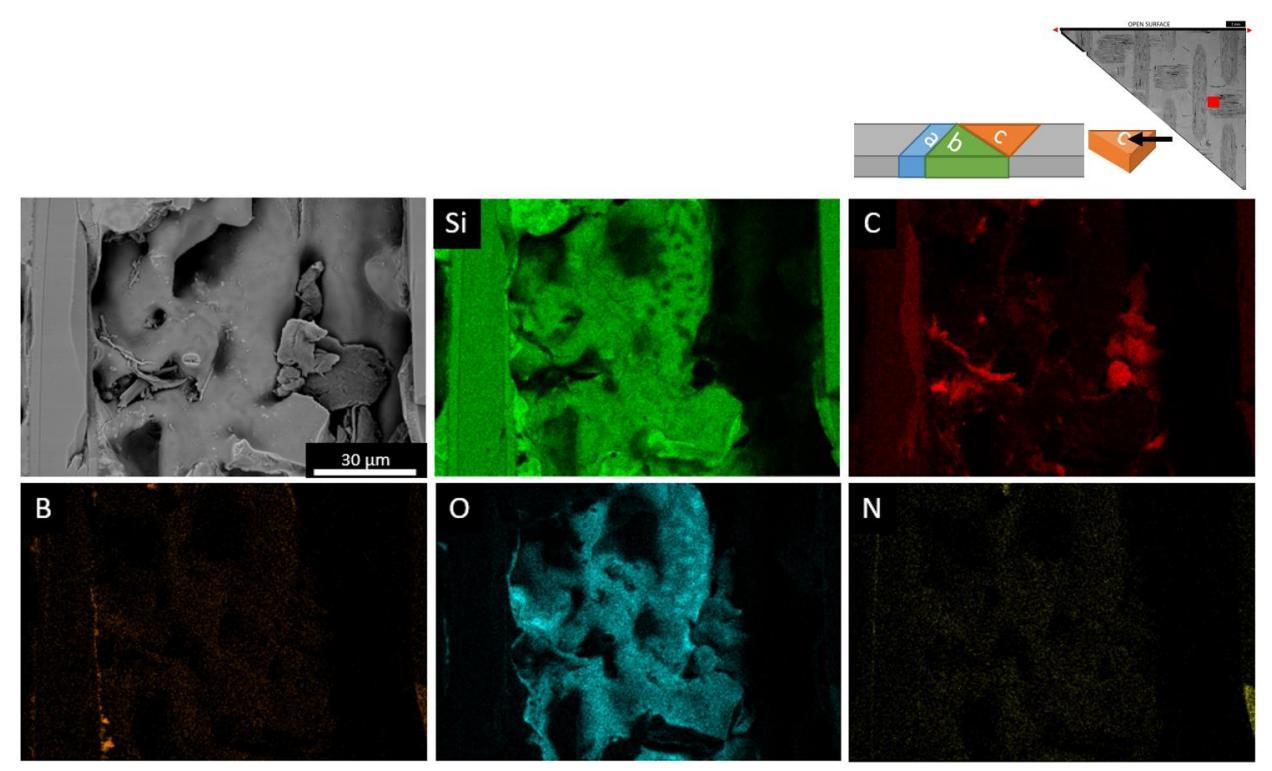
Figure 77: Oxidation of porous region in interior of SiC/BN/SiC CMC. The inset in the upper right corner shows location (red box) of image on the cross-section. Sample was tested for 50 hours at 180 MPa at 800°C.

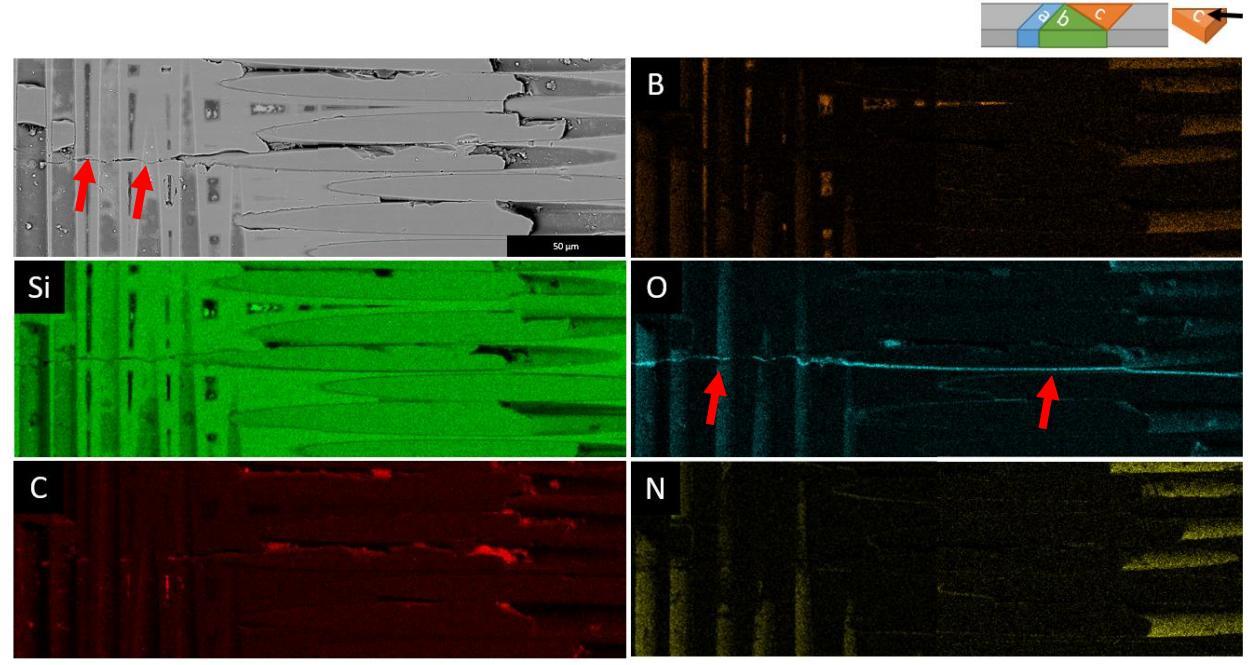
Figure 78: SEM/EDS maps showing crack in SiC/BN/SiC CMC interior after 50 hours at 800°C in lab air at 180 MPa. Red arrows point out oxidized BN fiber coating.

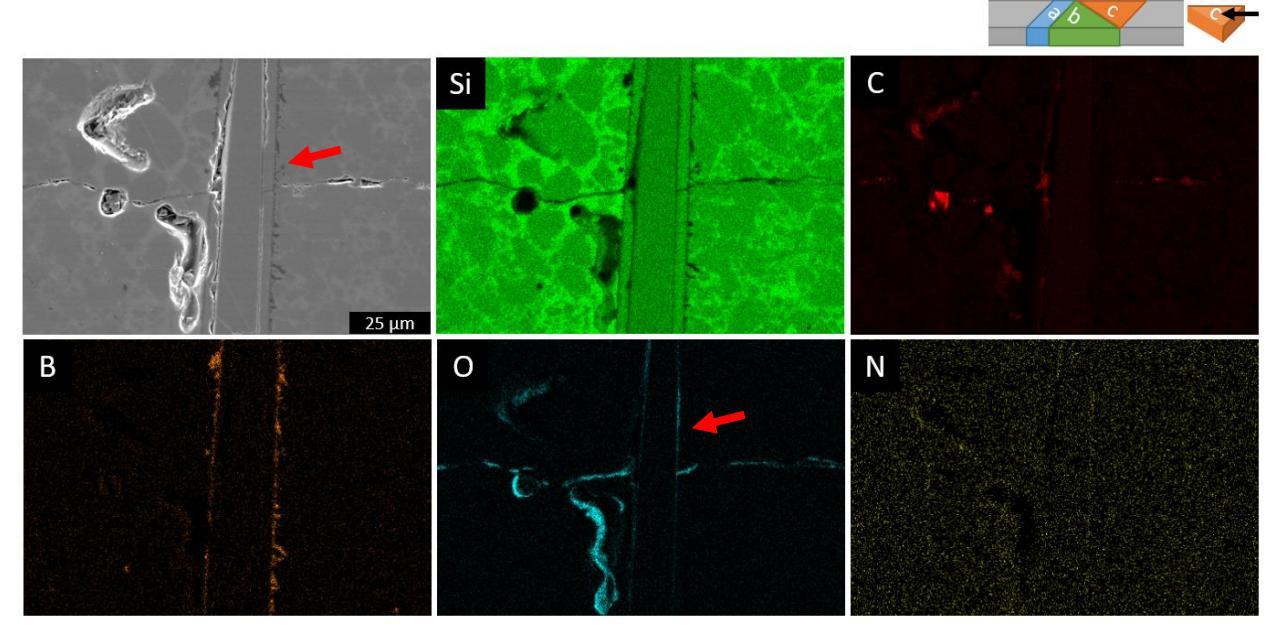
Figure 79: SEM/EDS maps of crack in SiC/BN/SiC CMC interior after 100 hour exposure at 800°C in lab air at 180 MPa. Red arrows point out oxidized coating.
#### 5.3.4 Oxidation load holds at 200 MPa at 600 and 800°C in lab air

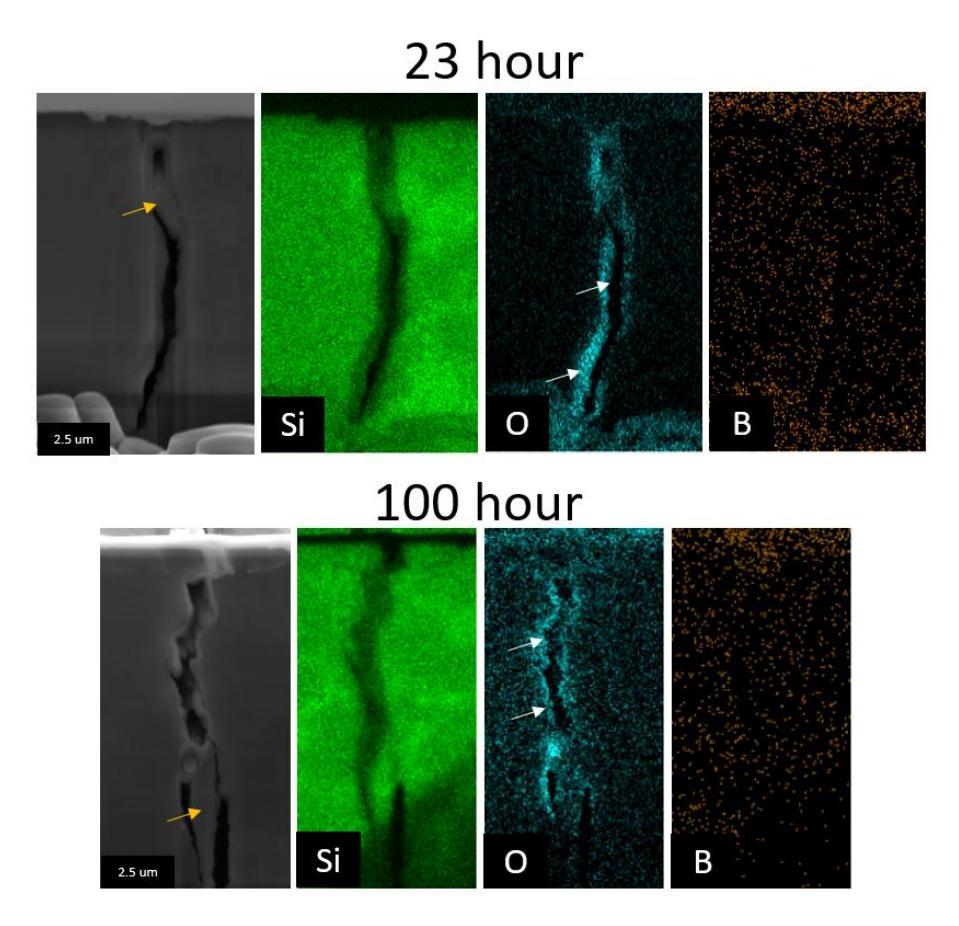
Figure 82: FIB milling of micro-cracks in the Si-SiC matrix material of SiC/BN/SiC CMC after 23 and 100 hour exposures at 600°C in lab air at 200 MPa. White arrows indicate oxidation on the crack faces. The yellow arrows indicate debris in the micro-crack.

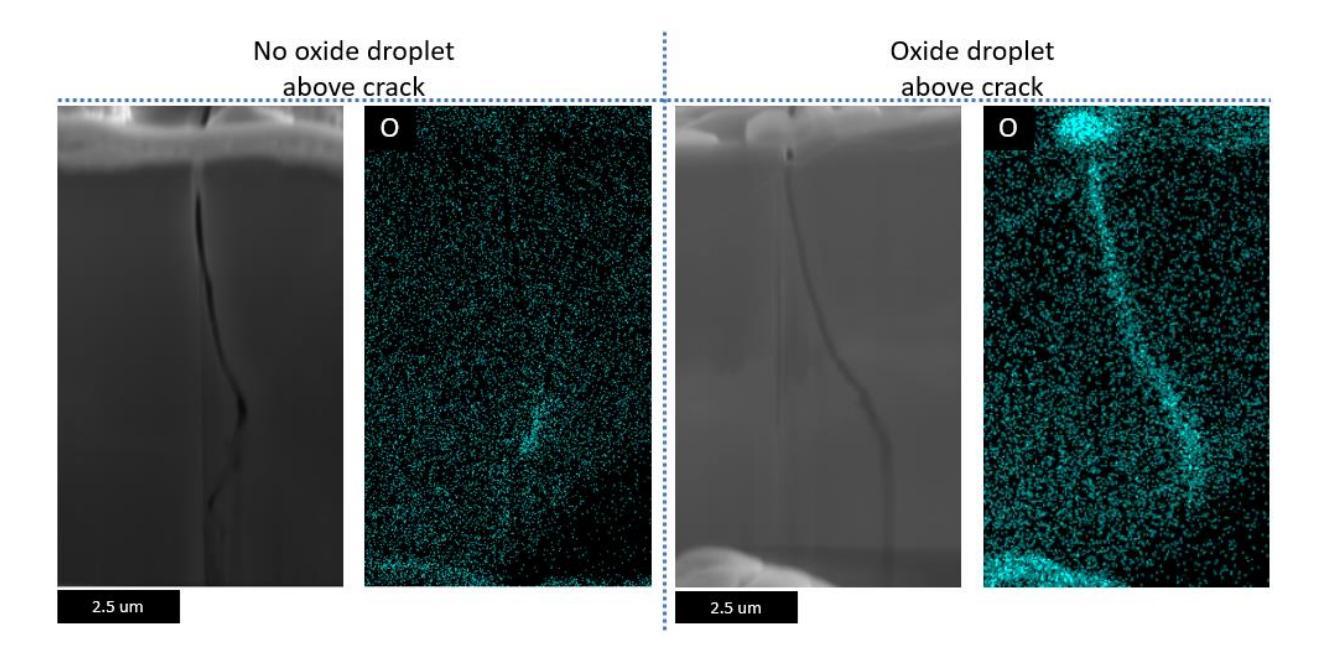
Figure 83: Comparison of unfilled and oxide-filled cracks in SiC/BN/SiC CMC of similar crack opening displacements after 800°C exposure for 49 hours in lab air at 200 MPa.

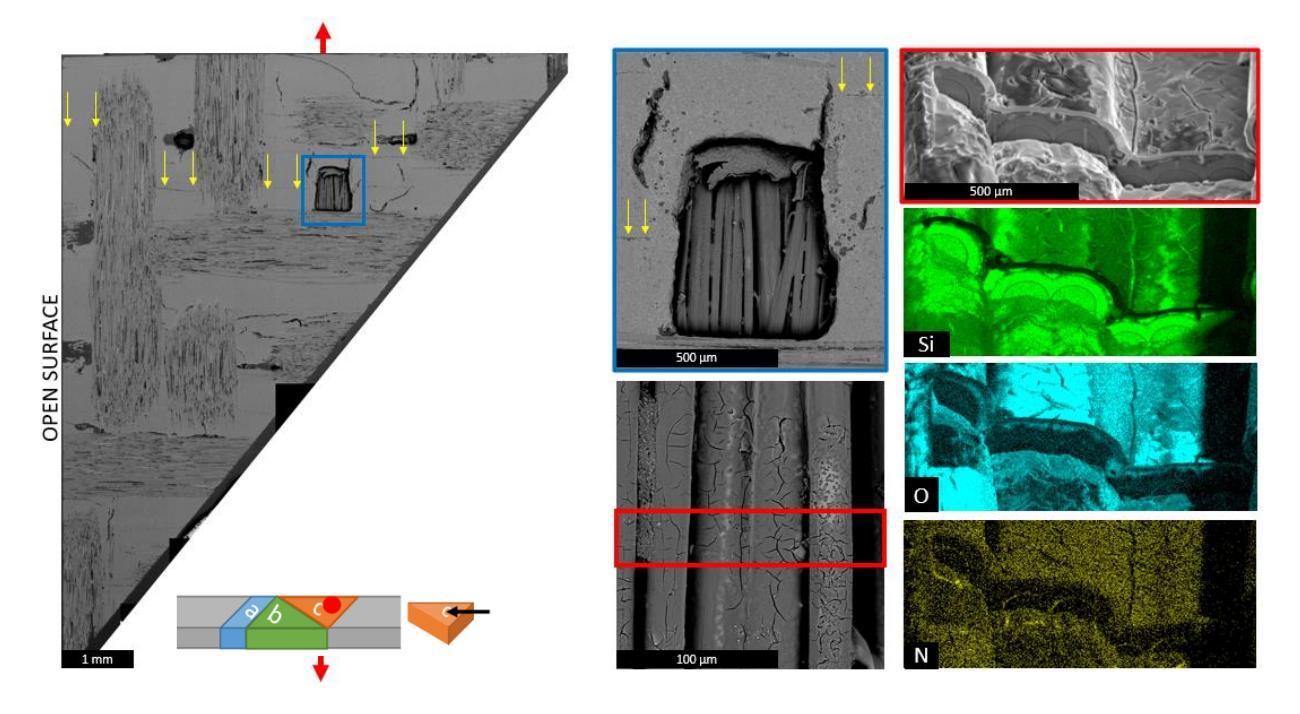
Figure 86: Mid-plane polish of SiC/BN/SiC CMC sample exposed to lab air at 600°C for 23 hours at 200 MPa. Yellow arrows point out a crack in the matrix that allowed oxidant travel to the porous region where the outer edge of CVI SiC on a fiber tow oxidized. Red arrows indicate loading direction.

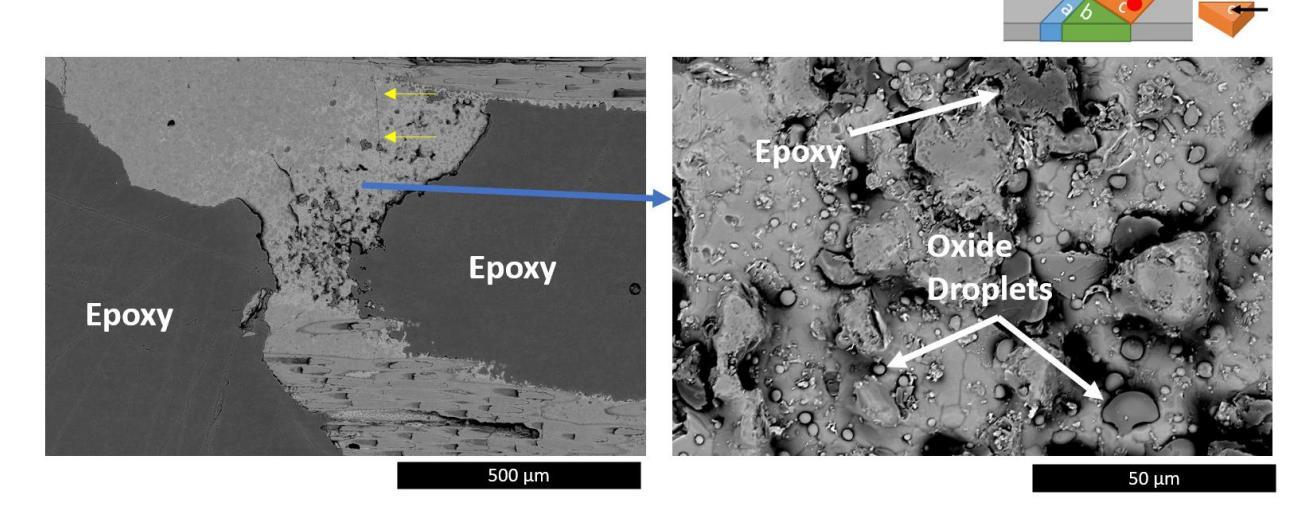
Figure 87: Oxide droplets on melt-infiltrated material in interior of SiC/BN/SiC composite for specimen exposed at 600°C for 100 hours at 200 MPa. Yellow arrows point to a matrix crack.

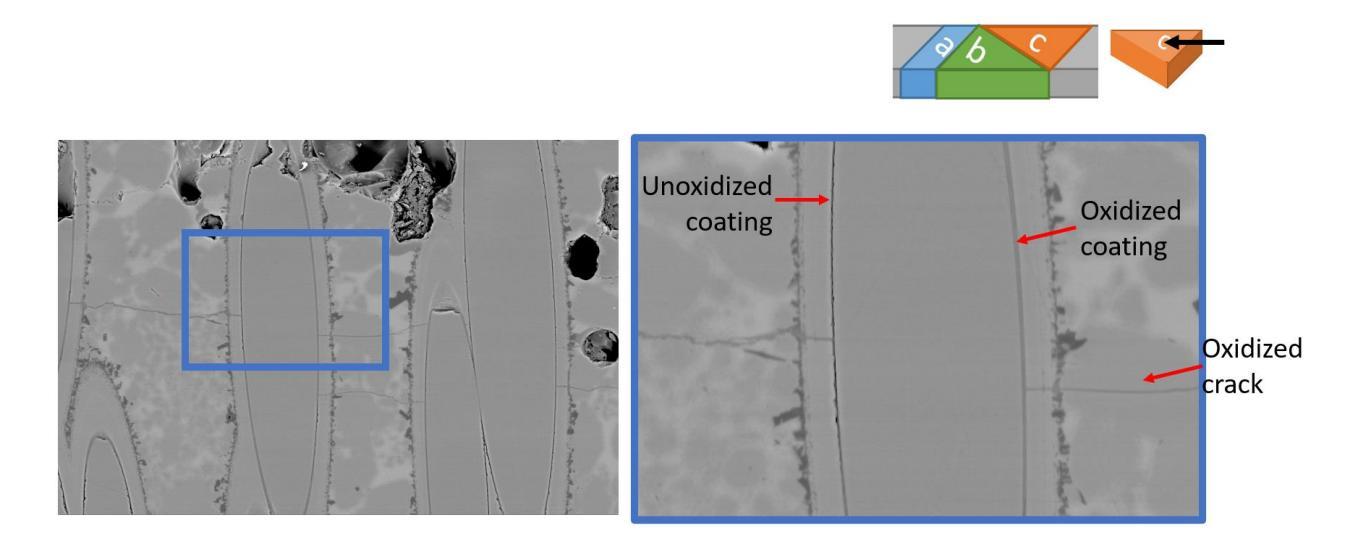
Figure 90: Oxidized crack near interior fiber tow after exposure at 800°C for 49 hours at 200 MPa. EDS point analysis was conducted at the points indicated with red arrows and are listed in Table 9. Scale bar purposefully omitted due to Rolls-Royce intellectual property.

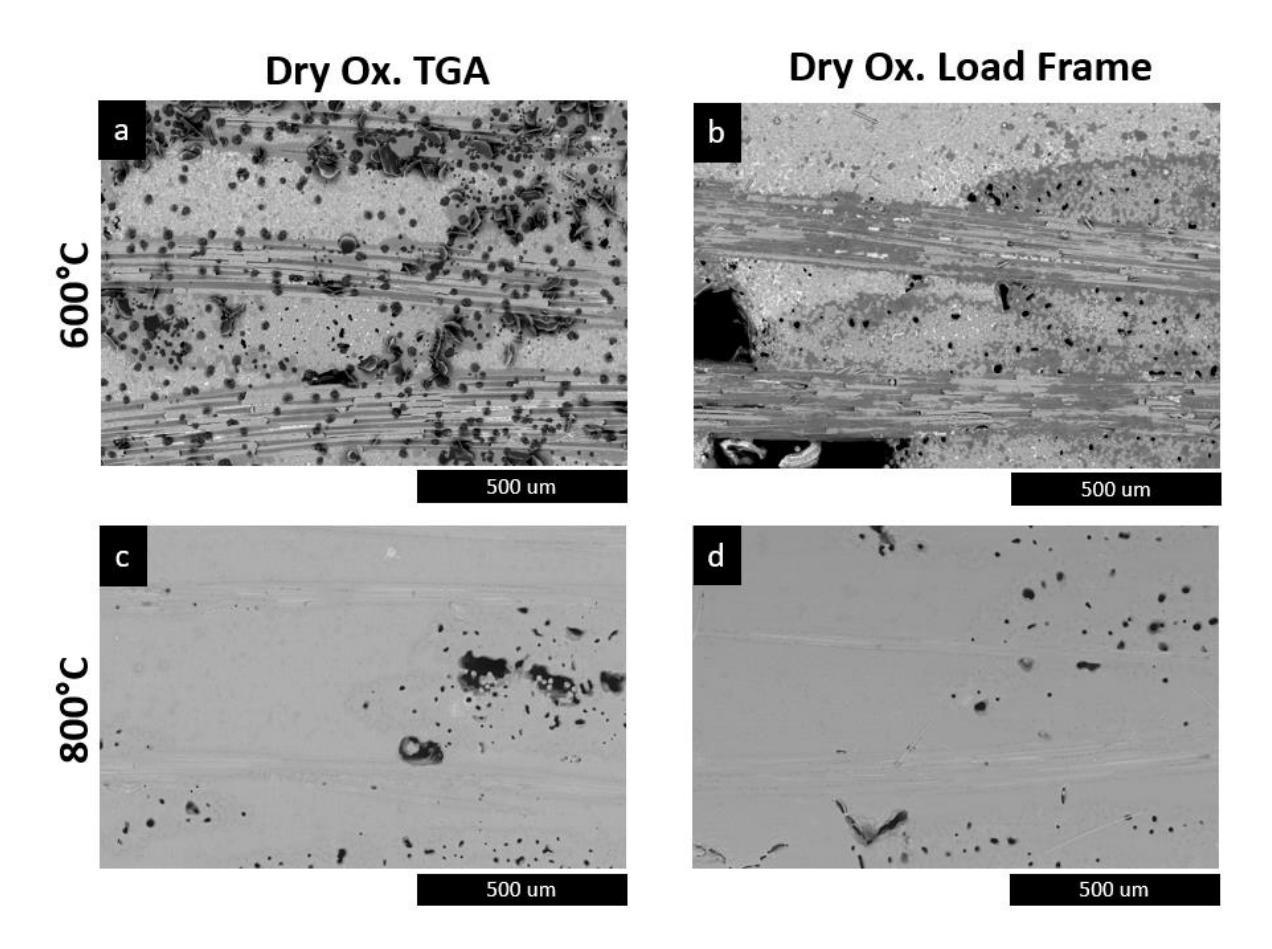
Figure 95: SEM backscatter plan view images of surface oxide morphologies on machined edges of SiC/BN/SiC CMC sample in dry oxygen exposures after 50 hours at a) 600°C in the TGA, b) 600°C in the load frame, c) 800°C in the TGA, and d) 800°C in the load frame.

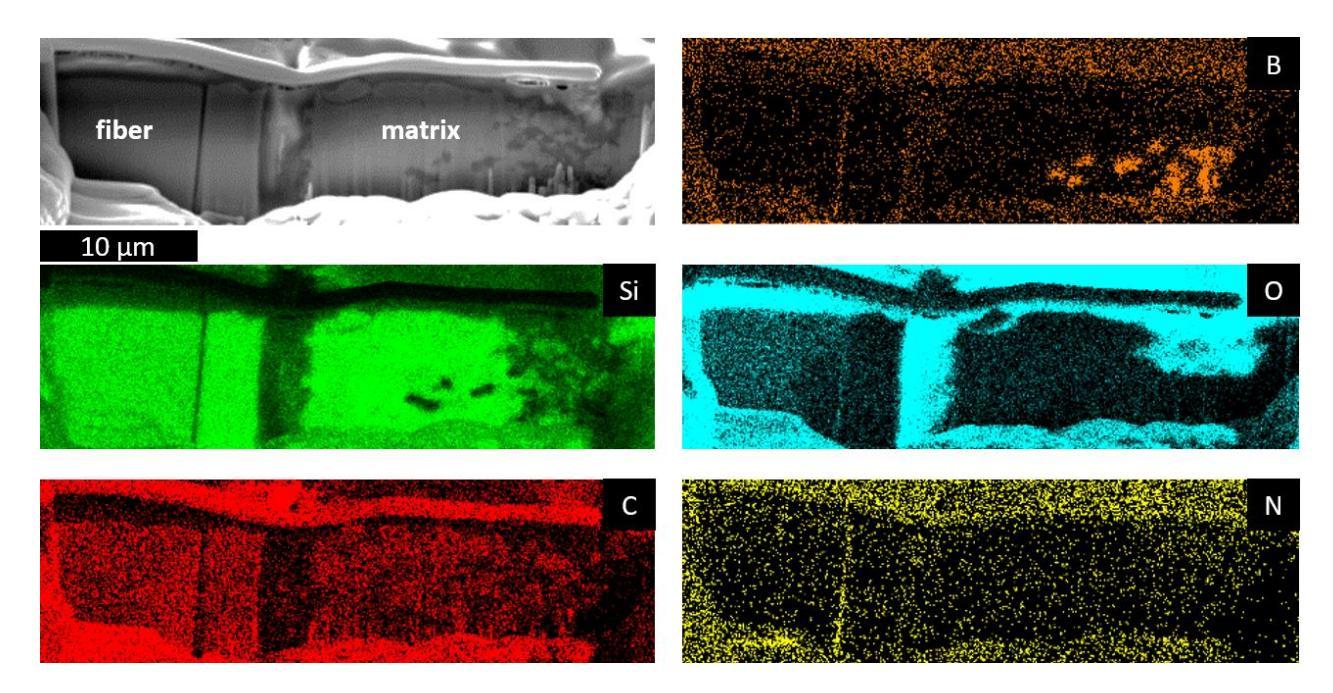
Figure 96: SEM/EDS analysis of FIB cross-section of SiC fibers in a SiC/BN/SiC CMC sample after 50 hour exposure at 600°C loaded to 200 MPa in dry oxygen.

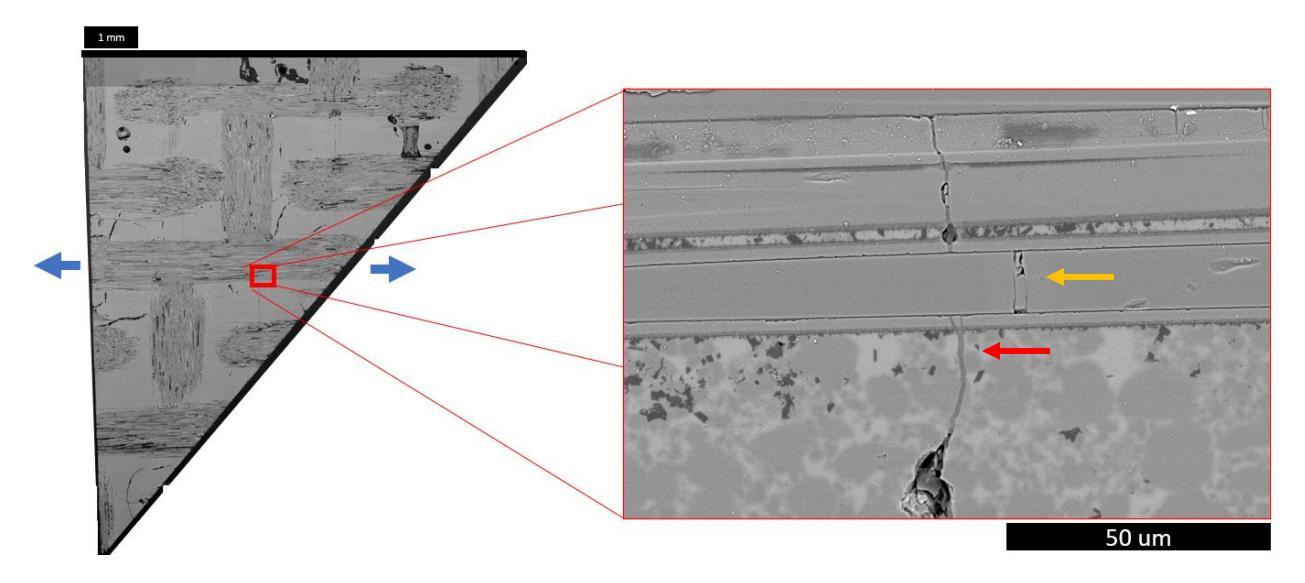
Figure 104: SEM image of polished cross-section of mid-plane of SiC/BN/SiC CMC sample exposed for 50 hours in dry oxygen at 800°C loaded to 150 MPa. Blue arrows indicate loading direction. Inset shows an oxide filled crack (red arrow) propagated through a longitudinal, load-bearing fiber tow. The yellow arrow points to a cracked SiC fiber.

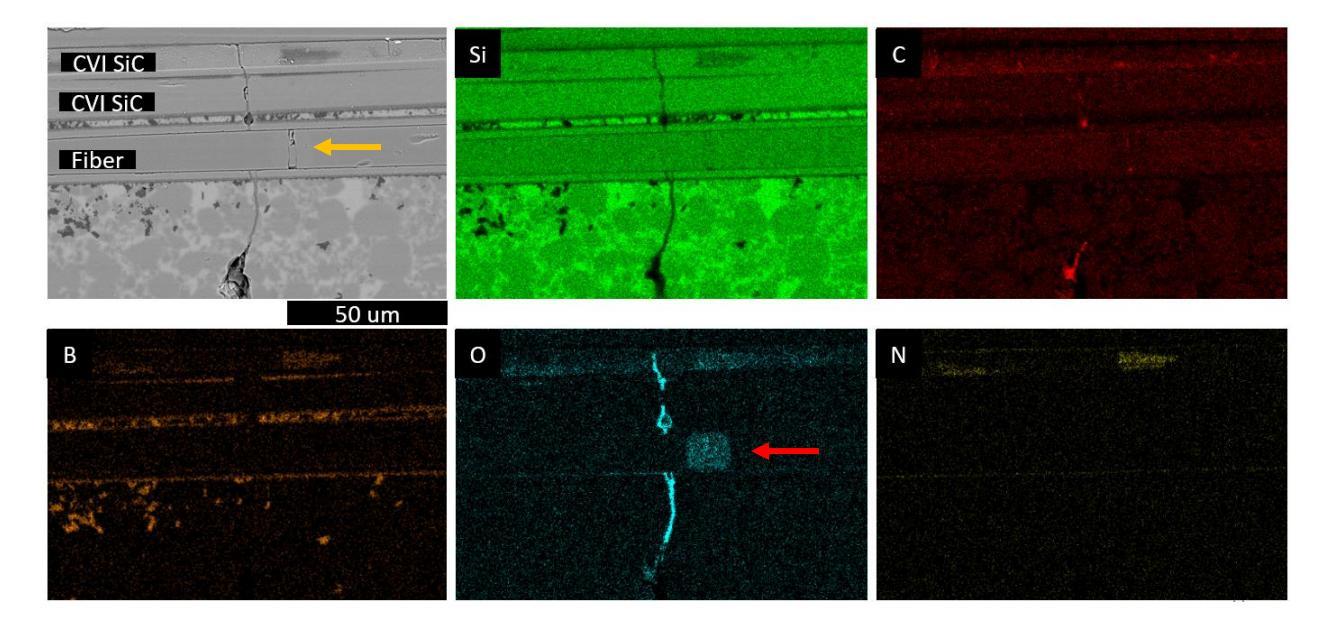
Figure 105: EDS maps of oxide filled crack near fiber tow in SiC/BN/SiC CMC exposed to 50 hours in dry oxygen at 800°C loaded to 150 MPa. A cracked SiC fiber (yellow arrow) displays oxygen solubility (red arrow).
