# Synergistic Effects of Oxidation and Load on SiC/BN/SiC Ceramic Matrix Composite Degradation at Intermediate Temperatures

## Dissertation

Kaitlin Detwiler

May 2022

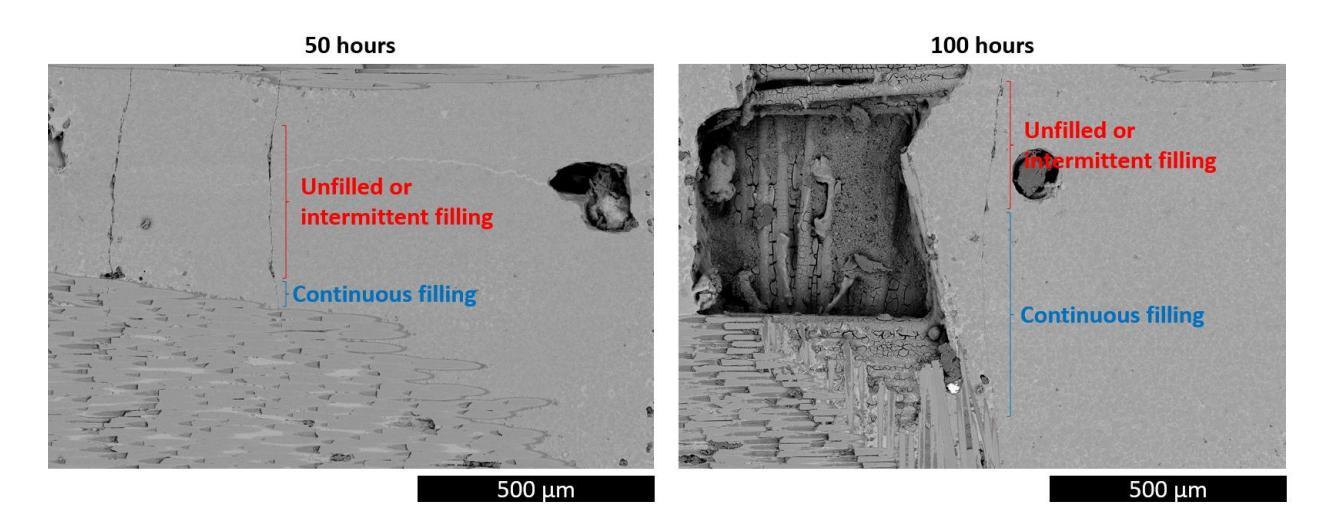
Figure 106: Backscatter SEM images of interior crack filling in SiC/BN/SiC CMC after 50 and 100 hours at 600°C at 200 MPa in dry oxygen.

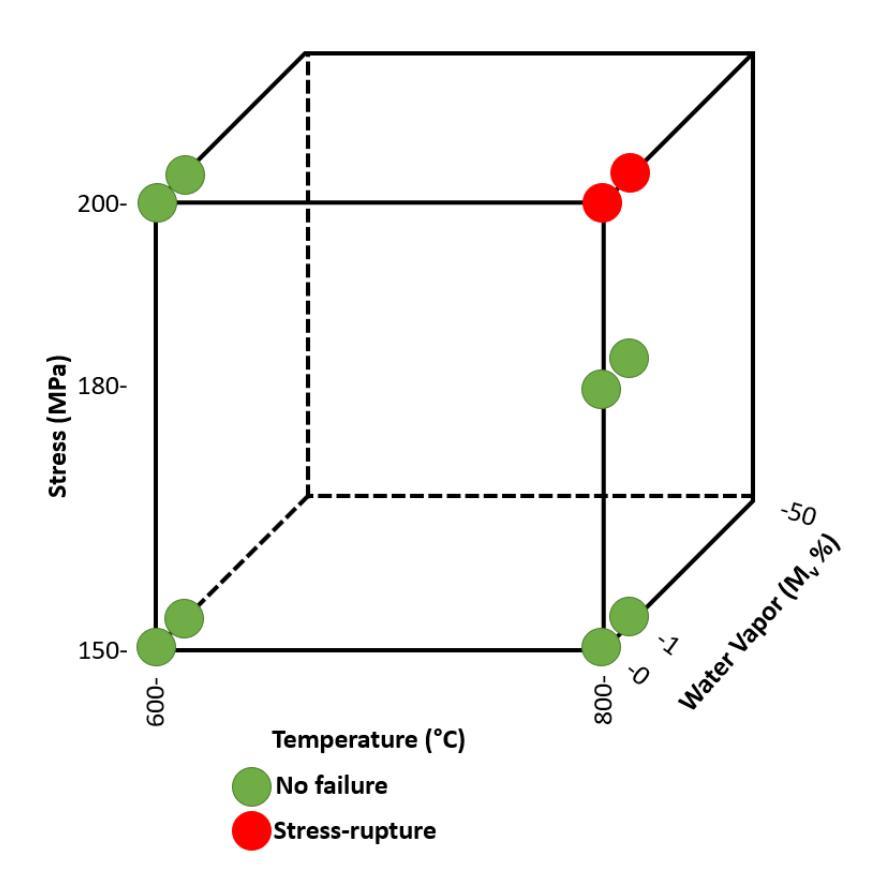
Figure 108: Illustration displaying the effects of temperature, stress, and water vapor content with results from dry oxygen and lab air. Green dots represent no stress-rupture at that condition and red dots represent at least one sample rupturing at that condition. Each dot represents two tests.

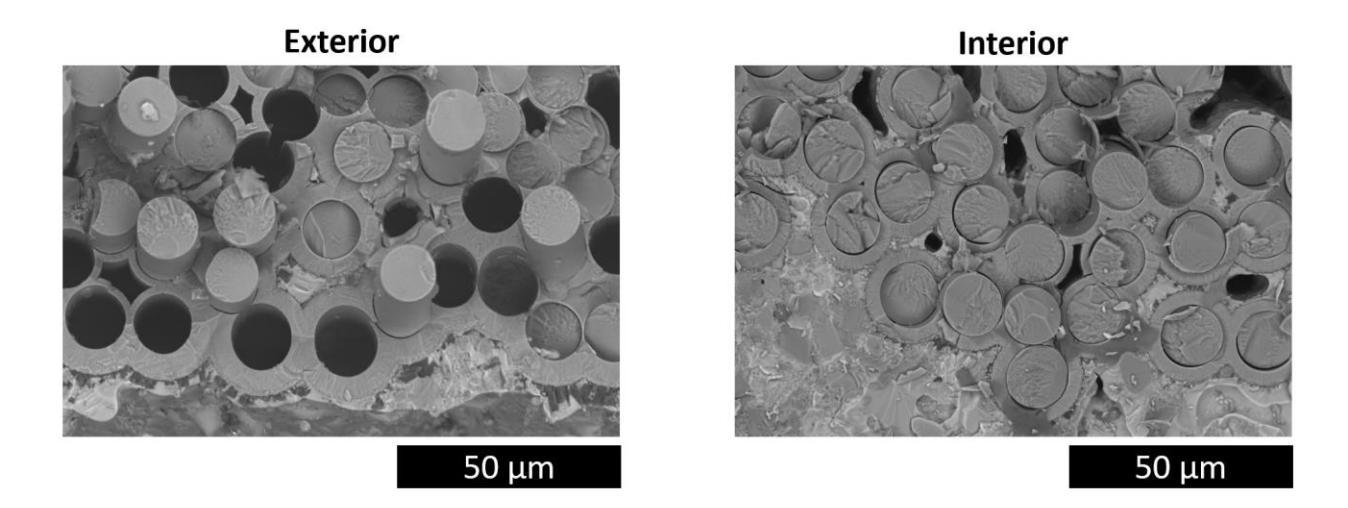
Figure 115: Backscatter SEM images of exterior and interior fiber tow from top fracture surface of SiC/BN/SiC CMC that stress-ruptured after exposure to 50%  $H_2O/50\%$   $O_2$  mixture at 600°C for 26 hours at 150 MPa. Fiber tows on the outer edges exhibit fiber pullout and interior tows exhibit flat, brittle failure.

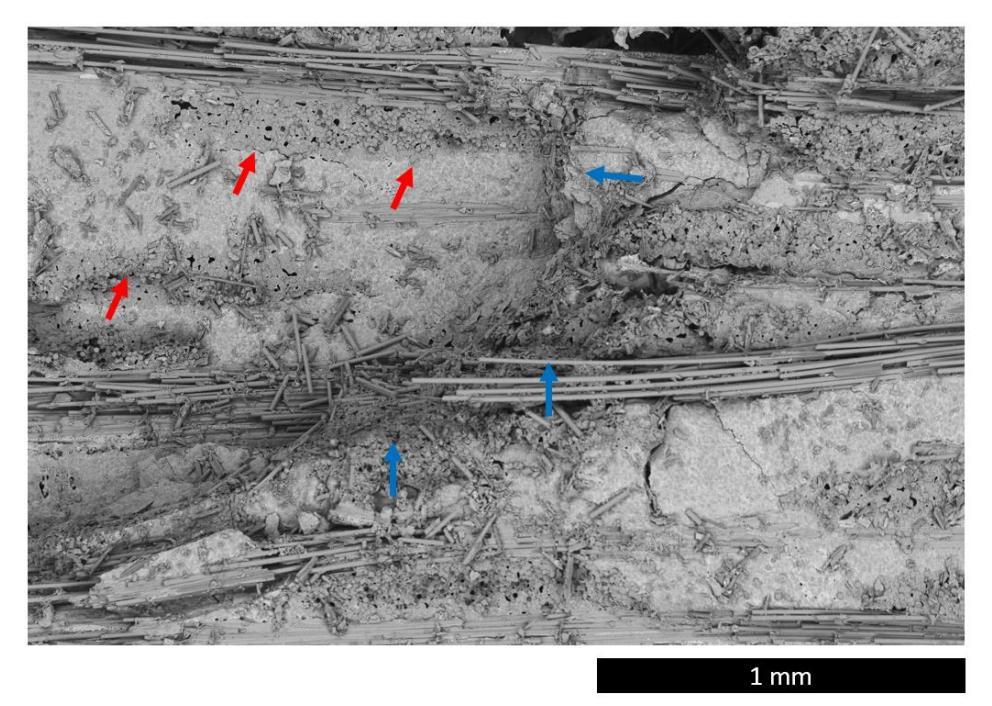
Figure 117: Backscatter SEM images of top fracture surfaces of SiC/BN/SiC CMC that stress-ruptured after exposure to  $50\% H_2O/50\% O_2$  mixture with a 30 hour pre-exposure + 12.7 hours at 150 MPa. Red arrows indicate flat fiber bundle and blue arrows indicate multi-ply topography in matrix material.

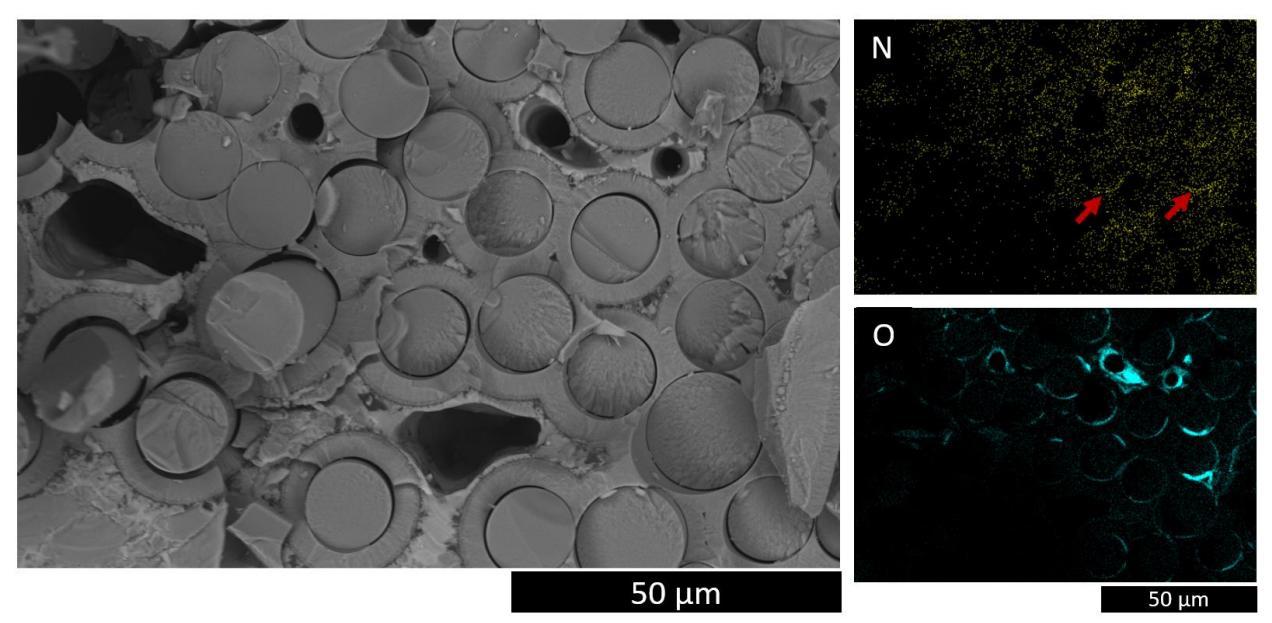
Figure 120: Backscatter SEM images and EDS maps of SiC fibers on interior of fracture surface in SiC/BN/SiC CMC exposed to  $50\% H_2O/50\% O_2$  mixture at  $600^{\circ}C$  the load frame for 26 hours at 150 MPa.

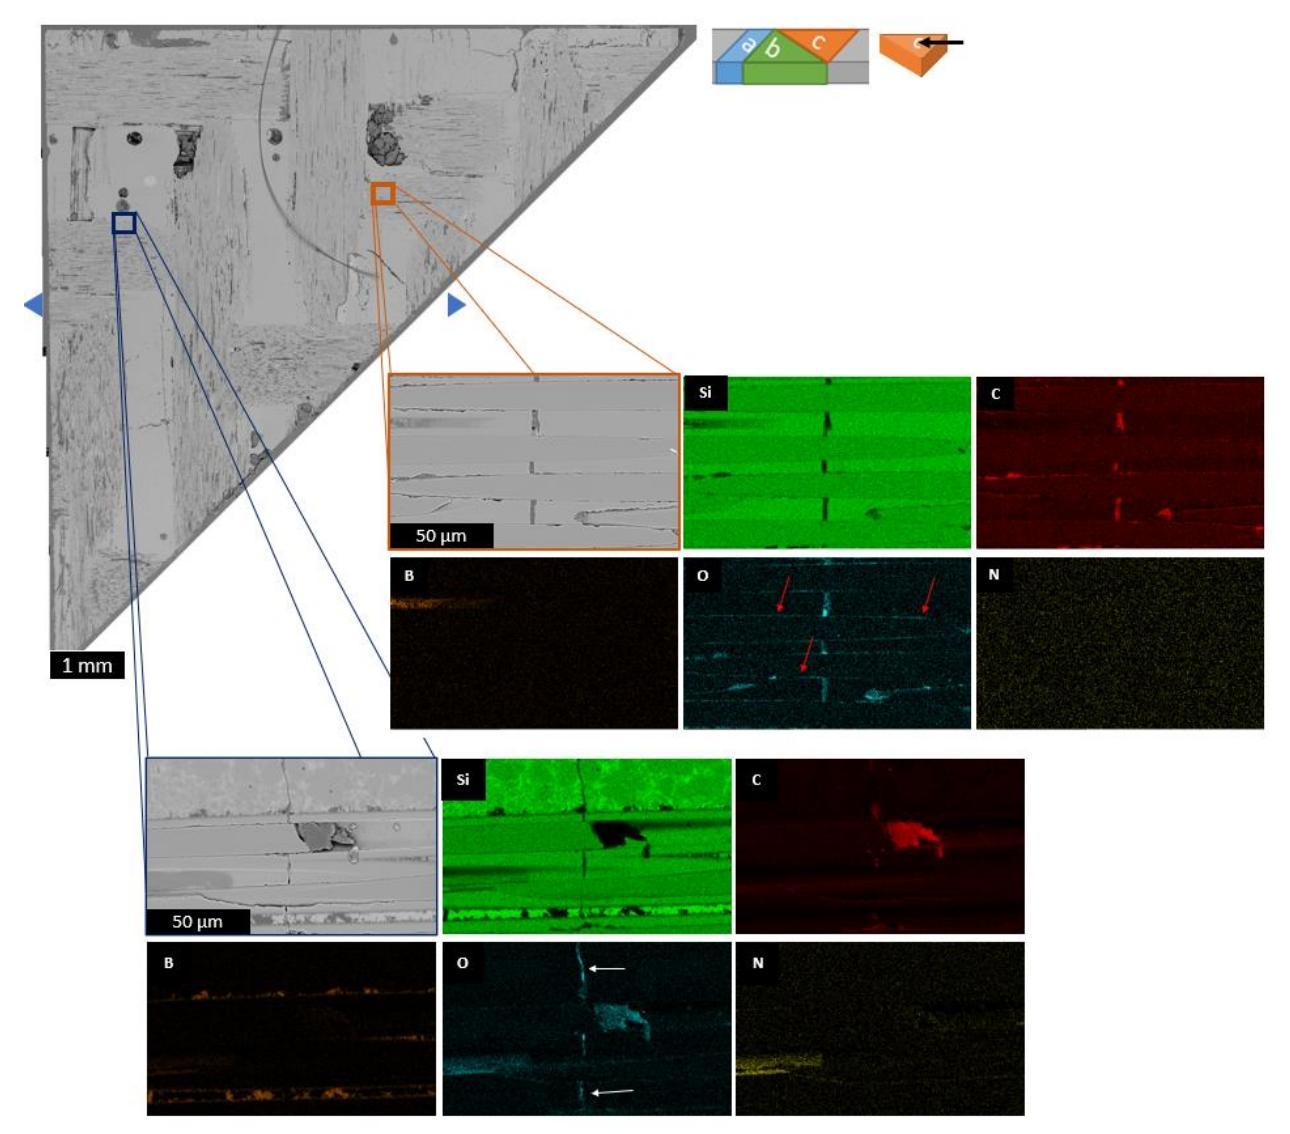
Figure 124: Backscatter SEM images cross-section C of SiC/BN/SiC CMC exposed to 50%  $H_2O/50\%$   $O_2$  mixture at 600°C in the load frame for 14 hours at 150 MPa. The test was interrupted after 14 hours. Blue arrows indicate loading direction. Red arrows indicate oxidized fiber coatings and white arrows indicate partial matrix crack filling.

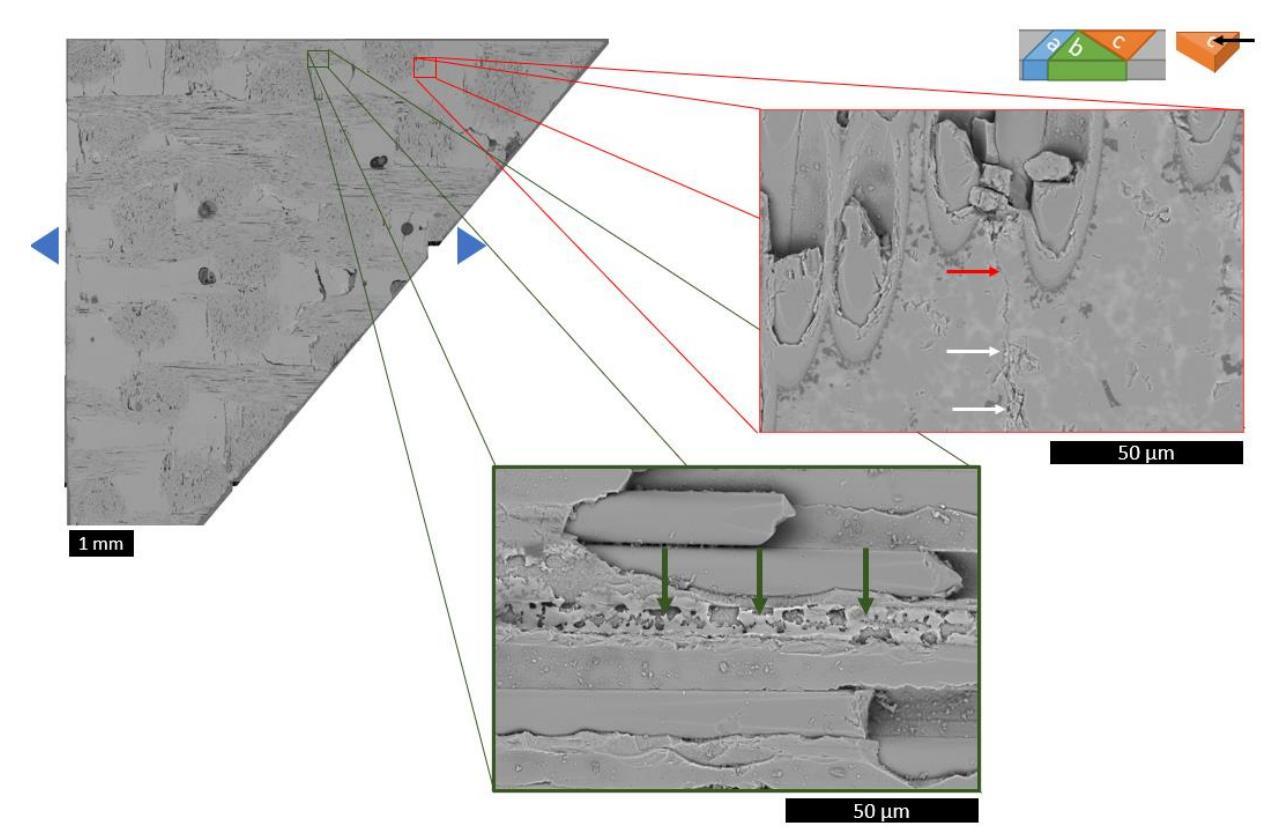
Figure 125: Backscatter SEM images cross-section C of SiC/BN/SiC CMC exposed to 50%  $H_2O/50\%$   $O_2$  mixture at 600°C in the load frame for 26 hours at 150 MPa. Blue arrows indicate loading direction. Red arrows indicate filled matrix crack and white arrows indicate unfilled matrix crack in red inset. Green inset shows intratow MI rich region where B-containing phase oxidized and volatilized, leaving voids, indicated by green arrows.

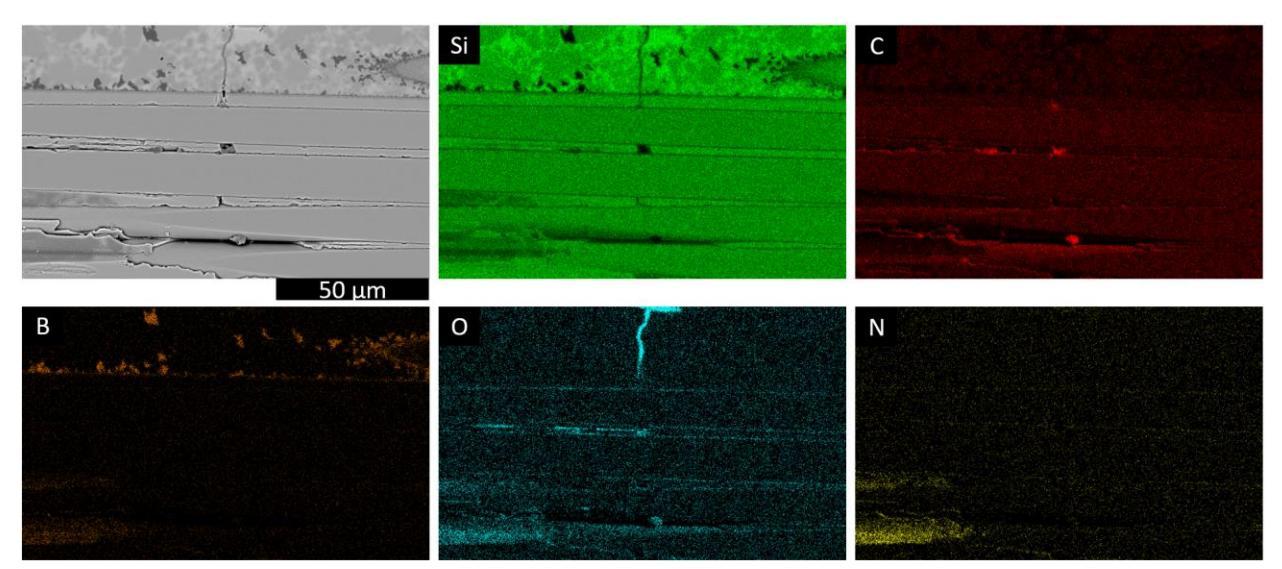
Figure 127: Backscatter SEM images and EDS maps of cross-section of SiC fibers in interior of SiC/BN/SiC CMC exposed to 50%  $H_2O/50\%$   $O_2$  mixture at 800°C in the load frame for 2 hours at 180 MPa.

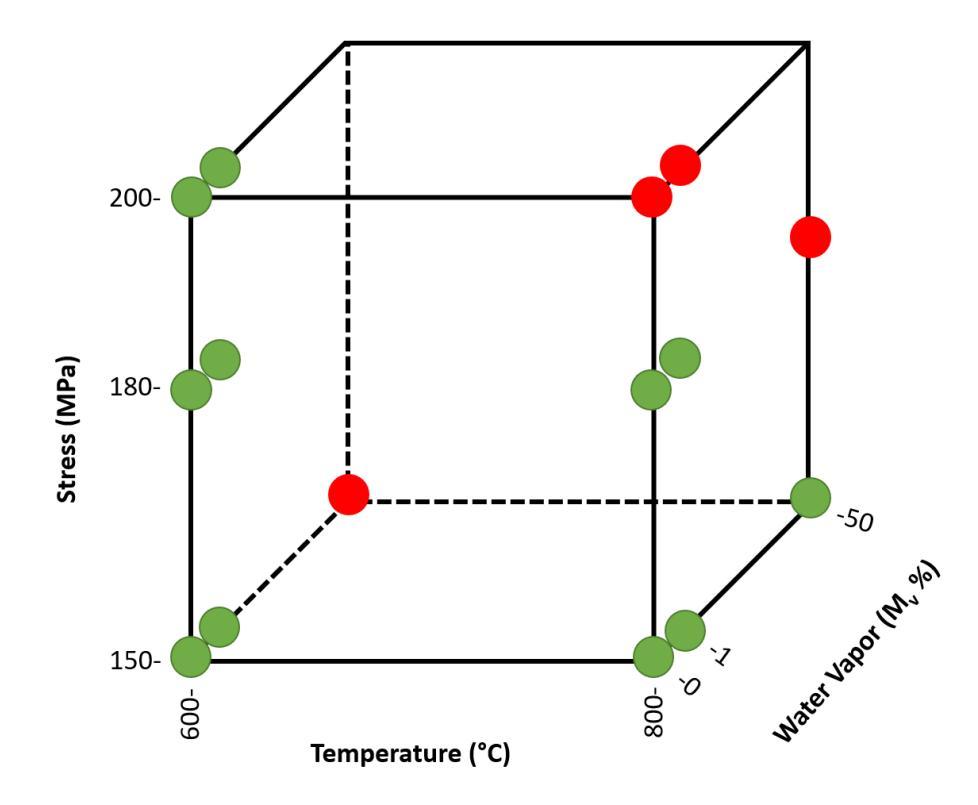
Figure 131: Illustration displaying the effects of temperature, stress, and water vapor content with results from dry oxygen, lab air, and wet oxygen. Green dots represent no stress-rupture at that condition and red dots represent at least one sample rupturing at that condition. Each dot represents at least two tests.

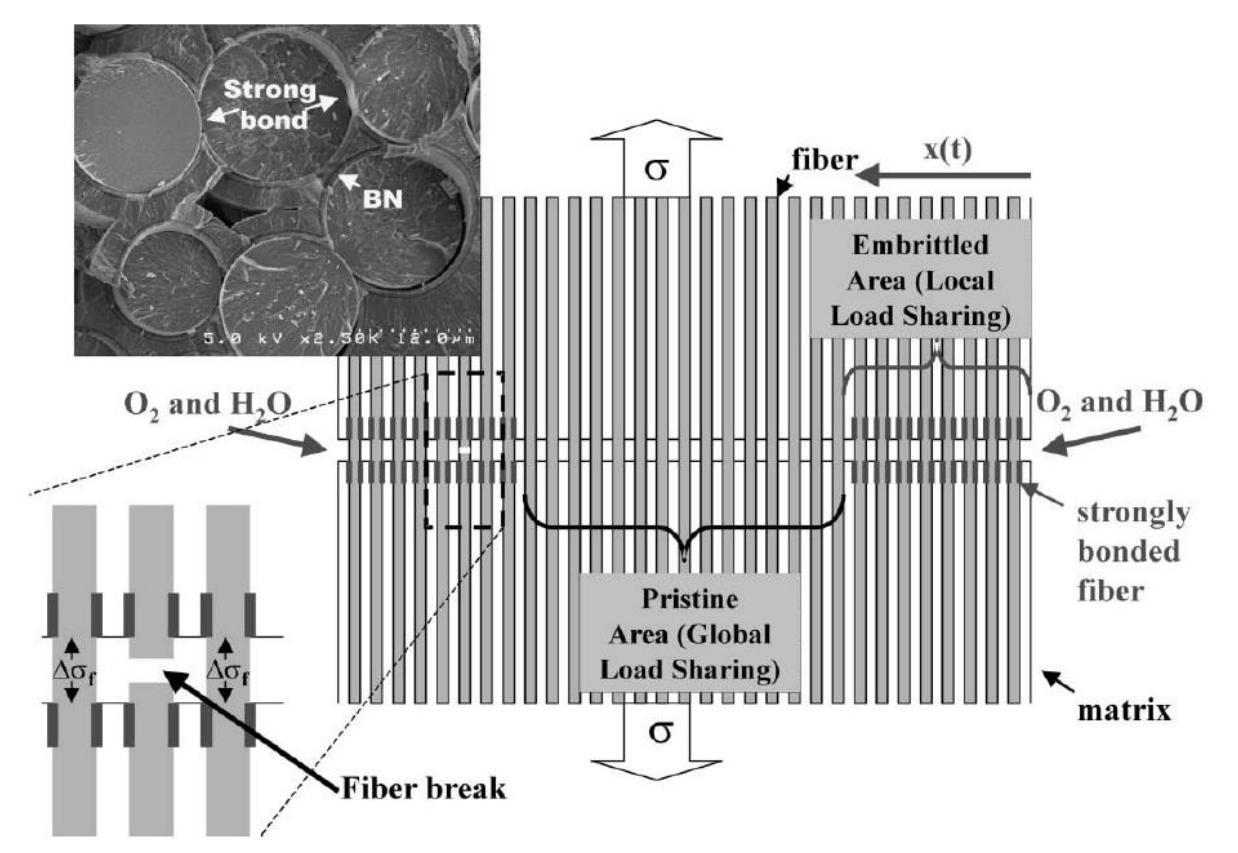
Figure 134: Model schematic for SiC/BN/SiC CMCs at intermediate temperature where the predominant failure mechanism is oxidation of the BN fiber coatings bonding the fibers to themselves or matrix material. X(t) is the embrittlement depth and  $\sigma_f$  is the stress on the fiber in a bridged matrix crack. Schematic obtained from [89]

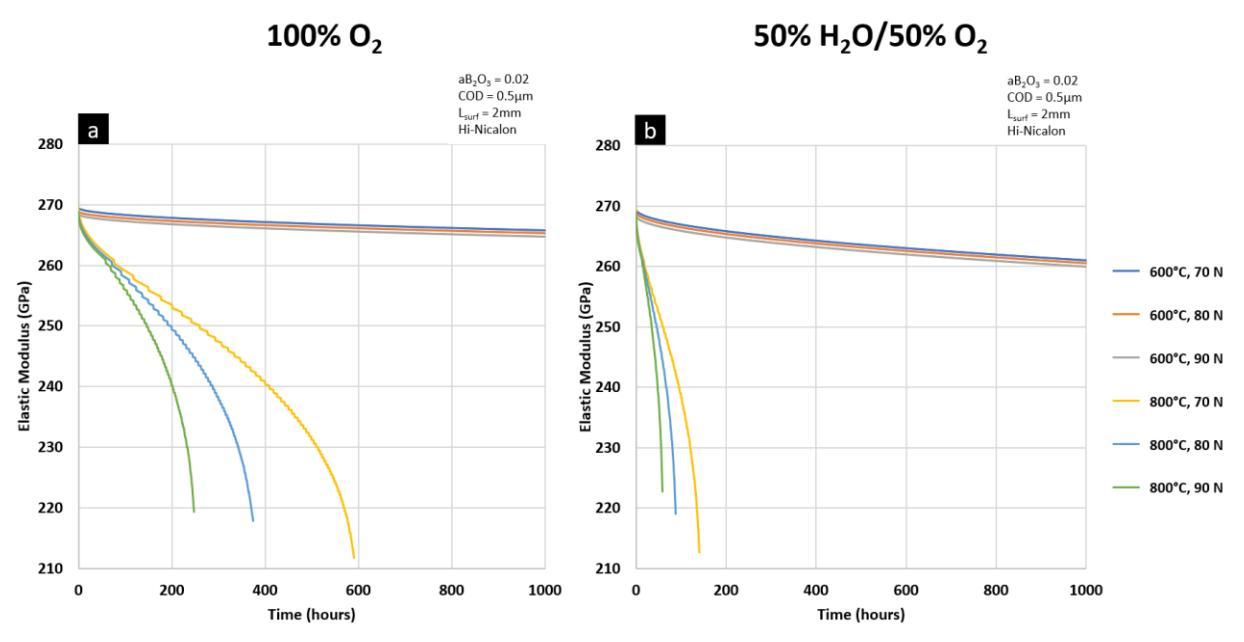
Figure 136: Predicted effect of applied force on SiC/BN/SiC CMC fiber tow elastic modulus at 600 and 800°C in a) 100%  $O_2$  and b) 50%  $H_2O/50\% O_2$ . Force values used were 70, 80, and 90 N.

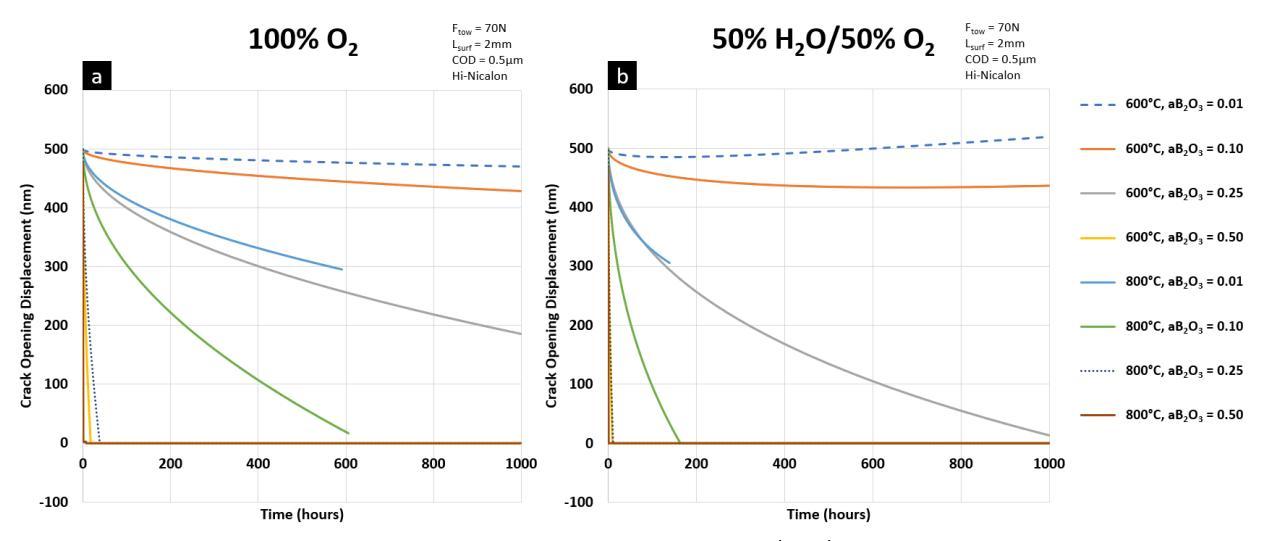
Figure 139: Crack opening displacement predictions for SiC/BN/SiC CMC vs. time for  $aB_2O_3 = 0.01$ , 0.10, 0.25, and 0.50 in a) 100%  $O_2$  and b) 50%  $H_2O/50\% O_2$ . Starting COD is  $0.5\mu$ m.

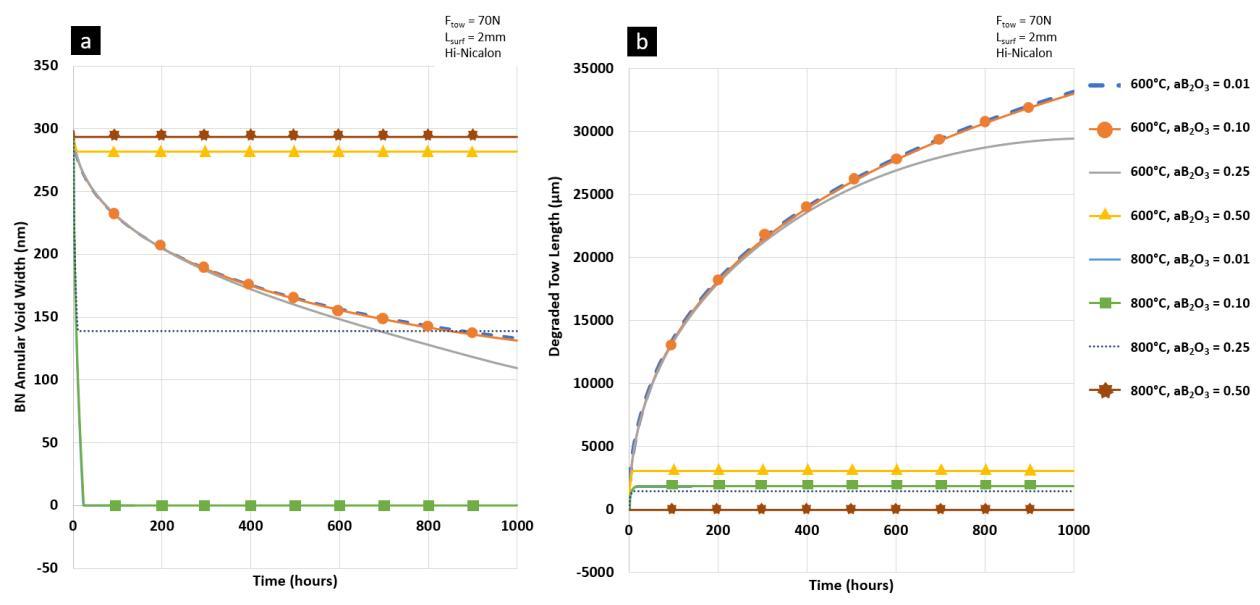
Figure 140: Predictions of SiC/BN/SiC CMC a) BN annular void width vs. time and b) Degraded tow length vs. time for  $aB_2O_3 = 0.01$ , 0.10, 0.25, and 0.50 in a) 100% O<sub>2</sub> and b) 50% H<sub>2</sub>O/50% O<sub>2</sub>. Starting COD is  $0.5\mu$ m.

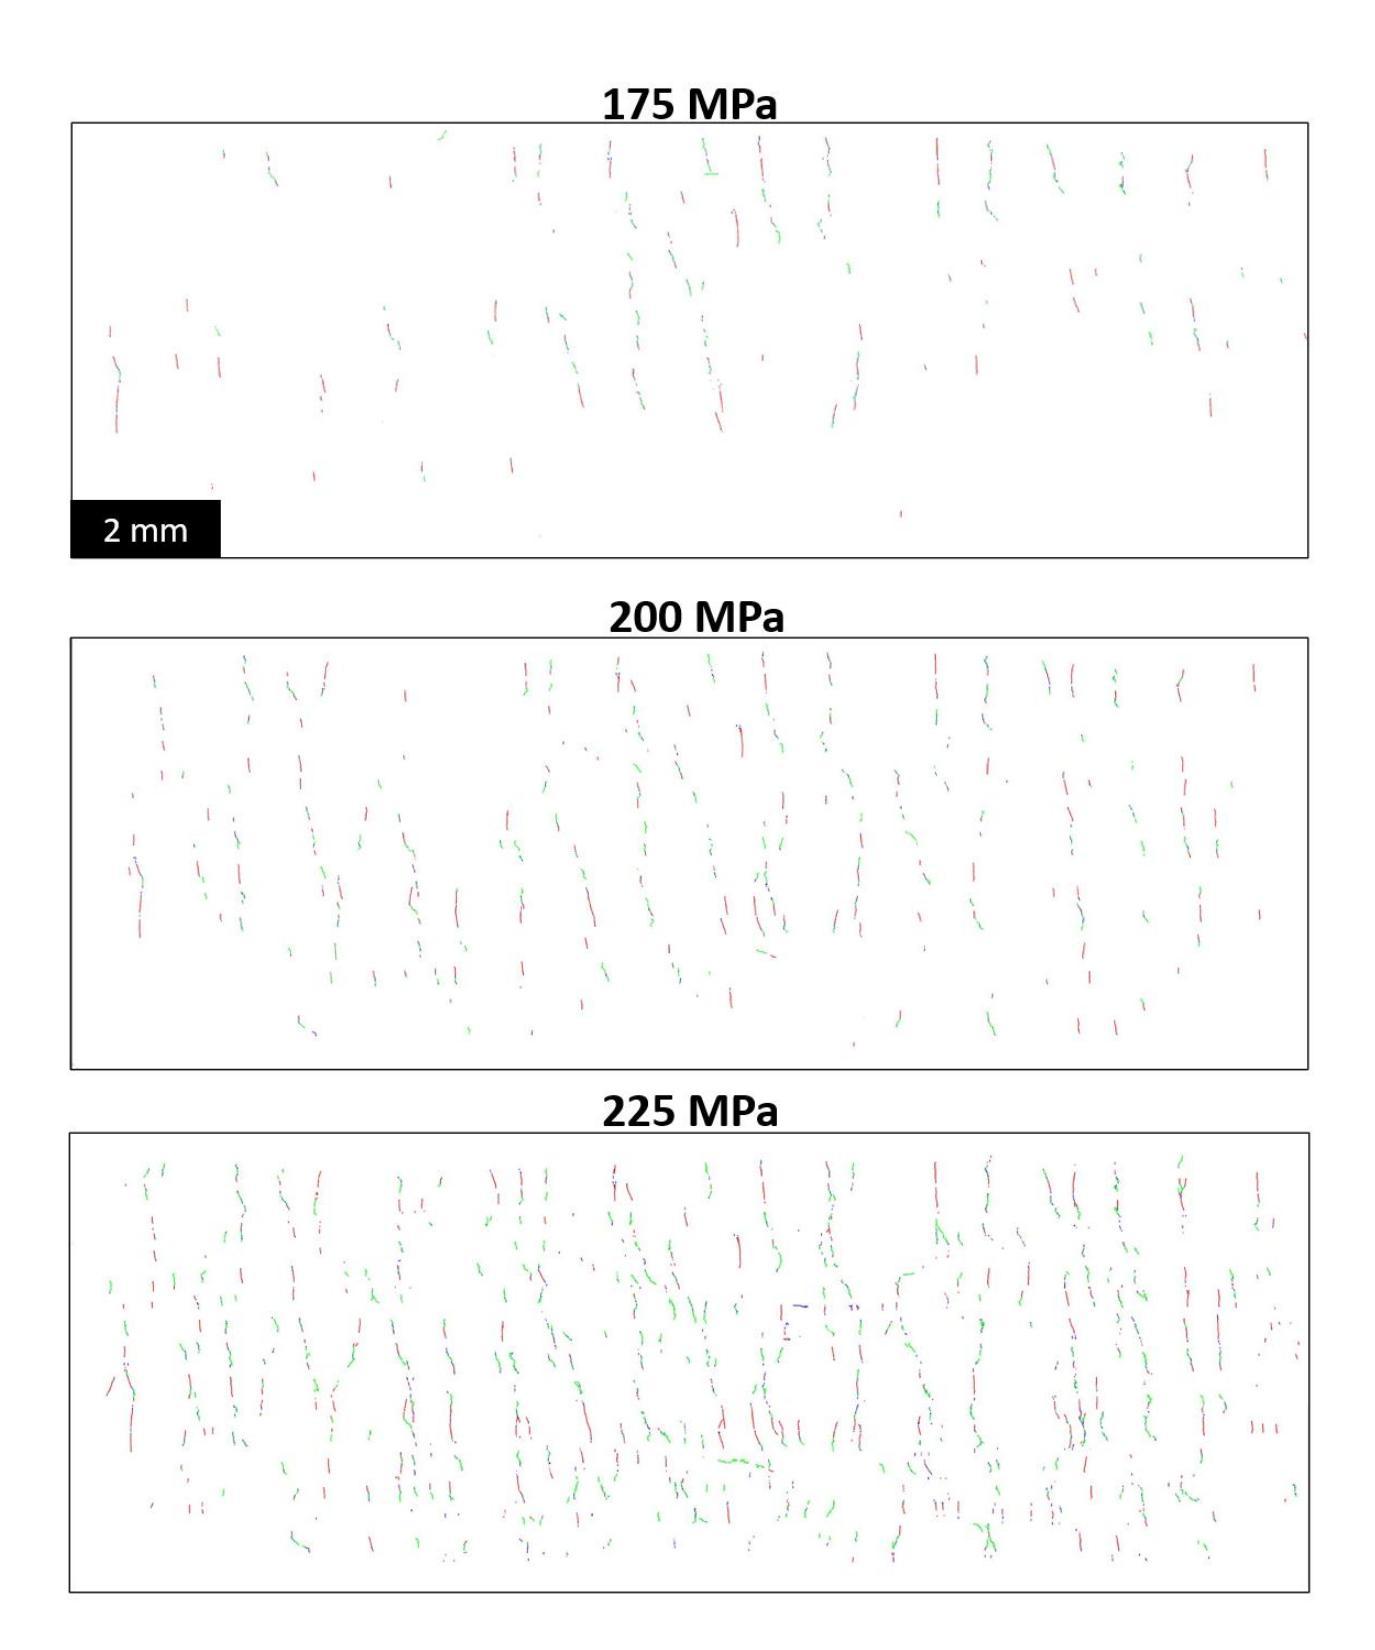
Figure 144: Mask of marked cracks from SiC/BN/SiC CMC tested at room temperature with tensile stage at 175, 200, and 225 MPa.

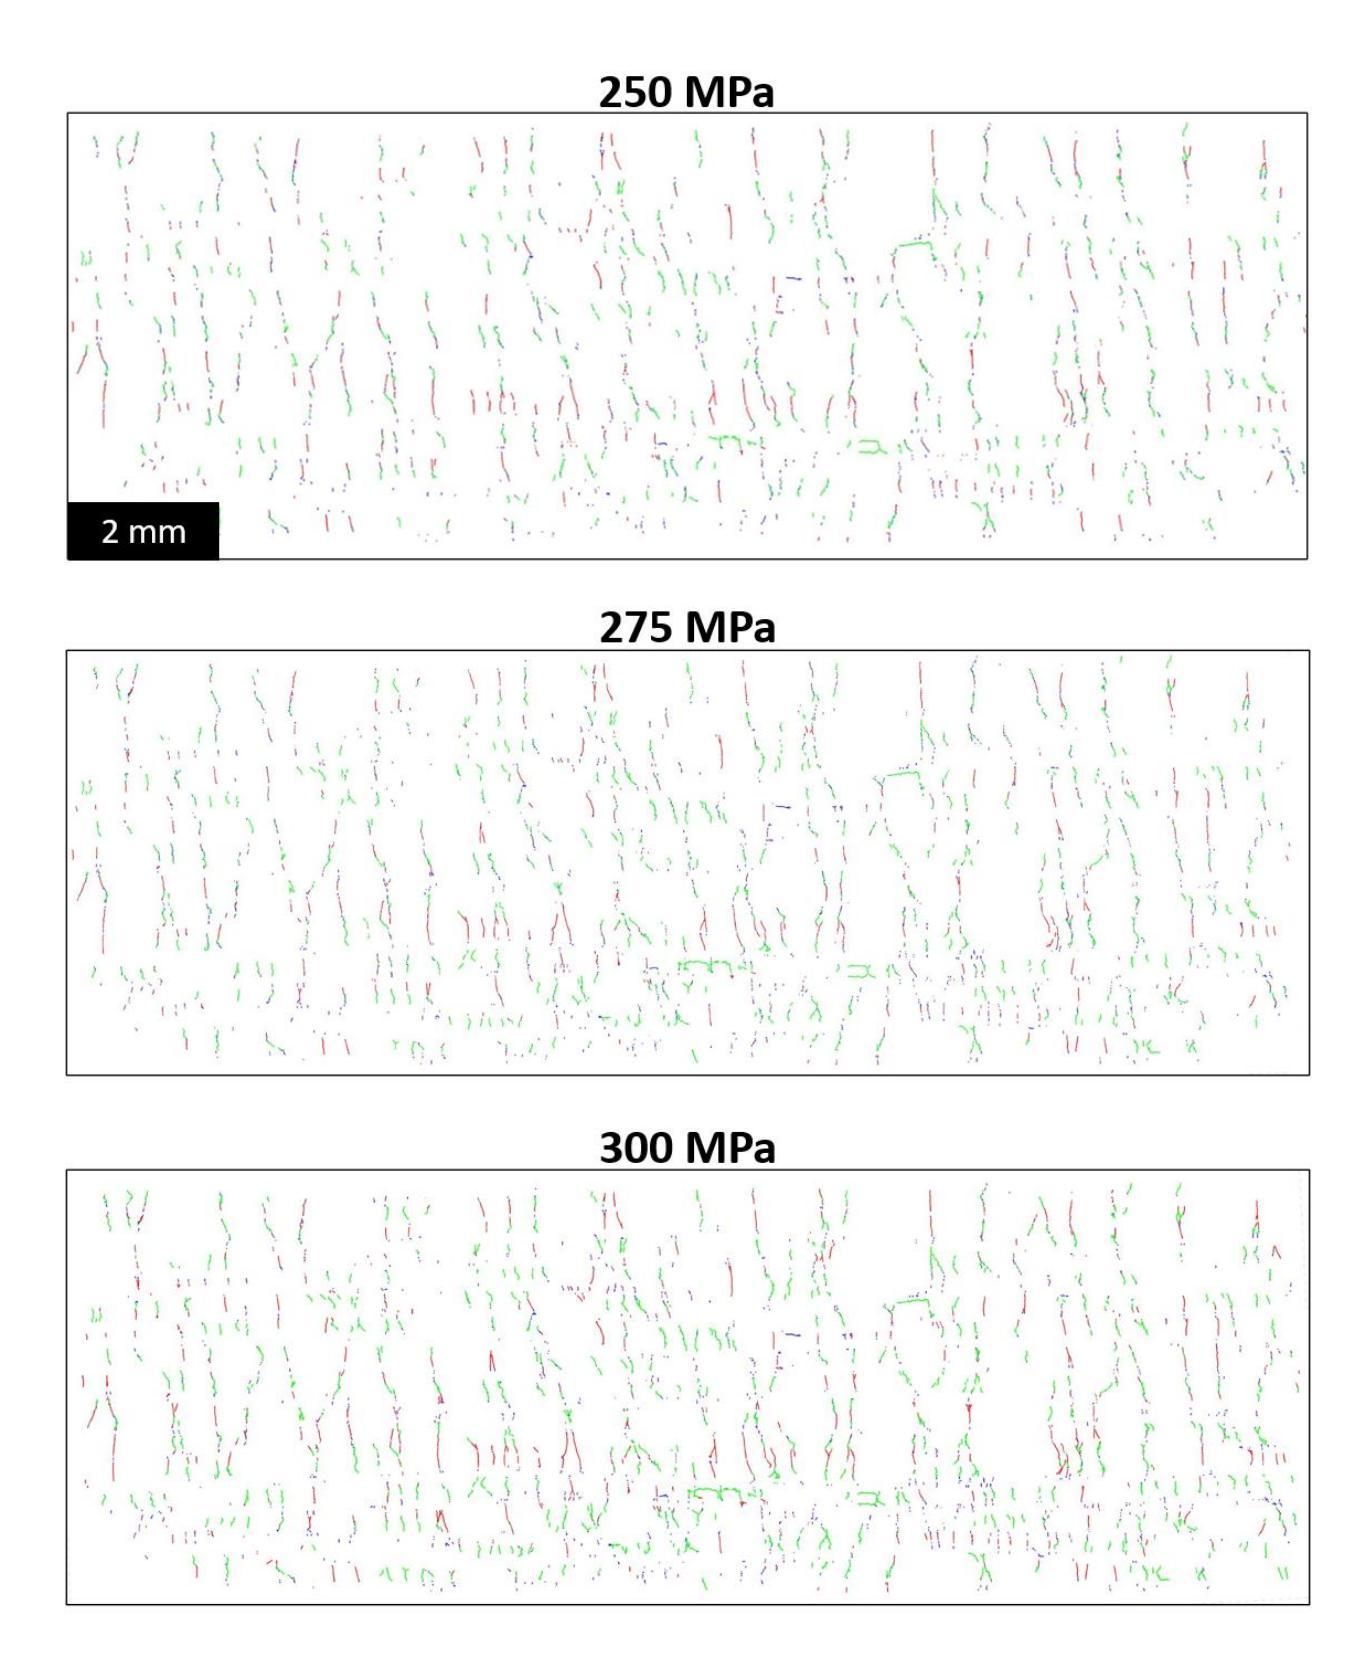
Figure 145: Mask of marked cracks from SiC/BN/SiC CMC tested at room temperature with tensile stage at 250, 275, and 300 MPa.

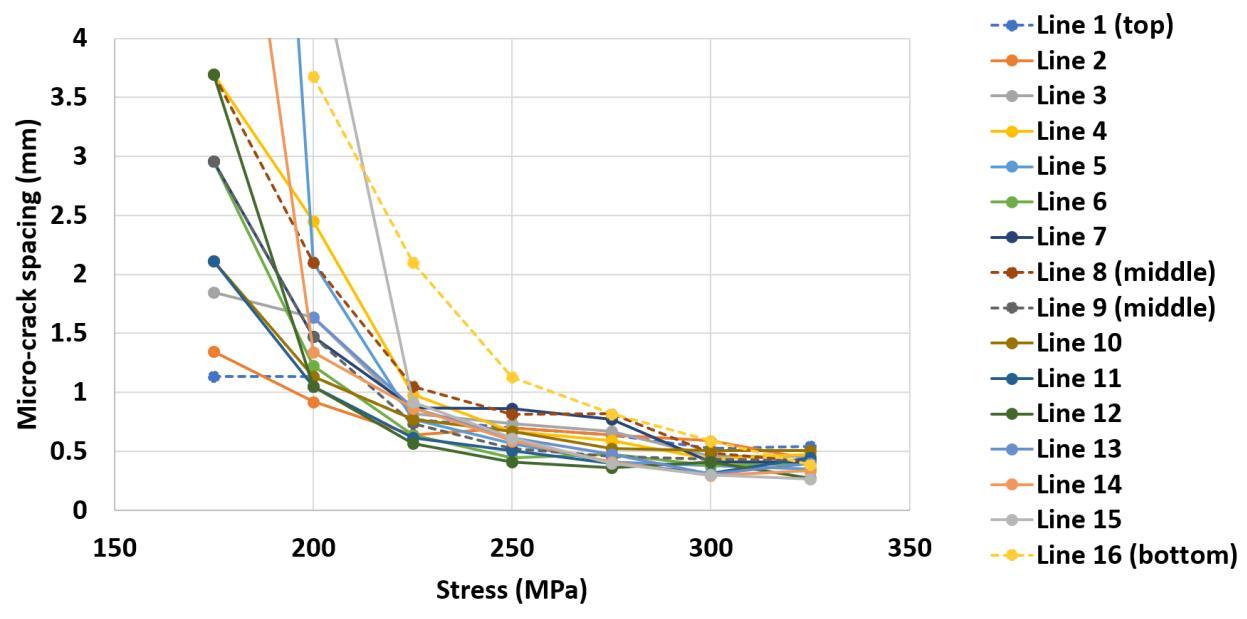
Figure 147: Micro-crack spacing for each line measured vs. applied stress for SiC/BN/SiC CMC tested at room temperature with tensile stage.

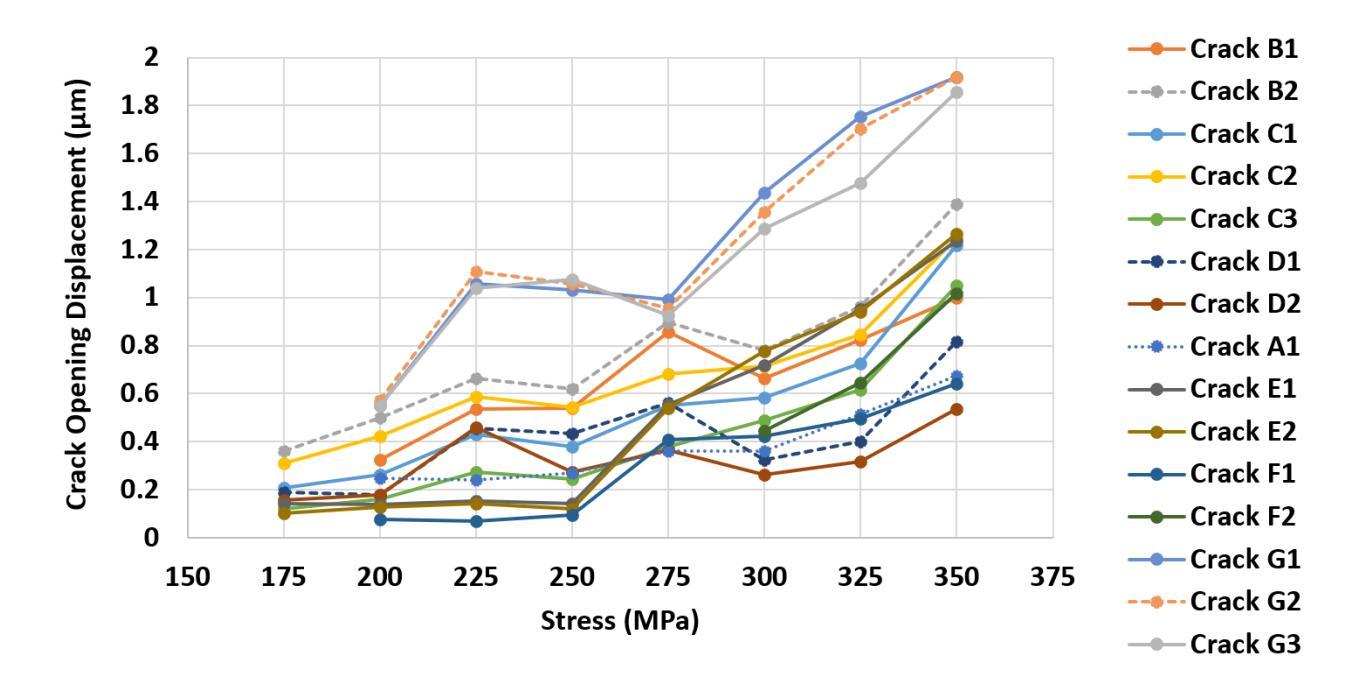
Figure 148: Crack opening displacements in matrix material vs. applied stress in SiC/BN/SiC CMC loaded at 600°C in SEM
