K'ellu Mayu Pedetrian Bridge  
Capstone Project

A Capstone Research Paper  
presented to the faculty of the  
School of Engineering and Applied Science  
University of Virginia

Calvin Reeves

April 30, 2024

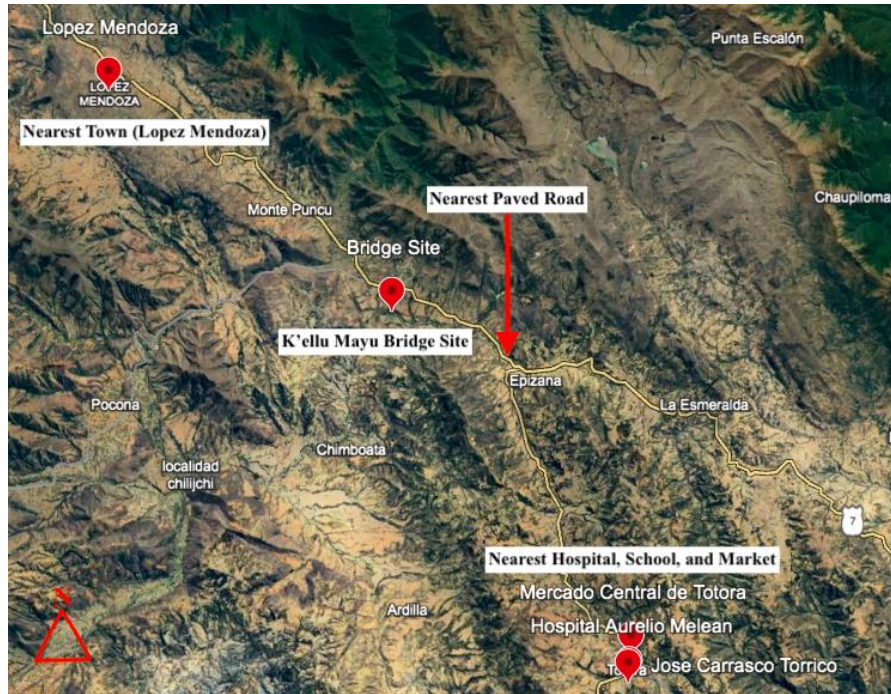
Figure 1. Bridge site location relative to other local resources

This report will describe the type, size, and location study performed by the UVA Capstone team for a pedestrian footbridge in Bolivia that crosses the Río K'ellu Mayu and links the Pocona Municipality to vital resources in the region (Figure 1).

The bridge is located in the Cochabamba region of Bolivia (Figure 1). According to the Project Social Evaluation report provided by the organization Engineers in Action (EIA) and prepared by Mr. Richar Galvez on May 7, 2022 (Appendix 5.4), the nearest pedestrian bridge is the Yana Gaga pedestrian bridge located 8 kilometers downstream of the site. Additionally, the site is 2 kilometers away from their nearest beneficiary community. The nearest town, Lopez Mendoza, is about 16 kilometers (about 9.94 mi) away to the west of the site, and the closest market, hospital, and school are 18 kilometers away to the east (Figure 1). In addition, the closest paved road to the site is Old Cochabamba Road Santa Cruz (Route 7).

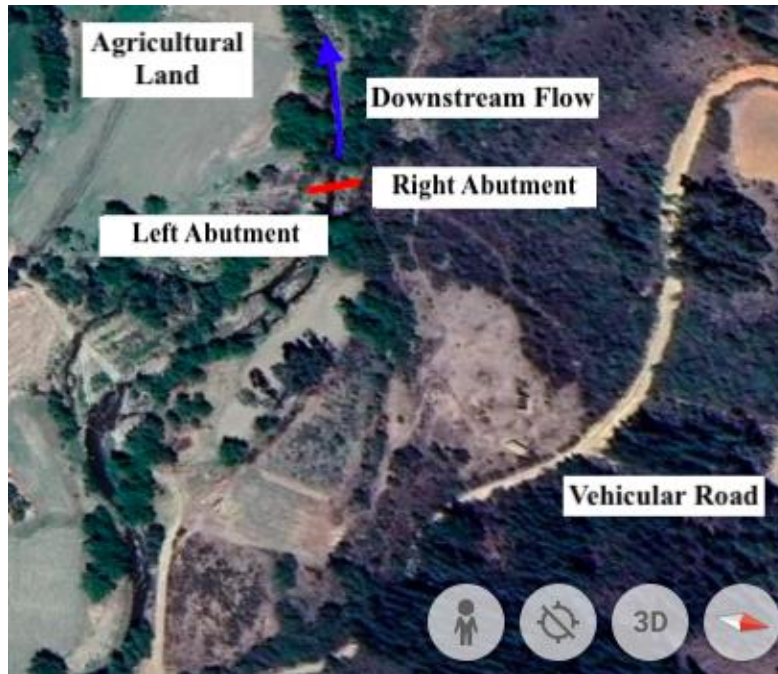
Figure 2. Aerial view of bridge site

The bridge's proposed alignment is illustrated in Figure 2. According to EIA conventions, one should be facing in the direction of the river's downstream flow when determining which is the "left" and "right" abutment. The K'ellu Mayu river flows westward, meaning the left abutment faces the agricultural land and the right abutment faces unpaved vehicular road (Figure 2). This unpaved vehicular road is a different road than the paved Old Cochabamba Road and is located closer to the site.

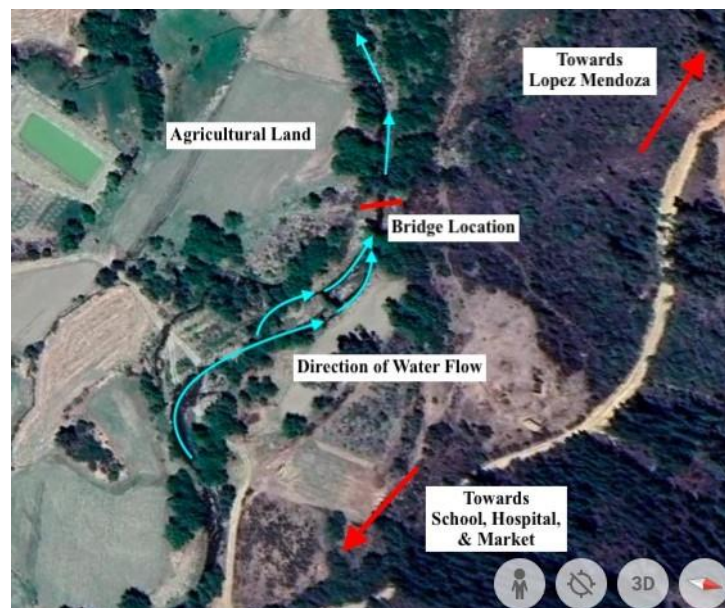
Figure 3. Site overview

Before beginning the bridge's design, an overview of the site's geotechnical and hydraulic conditions was developed using materials that EIA provided. Figure 3 shows an aerial view of the Río K'ellu Mayu bridge site (coordinates -17.620584, -65.271513). Using EIA's naming conventions, the left riverbank is facing the agricultural land, and the right bank is facing the road.

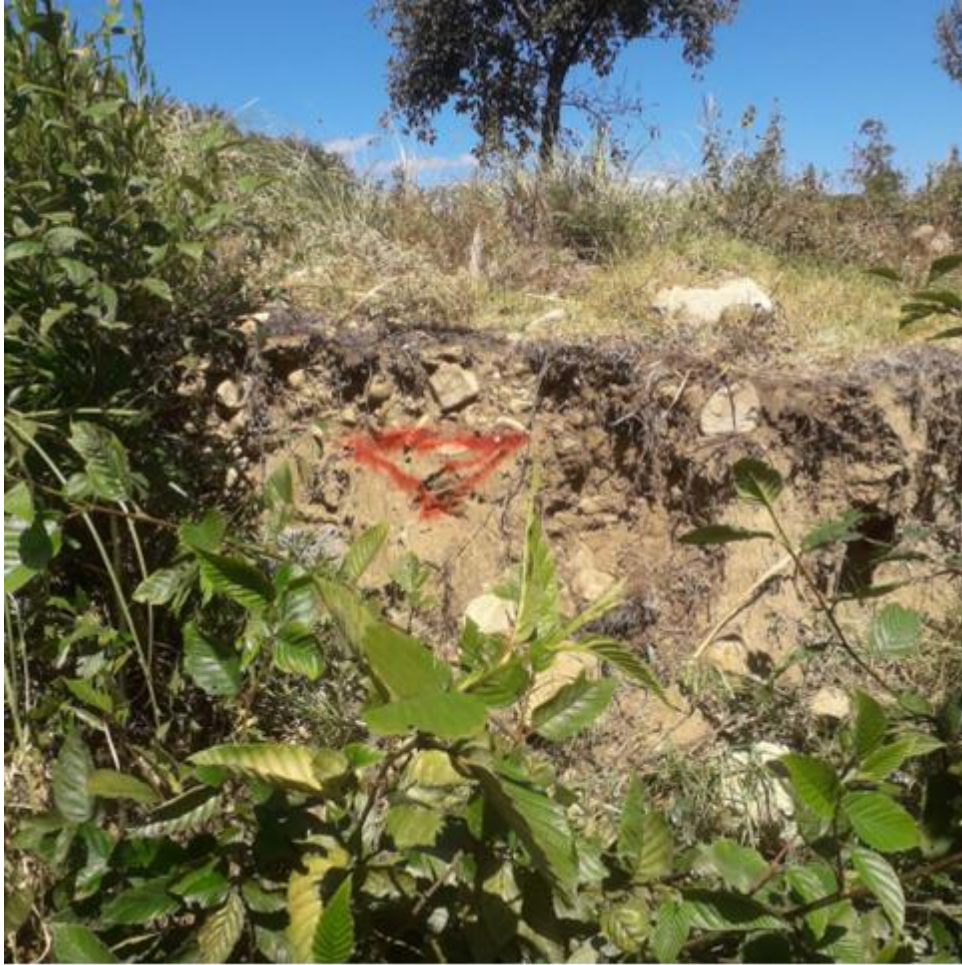
*Figure 7. High-water line marking*

The high-water line is the line at the riverbank where the water reaches during high water events (Figure 7). Per the Social Evaluation completed by Richar Galvez on May 07, 2022 (Appendix C), the river floods for approximately one day a year during the rainy season. The High-Water Line (HWL) was established by local elders from storm events they experienced in their lifetime. The HWL is 2732' above sea level. According to EIA's Bridge Program- Volume 2, all suspended bridge sites should be considered a gorge and will have a 3.0 meter freeboard<sup>5</sup>. Gorge flow only goes downstream quickly and rises. Freeboard is the minimum required height of the footbridge relative to the high-water line.

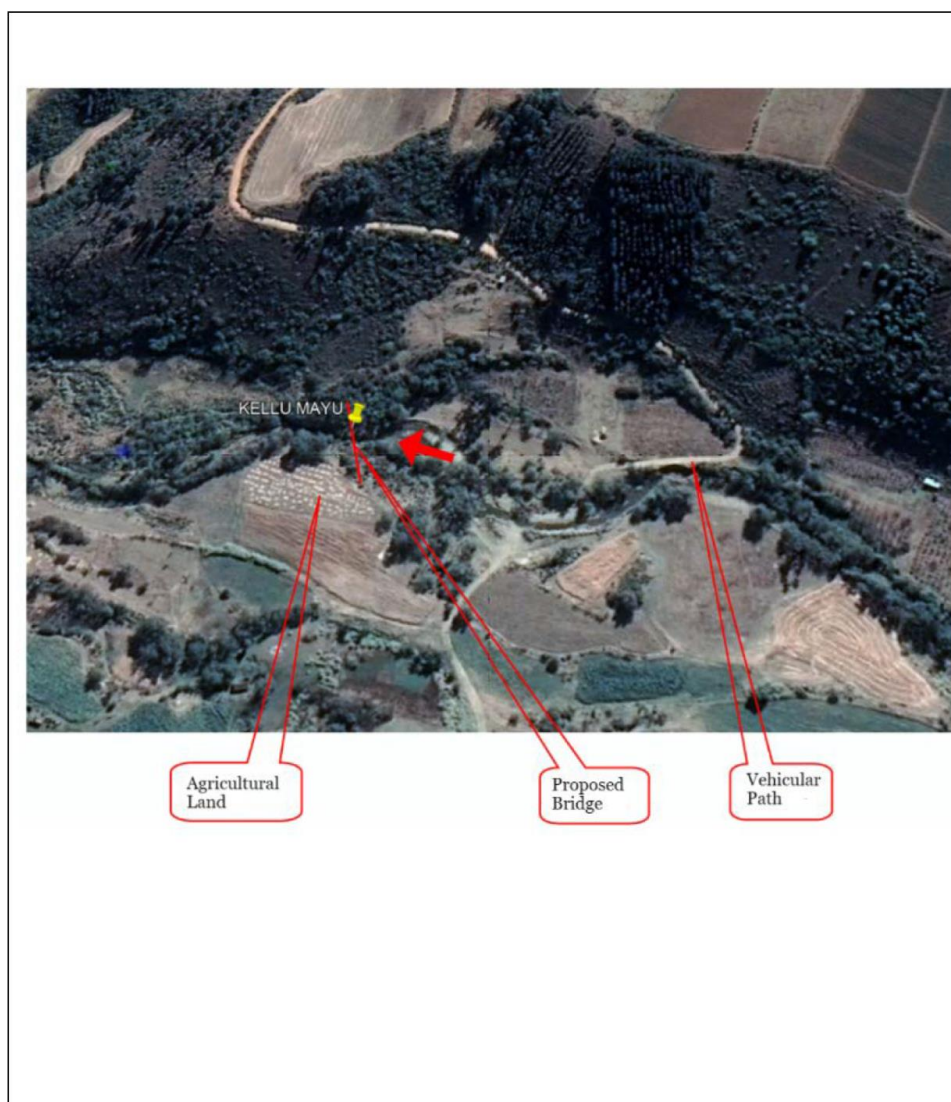
#### 4. Community map

*Include characteristics such as the location of the community or major centers of the population, the location of the proposed bridge, main roads and paths, schools, health centers, markets, churches, bus stops and buildings or communal houses.*
