Engineers in Action: Eswatini Suspended Bridge

A Technical Report submitted to the Department of Engineering Systems and Environment

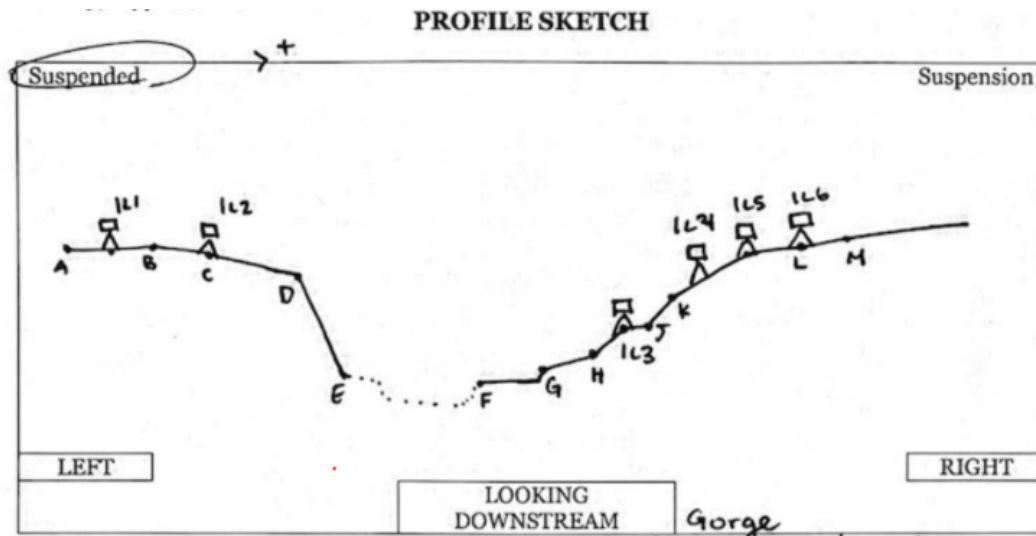
Figure 1. Surveying points provided in Technical Survey

The proposed alignment is shown below in Figure 1. The abutment area is mostly clear with no signs of erosion and big rocks along the proposed centerline. The technical assessment completed on site shows that there are no obstructions within the horizontal or vertical clearance areas along the proposed center line for the suspended bridge. There appears to be some vegetation and tree cover located both downstream and upstream, but the proposed centerline is free of both, as it is located within open fields on both the right and left side of the bank. Some larger rocks are located in the river at the location of the proposed center line, but they do not appear to be large enough to interfere with the construction of the bridge.

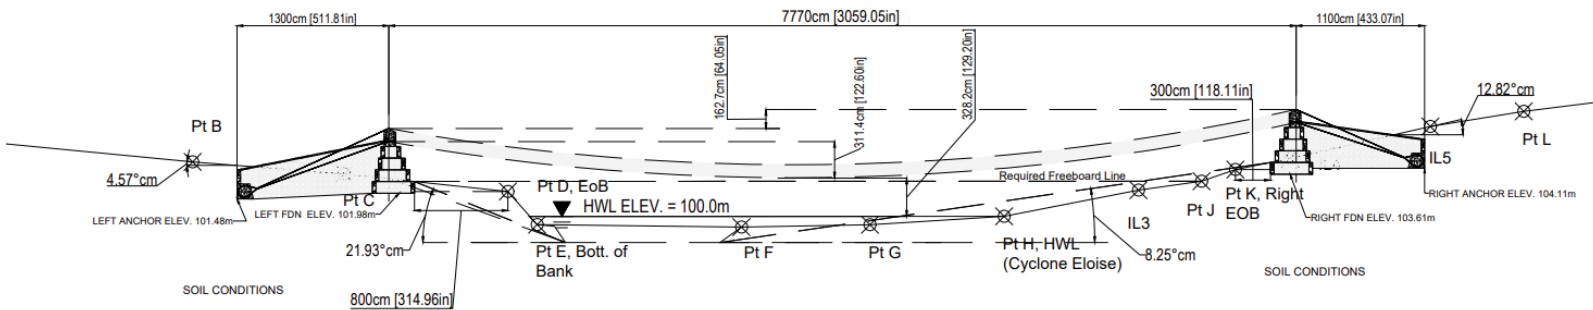
Figure 4. Preliminary design for Review Call #1

Our design for review call one used standard design elements and only met standard design checks. These standard design checks, which are specified by EIA, include: cable tensile capacity, suspender force analysis, tower overturning, foundation bearing pressure, anchor sliding, and anchor uplift. This design was also created to meet freeboard requirements based upon the shorter of two high water lines provided from surveyors. The primary goal of our design process was to minimize the span of the bridge—this relates to the constructability of the bridge as well as the cost of the bridge's superstructure. The profile of that design is shown in the figure below:

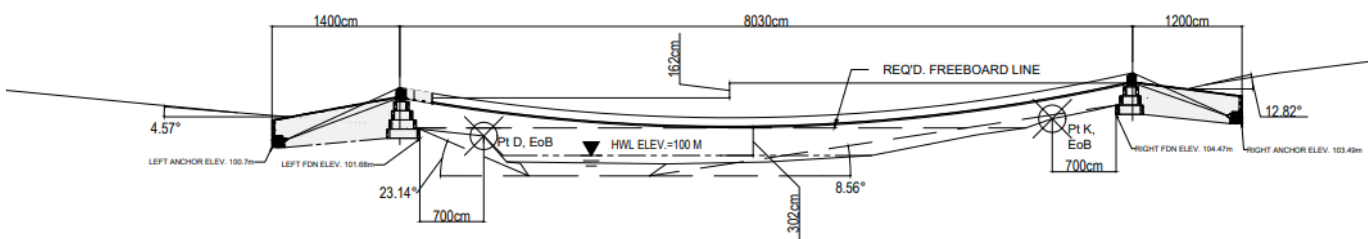
Figure 5. Design for Review Call #2

Comments from review call one as well as conversations with EIA personnel in January revealed that in addition to minimizing bridge span, reducing the amount of fill material and excavations required for bridge abutments should also govern design thinking. Our team took this into consideration before review call two. Our team created a design with a slightly longer bridge span than our previous one but it required smaller abutments. This reduction in abutment size was significant enough to make this new design more optimal than the previous one despite having a longer span length. A profile view of the design our team presented in review call two is shown below:

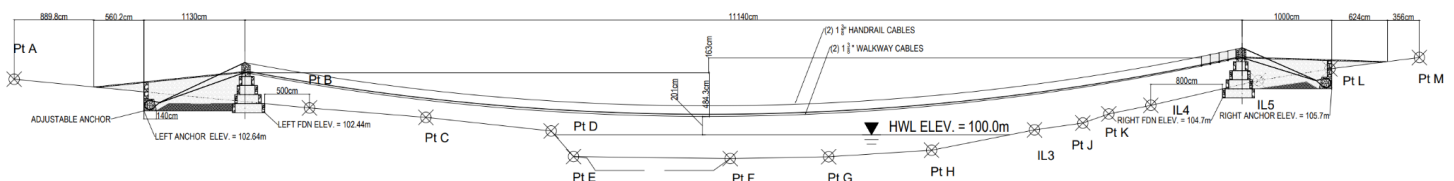
Figure 6. Design for Review Call #3

mark that was provided to our team. This required new geometric layouts to be tested to ensure standard requirements were met. Our team was also presented with a call to further optimize the bridge abutments used in our design, mainly in terms of excavation depth reduction. With these changes in mind, our team set out to create a new design that was presented in review call three. A profile of that design is shown below and the final drawings for that design are also included in Appendix B:

Slight adjustments were made to abutment design following review call three. These changes are shown in the full drawing set shown in the appendix.

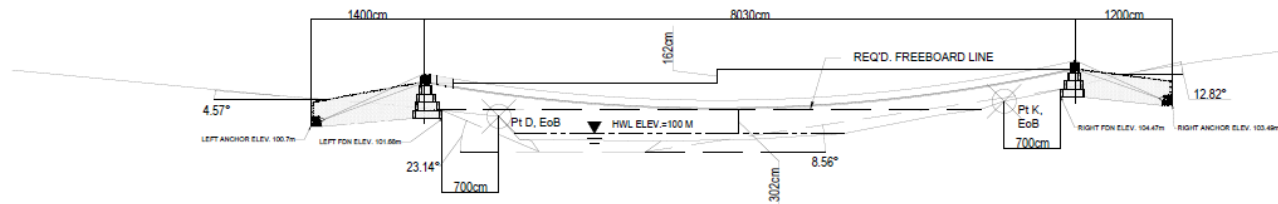
ELEVATION

- NOTES:
- DESIGN SAG: 4.02m (5.00%)
 - HOISTING SAG: 3.69m (4.60%)
f = 2.93m FROM LEFT ABUTMENT
f = 4.55m FROM RIGHT ABUTMENT
 - SURVEY INFORMATION PROVIDED BY FIRST&LAST NAME ON DATE.
 - LANDMARKS INCLUDED IN PLAN VIEW ARE FOR

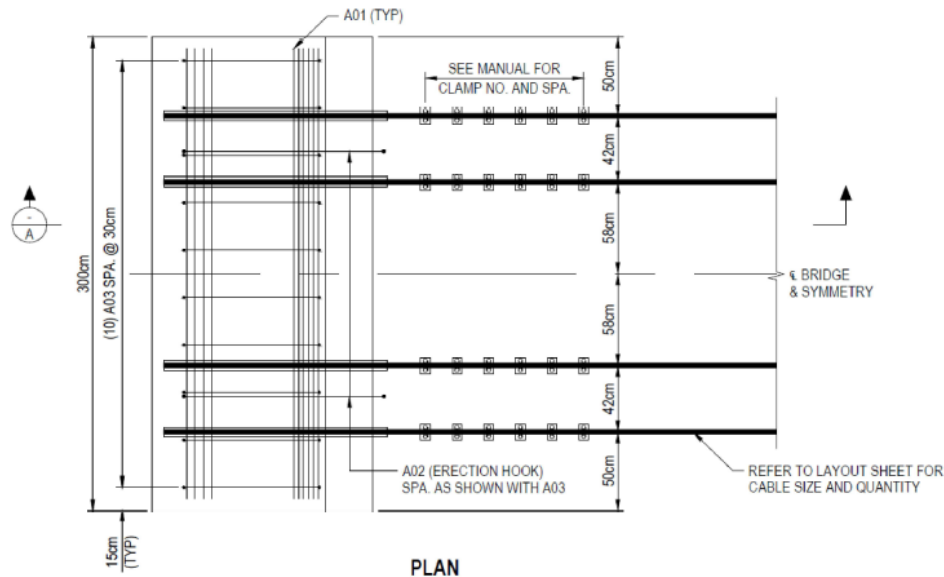
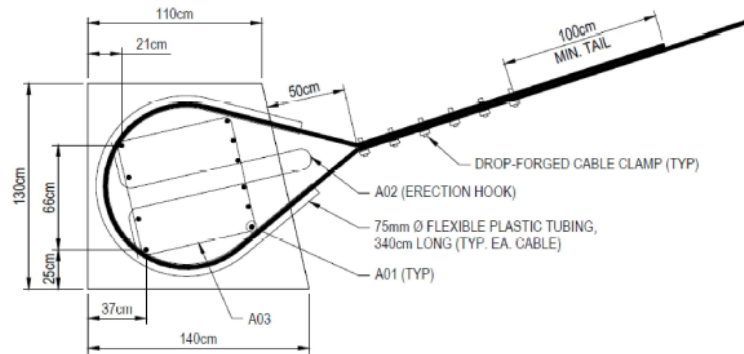
BILL OF MATERIALS				
REINFORCING BARS (PER ANCHOR)				
NAME	BAR SIZE (mm)	LENGTH (cm)	QUANTITY	LENGTH (m)
A01	19 (#6)	285	10	28.5
A02	16 (#5)	300	2	6.0
A03	13 (#4)	325	10	32.5
ITEM			QUANTITY	
CONCRETE			4.88m ³	
FLEXIBLE PLASTIC TUBING x 340cm			VARIES

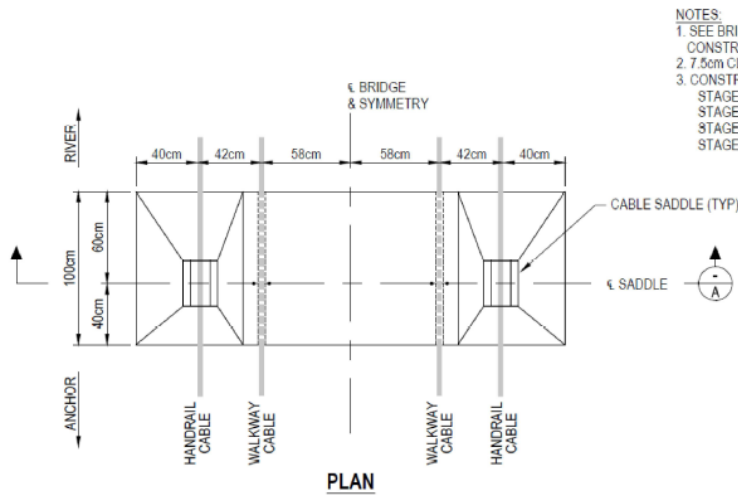
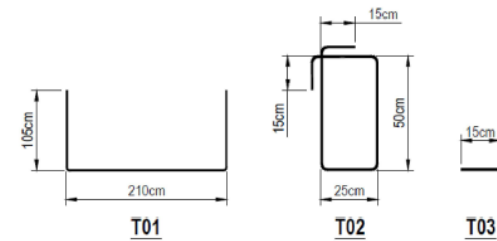
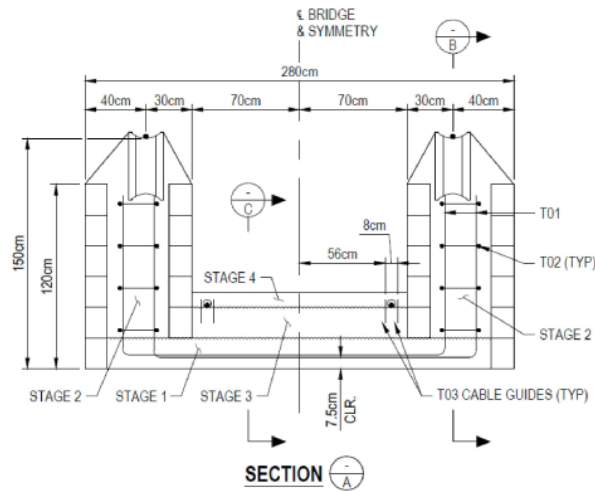
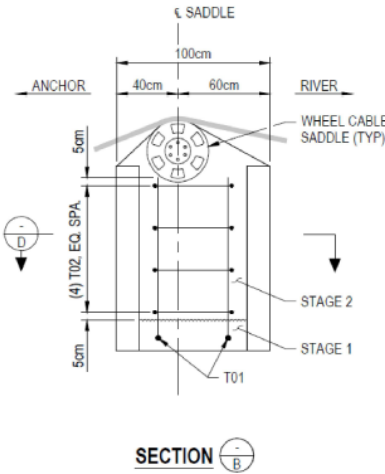
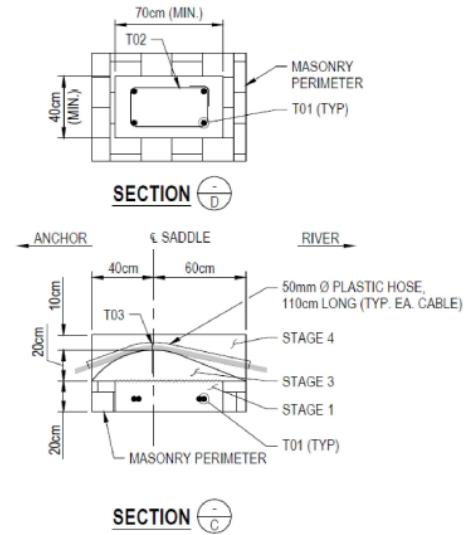
MAPHOVENI SUSPENDED FOOTBRIDGE T4_TOWER DETAILS	PROJECT NUMBER	DRAWING NUMBER
PROJECT_#		6

1. SEE BRIDGES TO PROSPERITY BRIDGE BUILDER MANUAL FOR CONSTRUCTION GUIDELINES.
2. 7.5cm CLEAR COVER SHALL BE PROVIDED FOR ALL REINFORCING.
3. CONSTRUCTION STAGES:
 STAGE 1 - BASE LEVEL MASONRY PERIMETER FILLED WITH CONCRETE.
 STAGE 2 - CONSTRUCT TOWERS IN LIFTS OF 20-40cm.
 STAGE 3 - CAST WALKWAY HUMP AND STAB T03 CABLE GUIDE BARS.
 STAGE 4 - CAST WALKWAY TOPPING SLAB OVER SLEEVED CABLES.

BILL OF MATERIALS				
REINFORCING BARS (PER TOWER)				
NAME	BAR SIZE (mm)	LENGTH (cm)	QUANTITY	LENGTH (m)
T01	16 (#5)	413	4	16.5
T02	10 (#3)	170	8	13.6
T03	10 (#3)	15	4	0.6

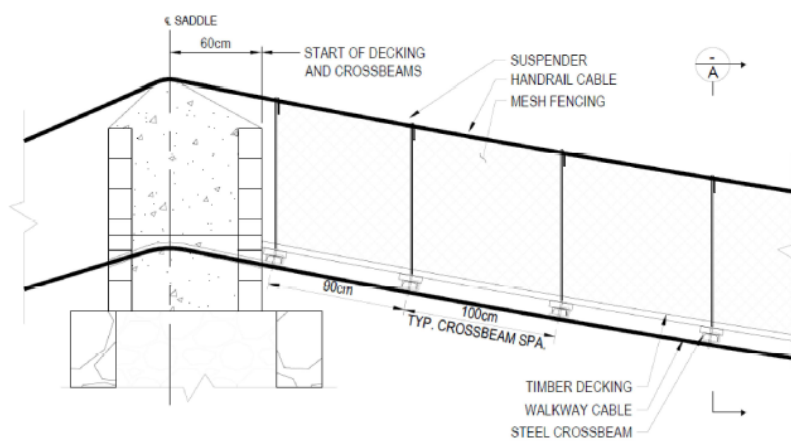
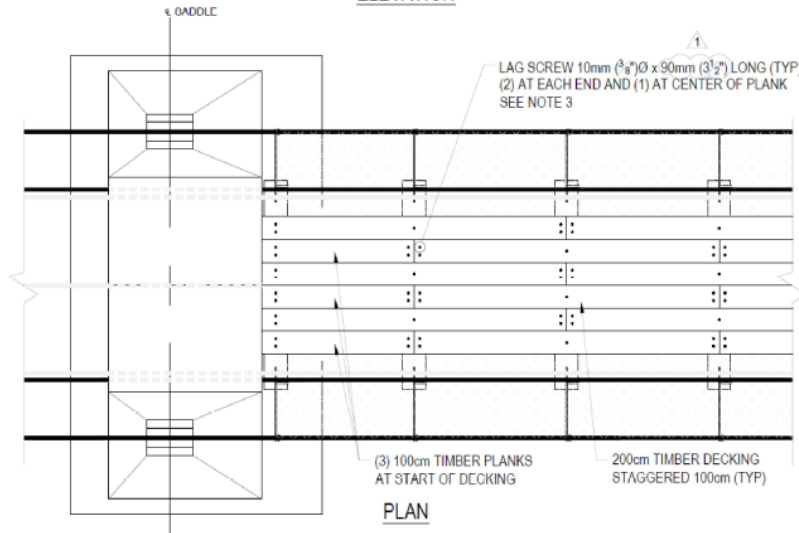
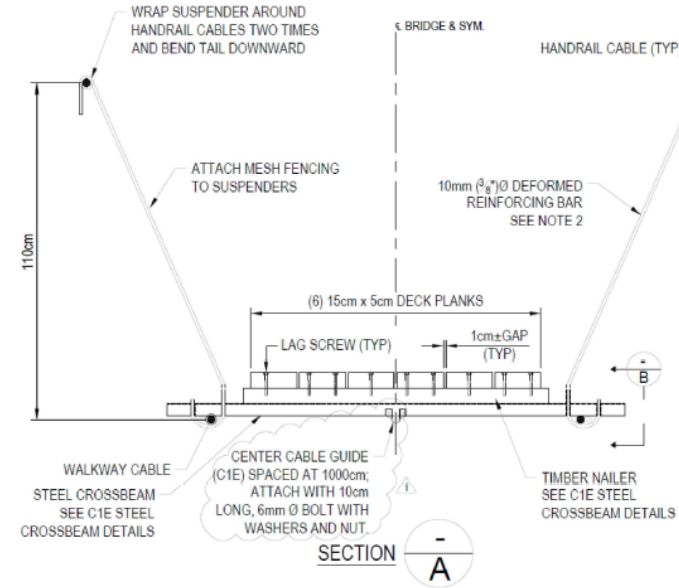
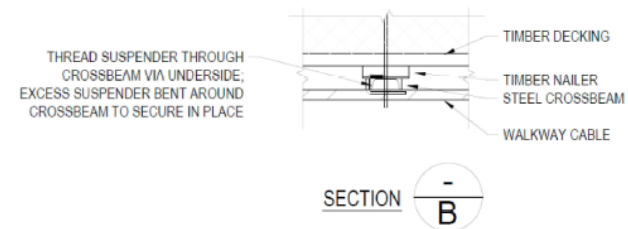
- NOTES:
1. SEE BRIDGES TO PROSPERITY BRIDGE BUILDER MANUAL FOR CONSTRUCTION GUIDELINES.
 2. CUT REBAR TO 200cm. BEND IN U TO FIT CROSSBEAM AT 40cm SO THAT STRAIGHT LEG IS 160cm.
 3. USE 8mm ϕ PILOT HOLE IN NAILER AND 10mm ϕ PILOT HOLE IN DECKING.
